**TITLE: Engineering Services Building Envelope Repairs and Leak Investigation
RI Youth Training School**

- **This addendum releases Attachment A - A report and analysis conducted by the firm of Simpson, Gumpertz & Heger**

Project 100264 – Leakage Investigation, Roosevelt Benton Youth Assessment Center,
Pastore Government Center, Cranston, RI

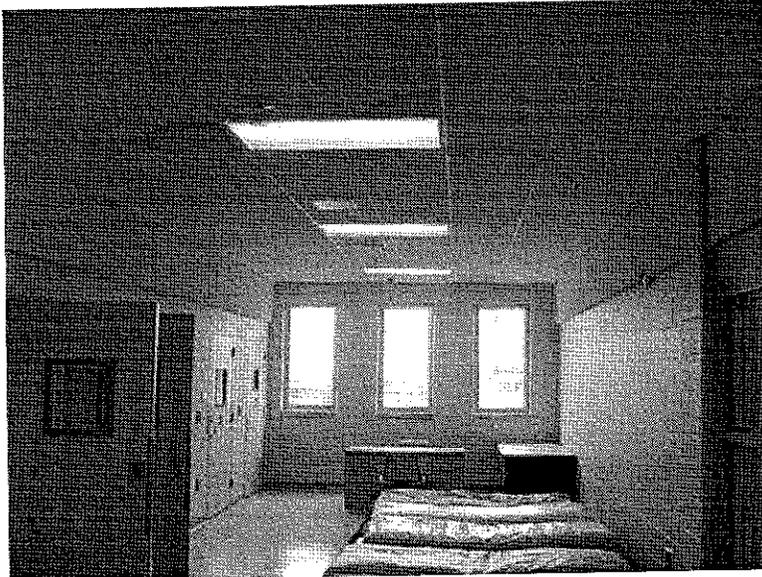
Photo 4

- Ceiling tiles, often below transitions between roof levels and below at least one louver (i.e. Unit A105; Photos 4 – 5). We note water stains and/or rust on various structural, electrical, and mechanical components located above ceilings, such as at lights, pipes, steel beams, and at joints and other penetrations through steel and concrete roof decks.
- We note water stains at the sill and jambs of at least one glass-block wall located at the end of a corridor (Photo 6). (We did not investigate glass-block issues during this phase of our work.)

Water-stained ceiling tiles by Unit A-105, below Area 1.

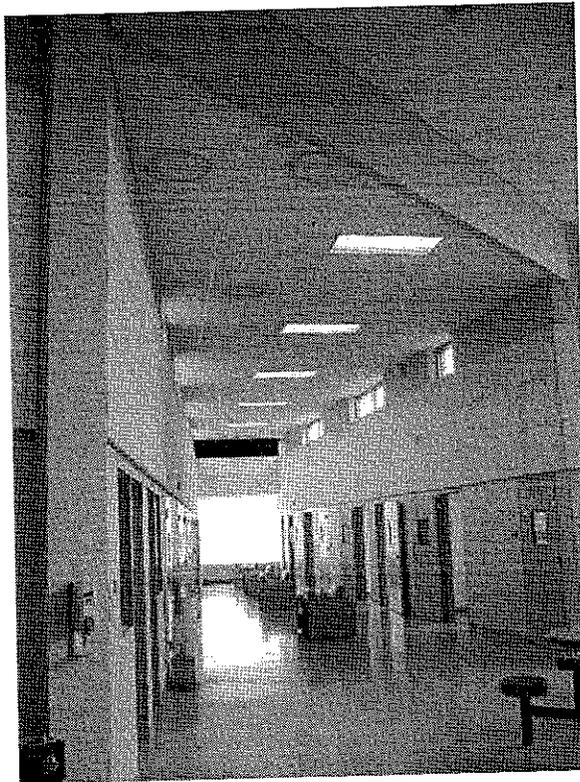
Photo 5

Water-stained ceiling tiles
below Area 2.

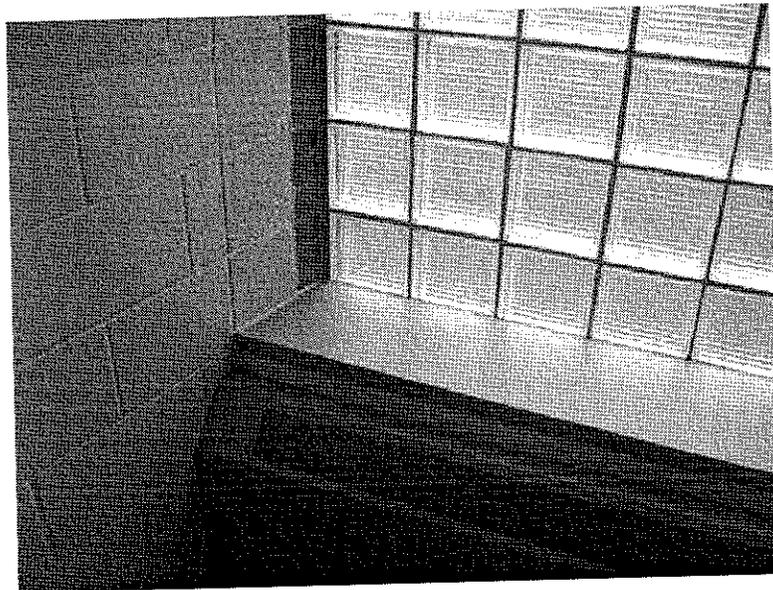
Photo 6

Water stains at sill of glass-
block wall.

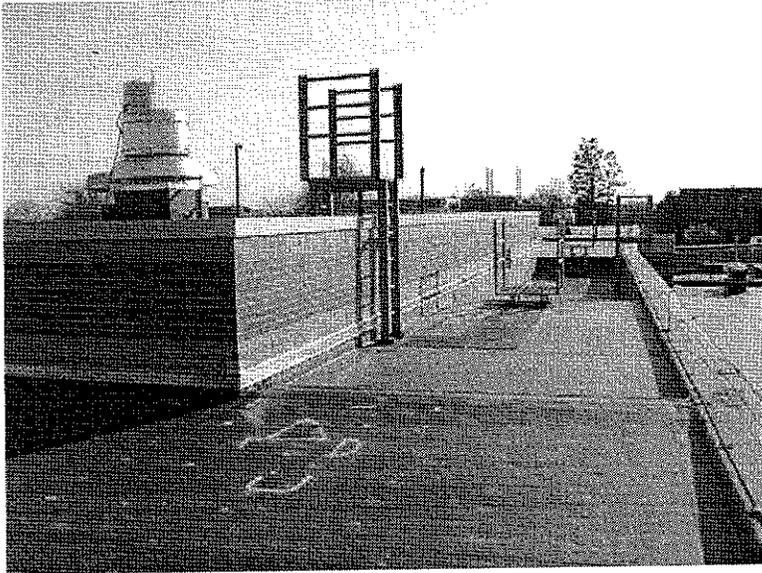
Photo 10

- Due to the unusual geometry of the building and the large number of roof levels that run longitudinally and parallel, there are long runs of through-wall flashing (TWF) adjacent to many of the roofs, including Area 1 (Photos 3 and 10). Various tight/acute inside corner conditions (Photo 11) and other unusual transitions such as parapet terminations and windows intersecting the TWF (Photo 12) create various complicated flashing conditions.

Long run of TWF.

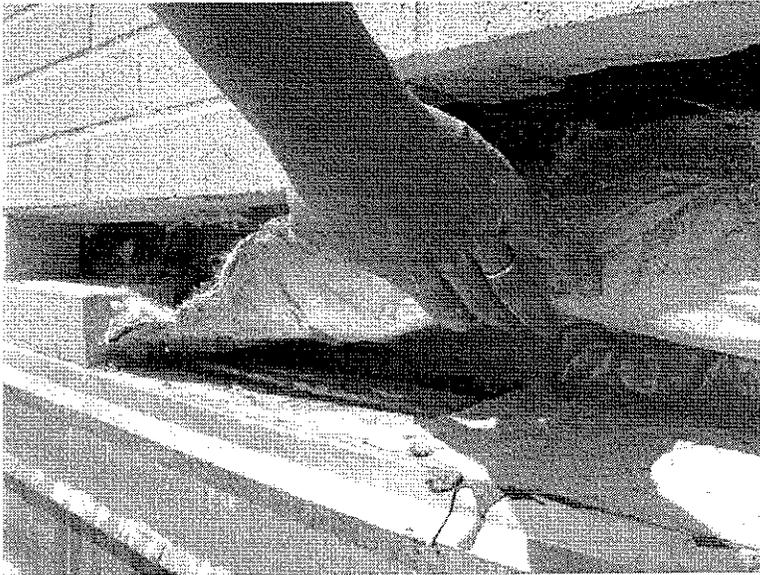
Photo 16

- In various areas the fabric is not bonded down to the stainless steel drip edge, including some areas several feet long (Photos 15 – 22). We were able to identify some of these areas prior to making probe openings by inserting a 12 in long, approximately 0.020-in thick, metal feeler gage between the fabric flashing and the metal drip (Photos 18 and 19). Some laps/seams in the stainless steel are not bonded/sealed (Photos 20 and 21). We observed one lap in the fabric flashing (Probe 2), and it also is not bonded or sealed (Photo 16).

Unbonded fabric flashing at Probe 2.

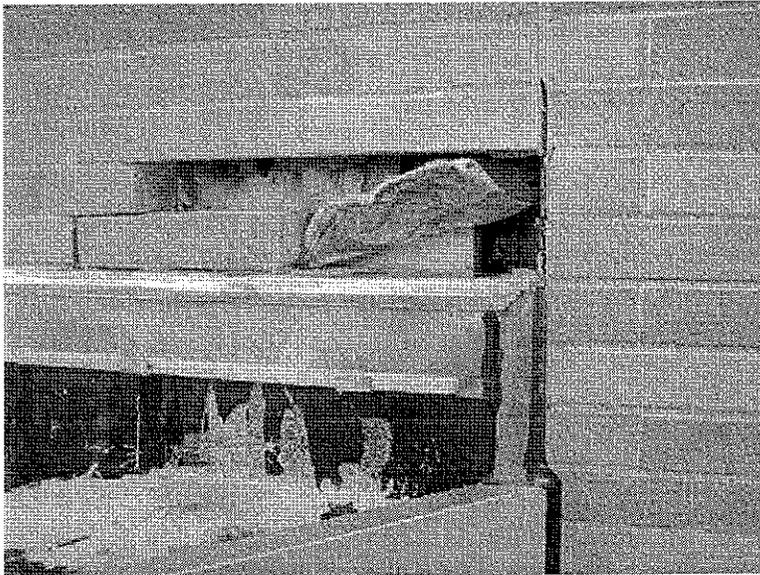
Photo 17

Unbonded fabric flashing and no end dam at Probe 4.

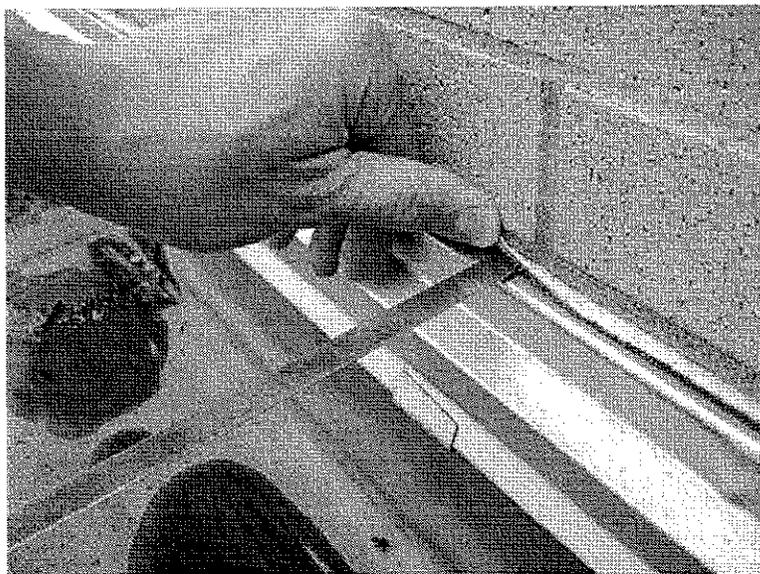
Photo 18

Feeler gage inserted between fabric flashing and metal drip, indicates lack of bond between these layers.

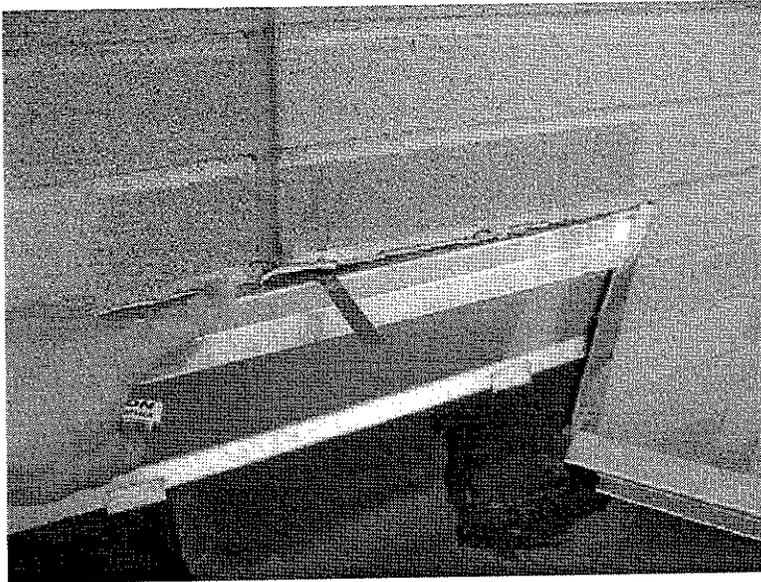
Photo 19

Feeler gage inserted between fabric flashing and metal drip.

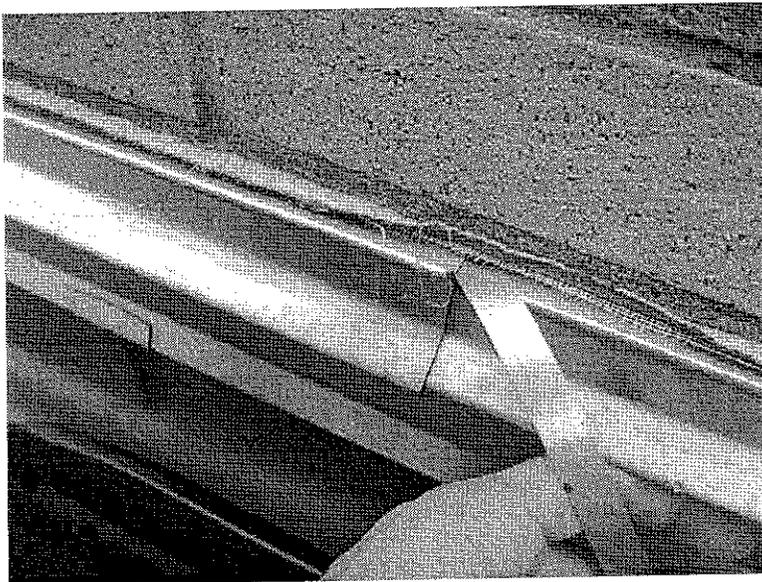
Photo 20

Feeler gage inserted in unsealed/unbonded seam in metal drip flashing.

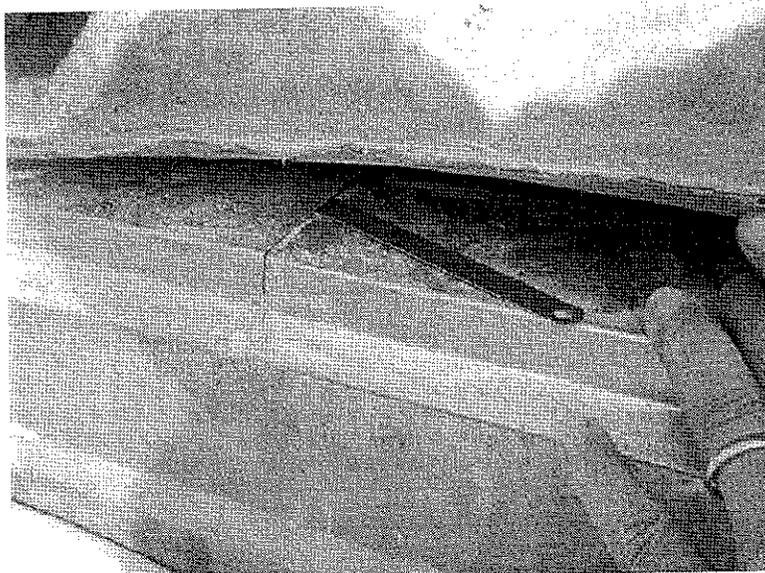
Photo 21

Feeler gage inserted in unsealed/unbonded seam in metal drip flashing at Probe 1

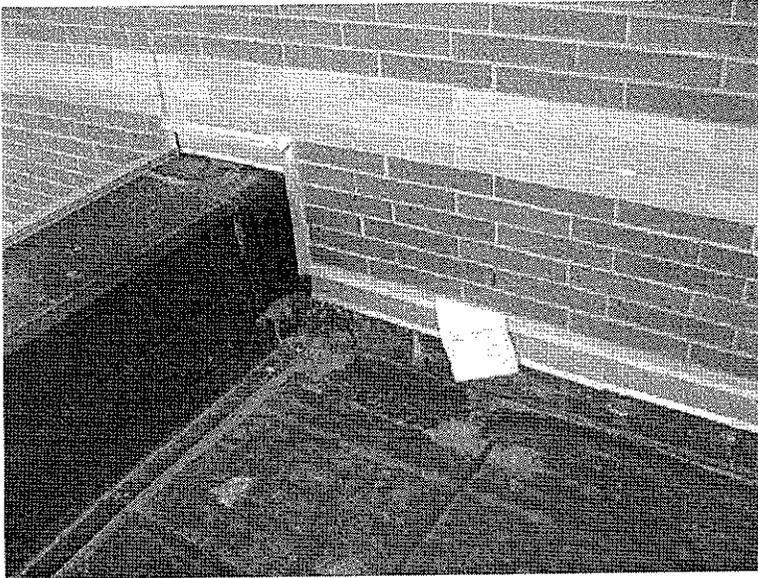
Photo 22

- We are able to insert our feeler gages (and other thin instruments, such as notebook covers) between fabric flashing and metal drips at various other areas of the west wing. We checked one area of the east wing, above the leaky Unit C-103, and note similar results (i.e., no bond between fabric and metal drip at some areas; Photo 22).

Material inserted between fabric flashing and metal drip, area over Unit C-103.

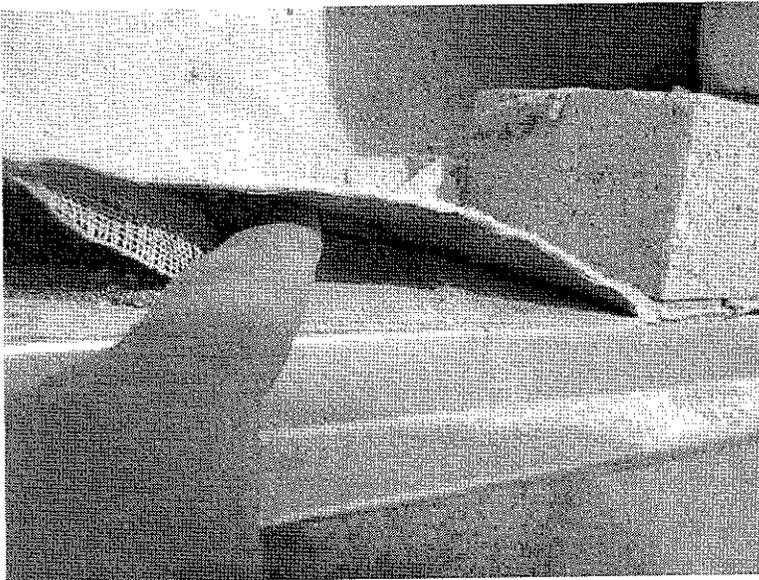
Photo 23

- The fabric flashing is delaminating within itself in various areas (Photos 23 – 24).
- Weep vents are not located at the lowest point on the flashing; they are raised up one course (Photo 25). Weep vents are sealed shut in many areas (Photo 26); this appears to be a remedial attempt at reducing leakage through the walls/flashing.

Delaminated fabric at Probe 1.

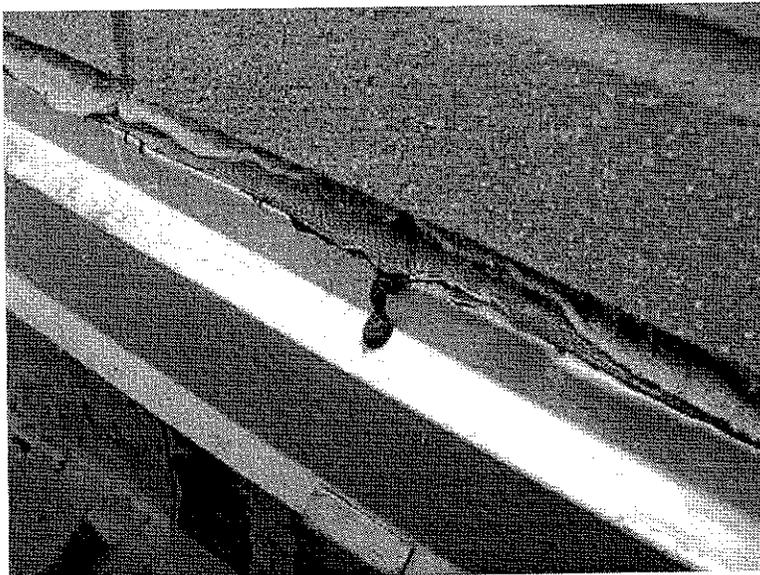
Photo 24

- Apparent freeze-thaw damage is visible at the mortar/bed joint immediately above the TWF in many areas (Photos 24 and 25).
- Termination bars at the top edge of TWF are not tight to the backup wall at some locations between fasteners (Photo 29), though the fabric does appear to be sealed to the backup wall at these locations.

Delaminated edge of fabric flashing and deteriorated mortar joint.

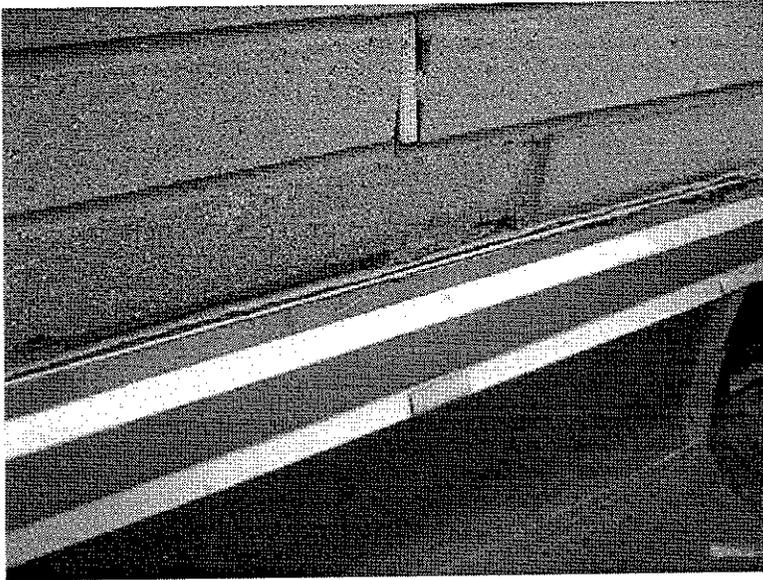
Photo 25

Weep vent raised up above TWF level, and deteriorated mortar joint at TWF level.

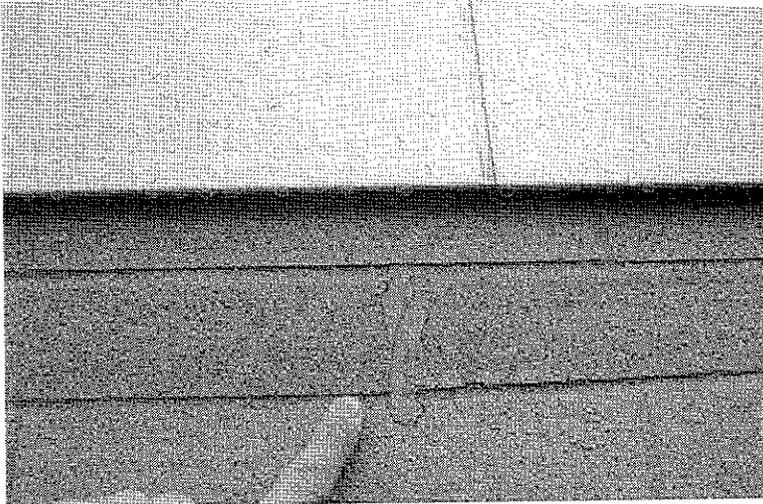
Photo 26

Previous surface-level attempts to address the TWF problems, such as sealing weep vents shut and applying sealant along the outer edge of TWF, have been unsuccessful in preventing leakage. In fact, the sealant applied at the edge of the TWF appears to be trapping water on the flashing, which actually exacerbates leakage. Trapping the moisture also exacerbates freeze-thaw damage at the bed joint below the first course of masonry.

Sealed weep vent, apparently an attempt to reduce leakage.

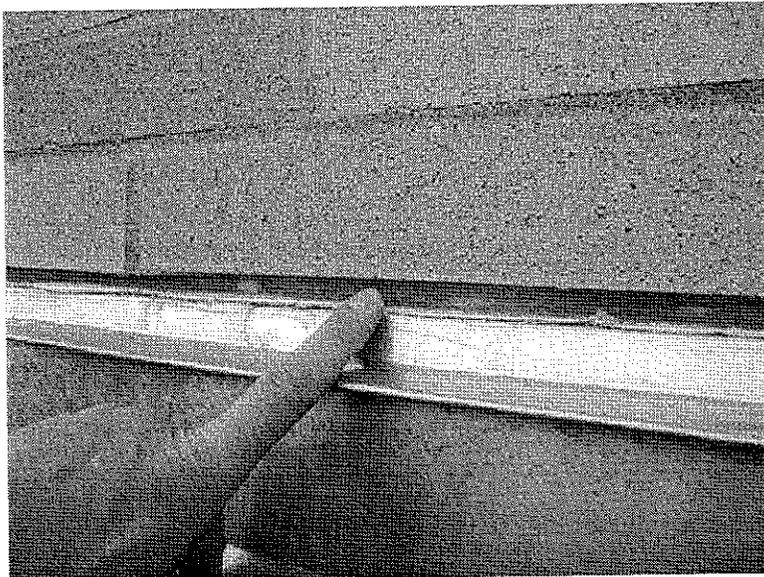
Photo 27

- Other apparent remedial measures are also present, such as sealant installed along the outer edge of the metal drip (Photo 27), and aluminum brake metal applied over the face of the brick at inside and outside corner conditions (Photo 28).

“Remedial” sealant in place between fabric flashing and masonry above

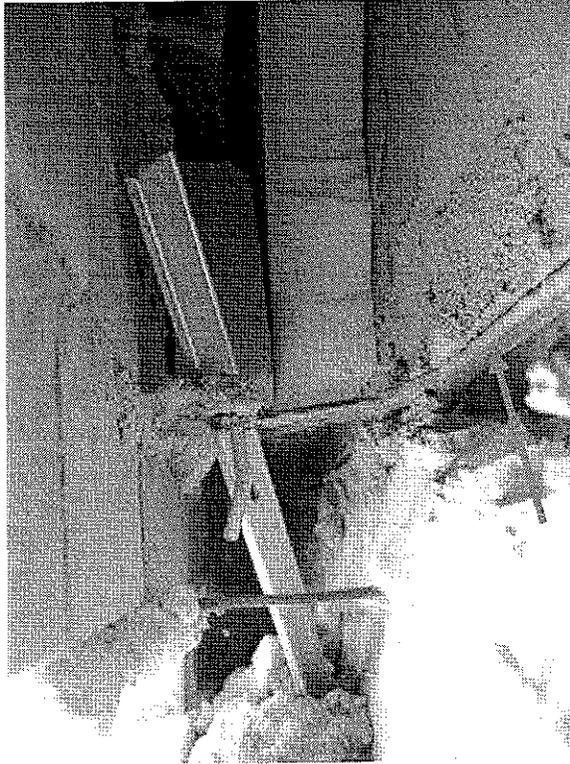
Photo 30

CMU wire reinforcing
"exposed" in cavity.

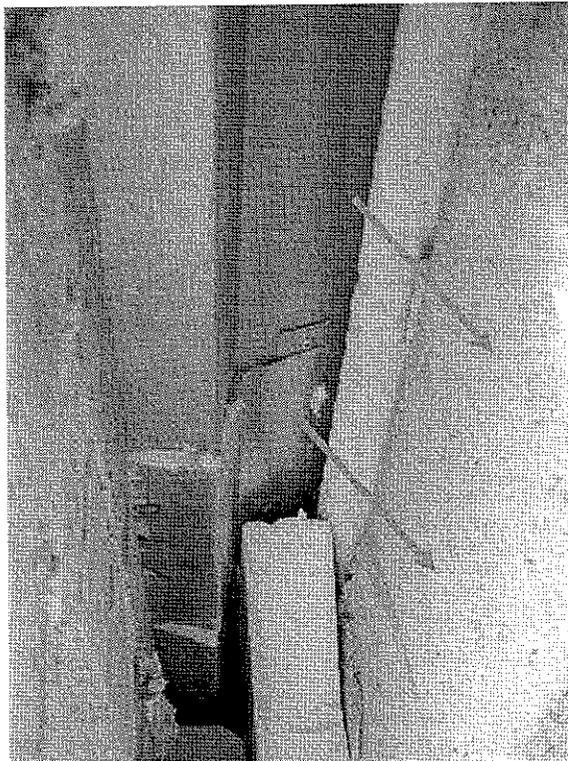
Photo 31

- At Probe 2, below the louver, no dampproofing is installed on the CMU backup wall (Photo 31). We do not know if this is related to the repair work that we understand was performed in this area.

CMU backup missing
dampproofing at Probe 2
(view within wall cavity).

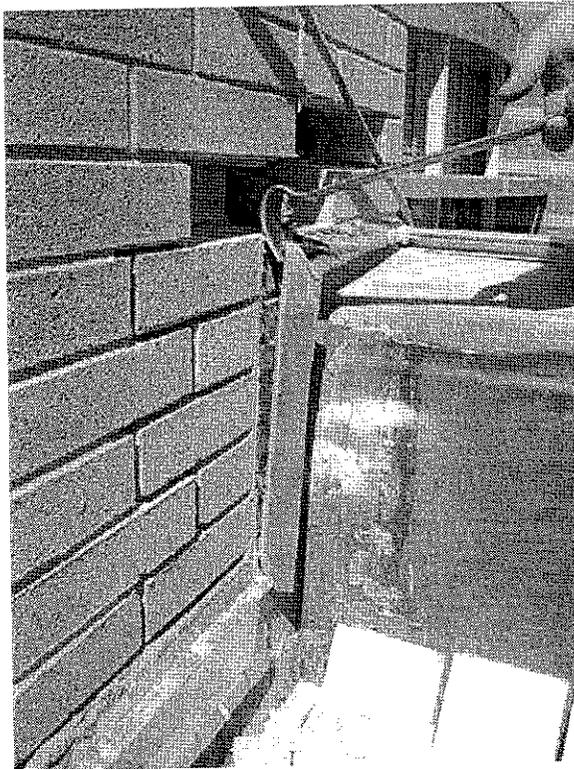
Photo 33

Parapet terminations at rising walls are common features on the building and the TWF is not continuous or effective at these conditions. Therefore, any reliable TWF repair will require reworking the TWF at and around parapet termination conditions. In addition, in many areas of the building, clerestory-style windows are located down at the level of the TWF. Removal and reinstallation of these windows will also be needed to allow widespread TWF replacement work.

Probe 3 showing how the TWF ends at the parapet edge; only a surface applied J-bead turns up the vertical transition.

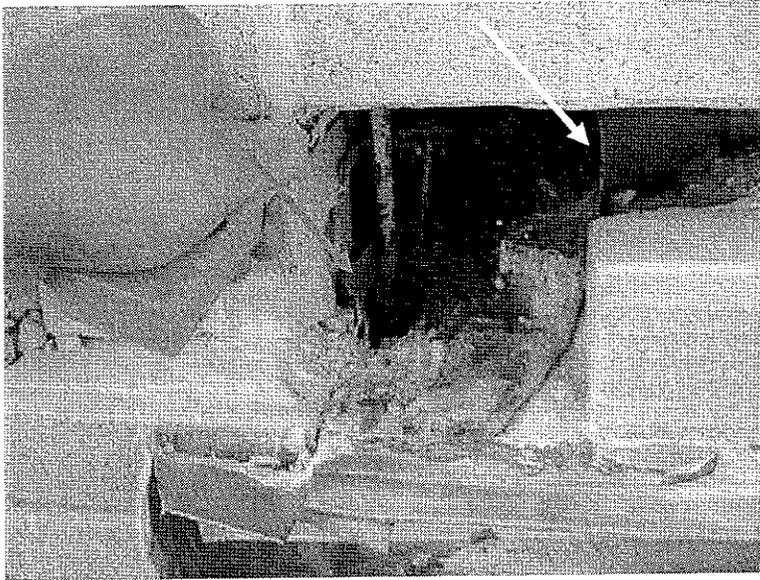
Photo 34

- We observed two TWF assemblies that appear to drain into the body of a parapet wall (rather than out onto the surface of the roof) at Area 1 (Probe 3). The main TWF assembly immediately above the roof does not turn up vertically.

View at Probe 3; note the fabric flashing buried deep in the wall that does not drain to the exterior (red arrow). Also note the atypical rubberized-asphalt-membrane pocket that was exposed during the probing (yellow arrow).

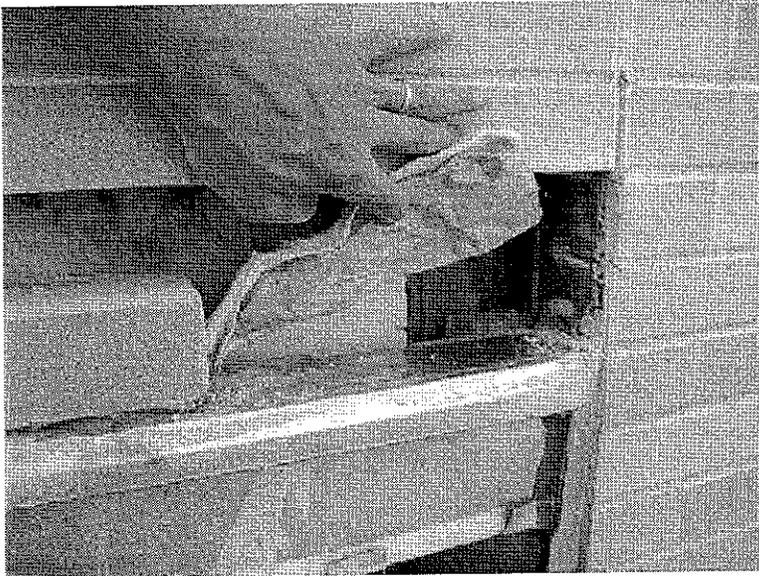
Photo 35

TWF termination at Area 2 wall (Probe 4); note that no end dam is present.

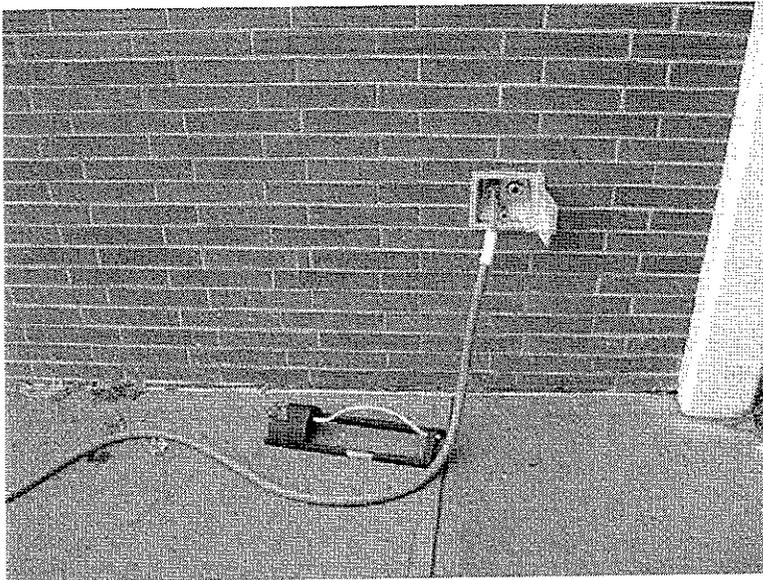
Photo 40

TWF at grade that resembles the problematic TWF flashing above low roofs.

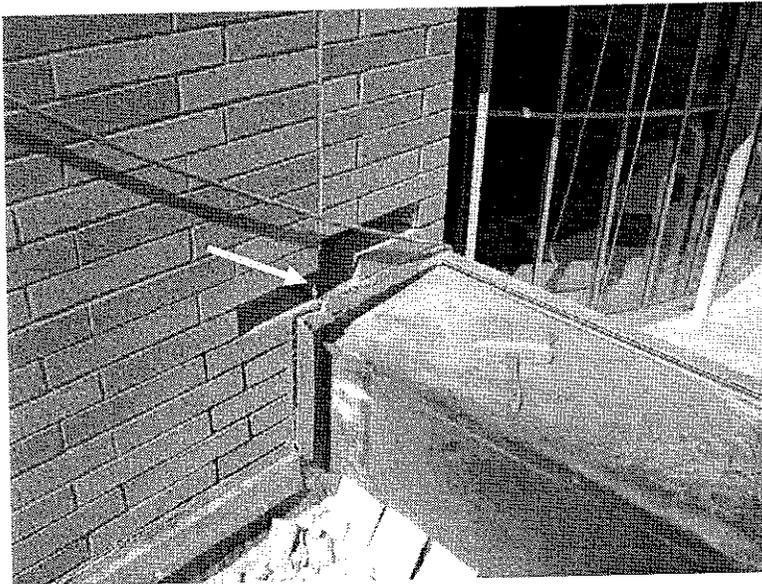
Photo 51

- Some areas appear to have been repaired previously, as indicated by nonmatching mortar (Photo 39), and other atypical sealant, mastic, and metal cap products discussed above. We also note that a rubberized-asphalt-membrane “pocket” is installed over a portion of the parapet termination in Area 1 (Probe 3; Photo 51). This condition is atypical and appears to be a remedial measure.
- We note that a layer of TWF is also located at grade (i.e. at the first floor; Photos 40 and 41). This flashing appears to be constructed similarly to the problematic TWF flashing described above.
- The fabric flashing at Probe 2 was partially damaged during removal of the brick masonry above.

Atypical RAM pocket at
parapet termination at
Probe 3

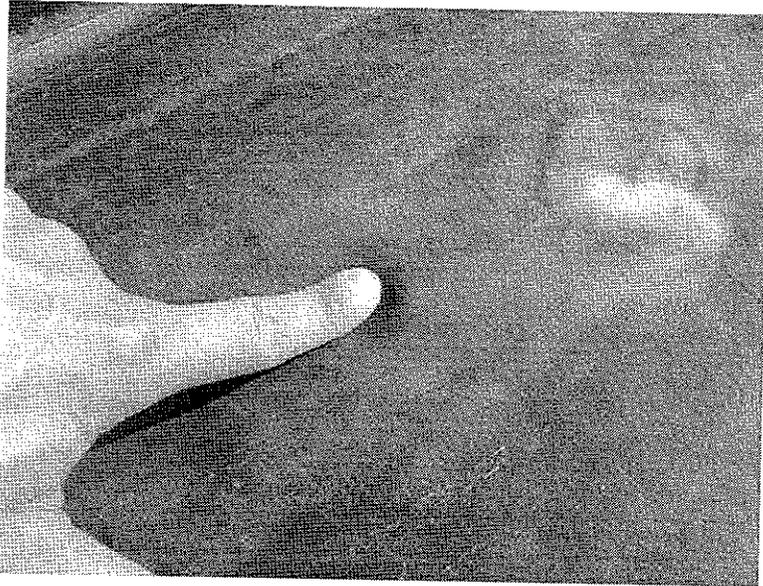
Photo 52

- We note no obvious defects at the exposed surface of the roof membrane. We note occasional small pieces of debris, such as fasteners and washers and screws related to the lightning protection system, on the surface of various roof areas, though we do not note any related damage to the membrane. We also note occasional partial "nail pops" (i.e., fasteners beneath the membrane that are beginning to back out) at some west wing areas away from Areas 1 to 3, though there does not appear to be any associated damage to the membrane (Photo 52).

Partial nail pop visible through roof membrane; membrane currently is not damaged

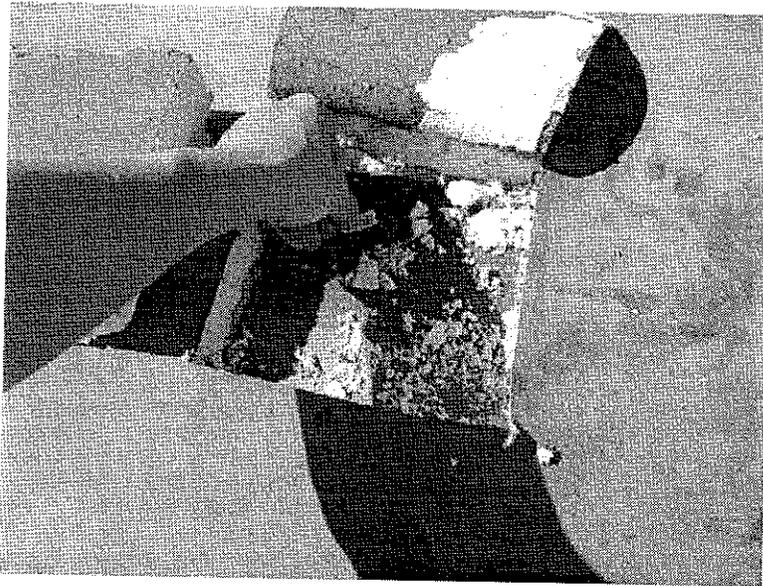
Photo 53

Unfortunately significant areas of the roof have been damaged due to ongoing leakage through the adjacent rising walls. The roof membrane is adhered to the fiberglass facer of the iso roof insulation; wetting the insulation has caused it to soften, reduced its thermal effectiveness, and has begun to cause the fiberglass facers to delaminate from the foam core. Delaminated facers to which the EPDM membrane is bonded compromise the uplift resistance of the roofing system.

Roof probe (Probe 6); note the pink color of moisture-indicating paper that indicates presence of water

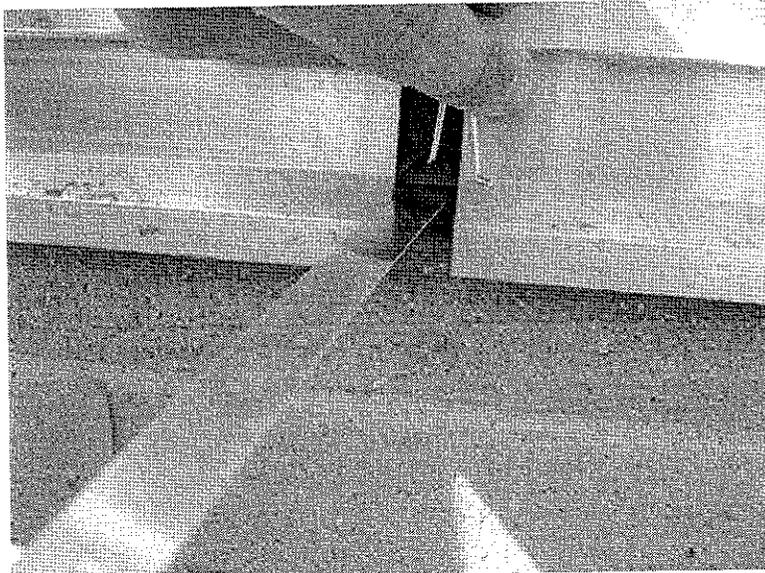
Photo 57

- At roof edge conditions, the roof membrane does not appear to connect to (or overlap/counterflash) the dampproofing on the CMU backup wall. The bottom edge of the associated wood blocking is visible below the edge of the membrane at Probes 7 and 8 (Photos 55 and 57).

Up-close view of joint in base component of roof edge flashing; note the edge of the EPDM membrane, the wood blocking, and the unsealed joint beneath the blocking (feeler gage inserted).

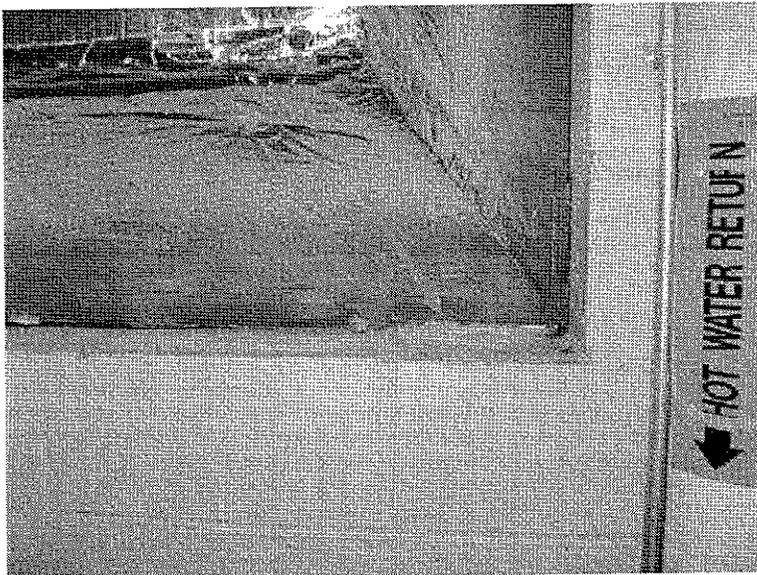
Photo 61

- There is no flashing or other material connecting the perimeter of the louver to the weather barrier (dampproofing) of the adjacent masonry wall system (though there is a pan flashing at the sill, as noted above). Cavity insulation is visible from the interior of the mechanical space (Photos 61 and 62). Interior mechanical space is visible through our probe openings in the brick veneer.
- A reverse pitch/slope is present at the louver sill flashing pan; the pan slopes to the interior rather than the exterior (Photo 59).

Exterior cavity insulation visible from interior/mechanical space by louver

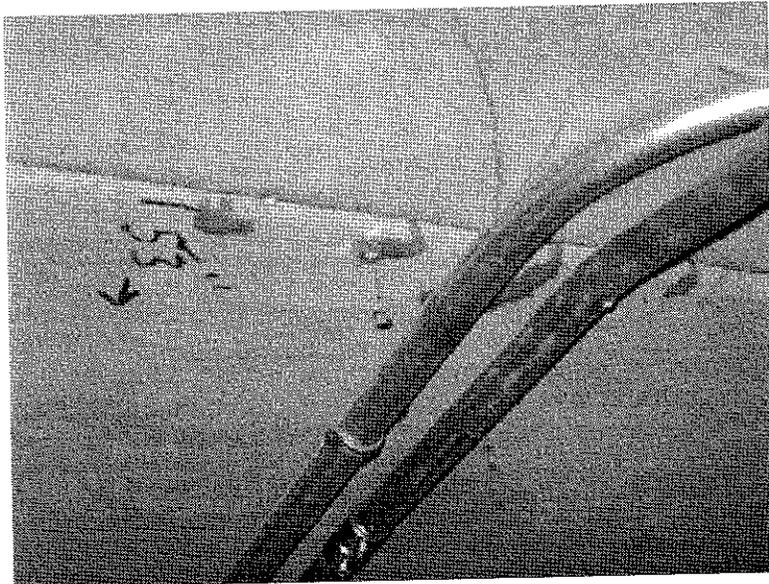
Photo 66

- During WT2C, 3, 10, and 11, water leaked to the interior through various unsealed/nonadhered joints in the TWF. WT 3 was halted almost immediately (under 5 min) due to heavy leakage to the interior. The lack of an end dam or other reliable transition also contributes to leakage during WT 10 and 11
- During WT1, we noted water on the floor of Unit A105 near the east exterior wall. The water appears long before any water drips from the ceiling area above and appears to be related to the east exterior masonry wall. We suspect that it is due to incidental water from the nearby spigot leaking through the TWF that is located at grade, though we did not investigate this leakage path further.

Water passing through joint between precast concrete deck planks during WT2C.

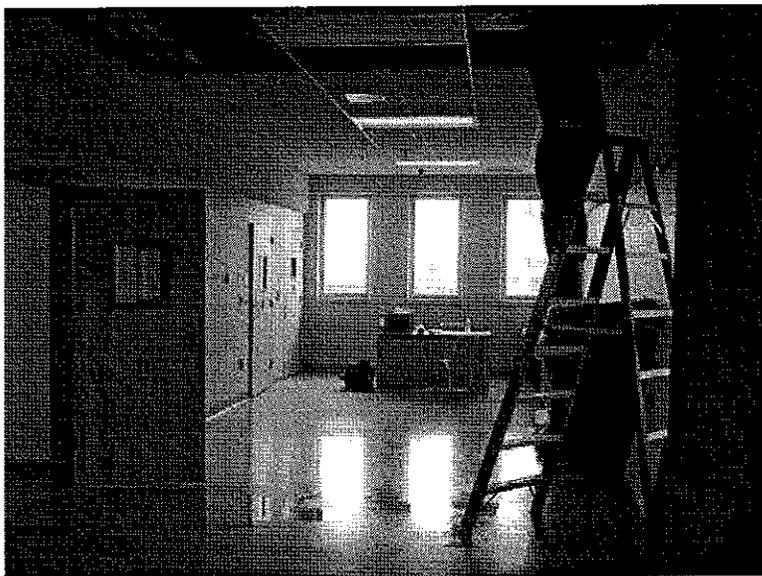
Photo 69

Heavy leakage during WT3; note the water collecting on the floor.

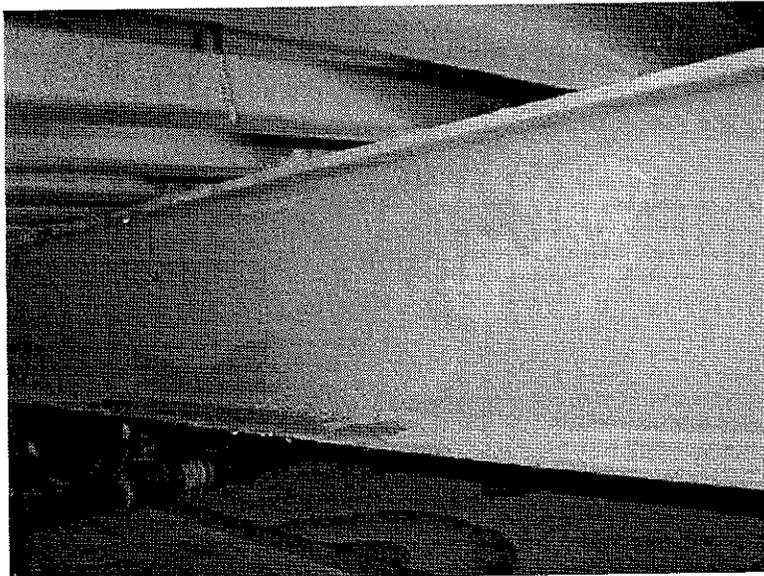
Photo 74

Water entering the building at defects in the TWF travels long distances within the metal flutes of the corrugated steel decking and on flanges of structural steel beams below Area 2, as well as leaking down immediately below the defective wall flashing. The lengthy, relatively unbroken water paths created by the decking and steel beams may seem to indicate roof leakage to the building occupants when wall leakage is actually the problem (though damage to the roof is also occurring due to this leakage path).

Water collecting on flange of steel beam and dripping off during WT11.

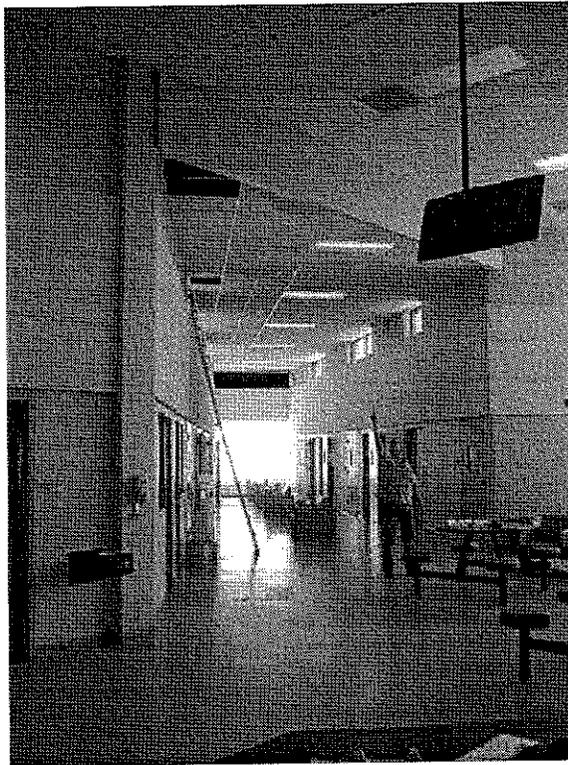
Photo 75

Water leakage during WT11;
note wet ceiling tiles and
water collecting on the floor.

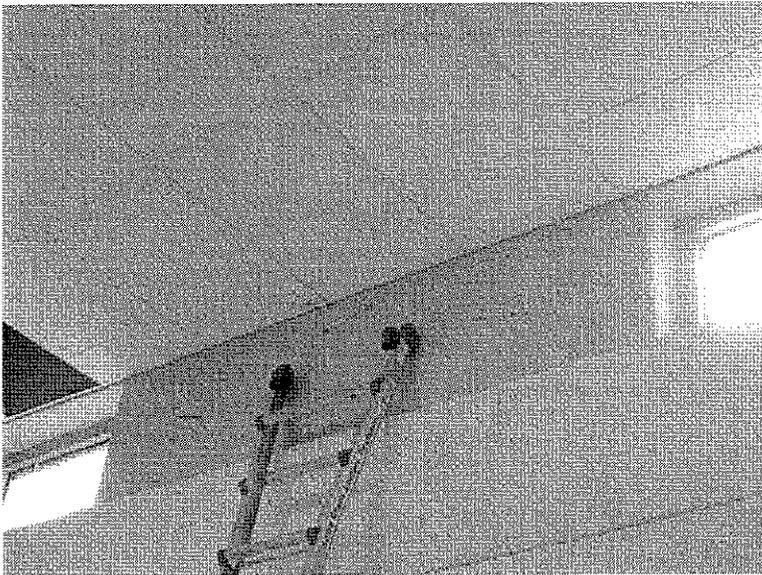
Photo 78

Heavy leakage during WT13A; note the pink color of moisture-indicating paper that indicates presence of water.
