**0031N OLD SAKONNET RIVER BRIDGE DEMOLITION**

NOTICE TO PROSPECTIVE BIDDERS

ADDENDUM NO. 1 Prospective bidders and all concerned are hereby notified of the following changes in the Plans, Specifications, Proposal and Distribution of Quantities for this contract. These changes shall be incorporated in the Plans, Specifications, Proposal and Distribution of Quantities, and shall become an integral part of the Contract Documents.

The purpose of the examination was to determine the condition of the coating system in order to provide recommendations for maintenance coating work. This report includes background information, observations and data from the field investigation, laboratory results, a discussion of the findings and recommendations for maintaining the protective coating system on the bridge. Photographs depict typical coating conditions.

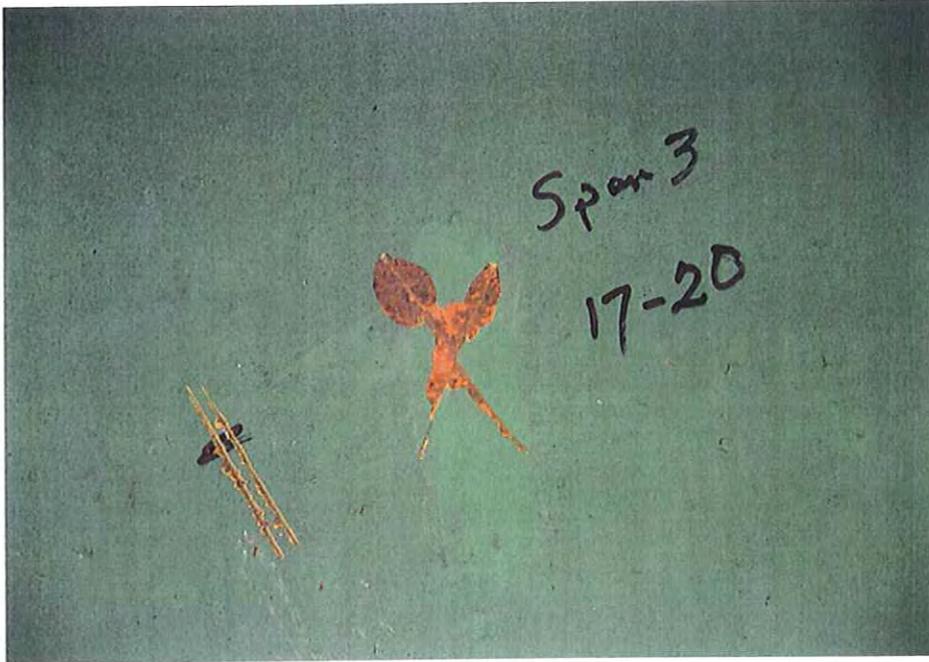
Photograph No. 1

Site of adhesion test on a rolled stringer in Bay 3. Note poor adhesion results, that resulted in the fracture occurring within the aged brittle orange primer.

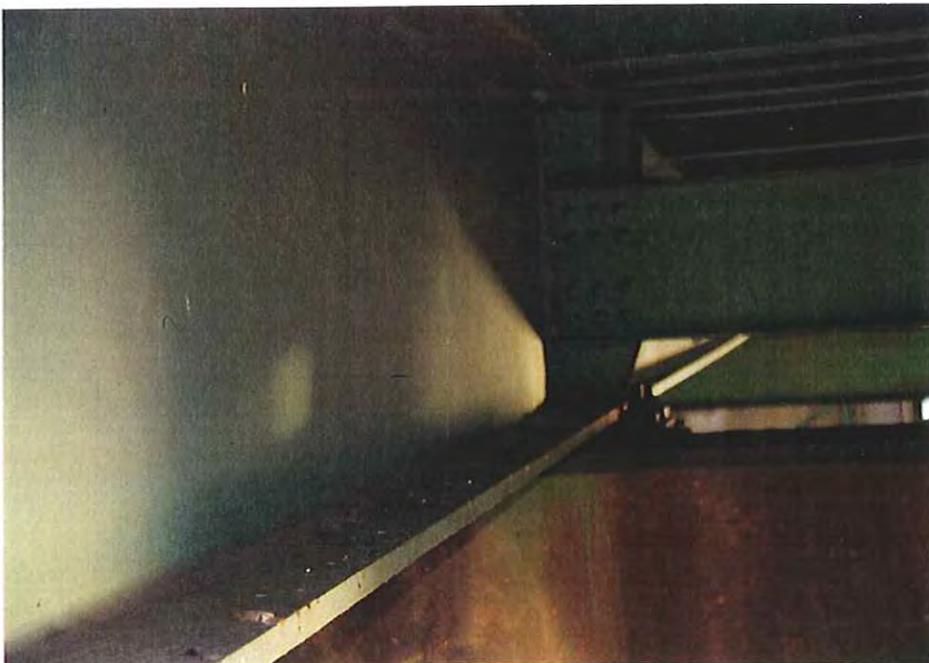
Photograph No. 2

Typical coating condition in the west bays. Shown is a stringer in Bay 3.

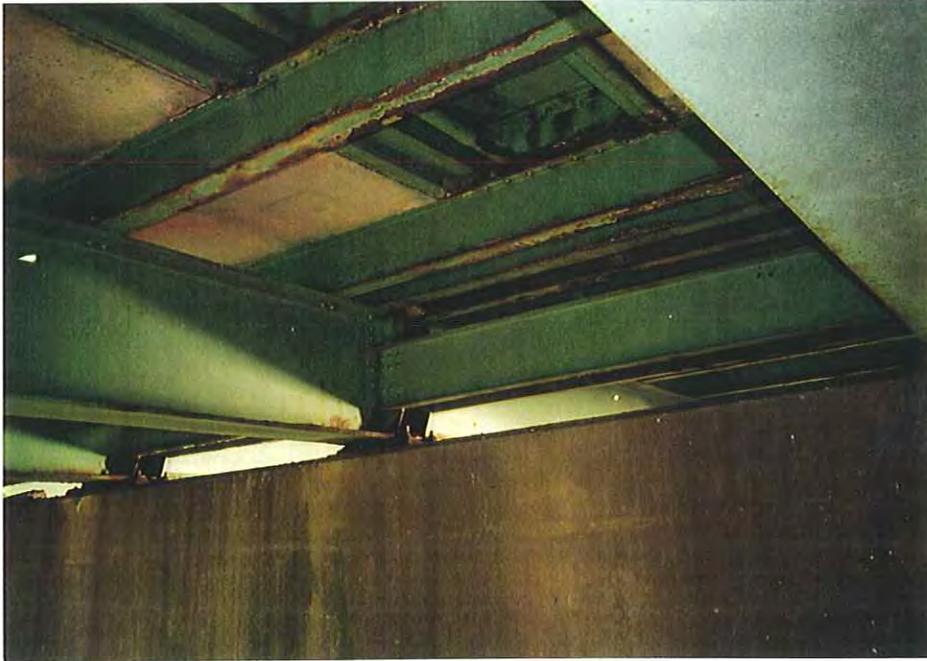
Photograph No. 3

Note corrosion over the center of Pier 3, due to water run-off.

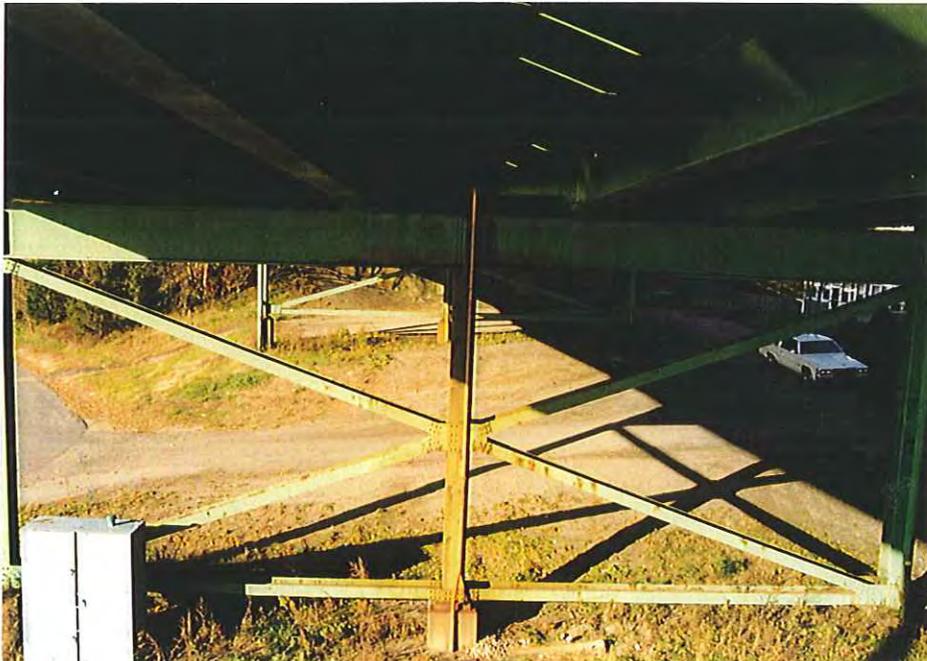
Photograph No. 4

Note the center portion of Bent 2 has corrosion and rust staining.

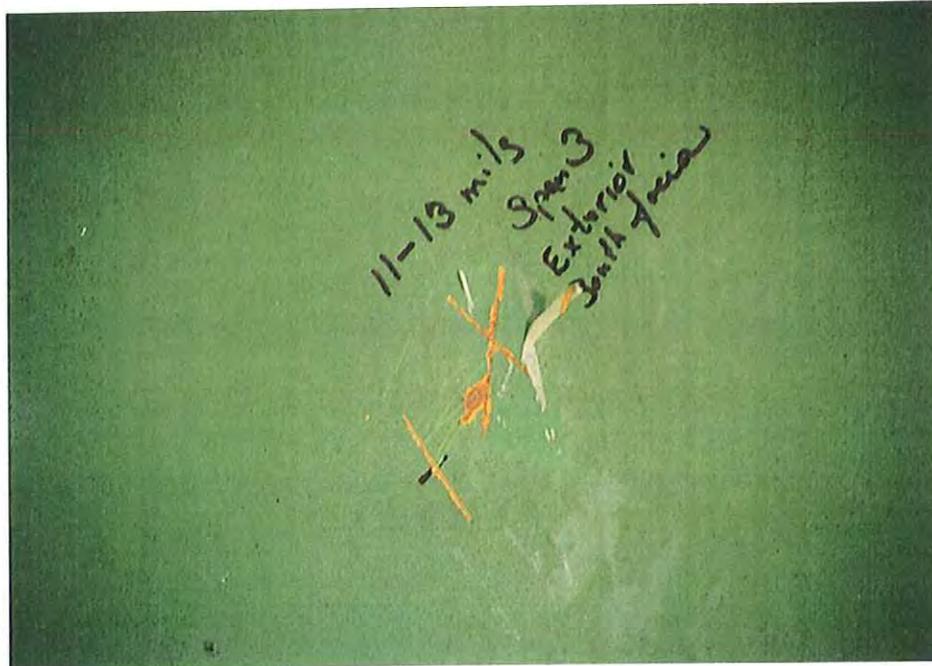
Photograph No. 5

Adhesion was generally improved on the outside fascias, as demonstrated in this photo. Also note that total film thickness was less than many areas of the bridge.

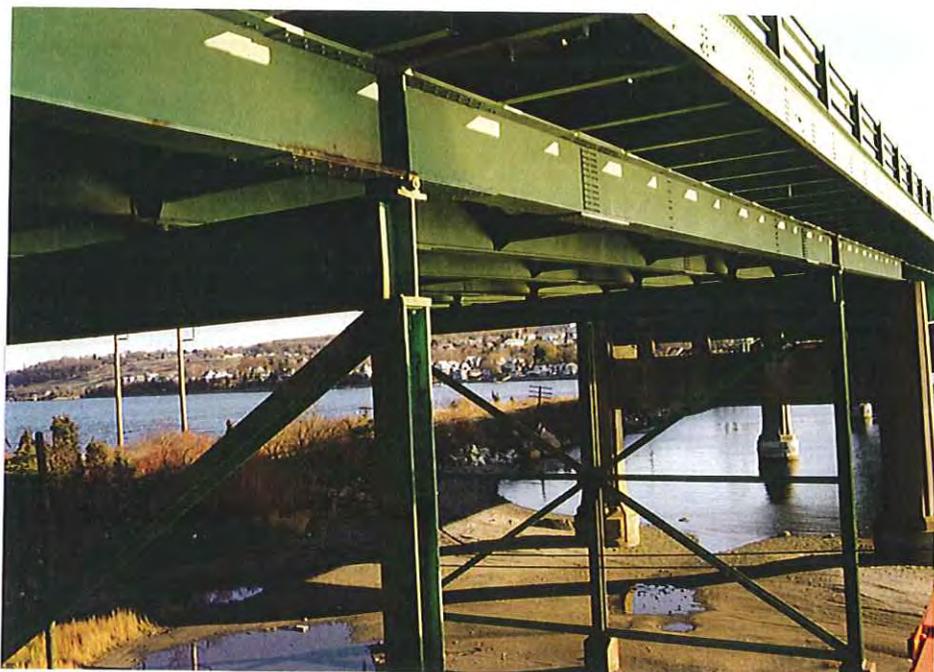
Photograph No. 6

Looking toward Bents 4 and 5, note corrosion on the bottom flange over the Bent, probably due to water leaking from an expansion joint.

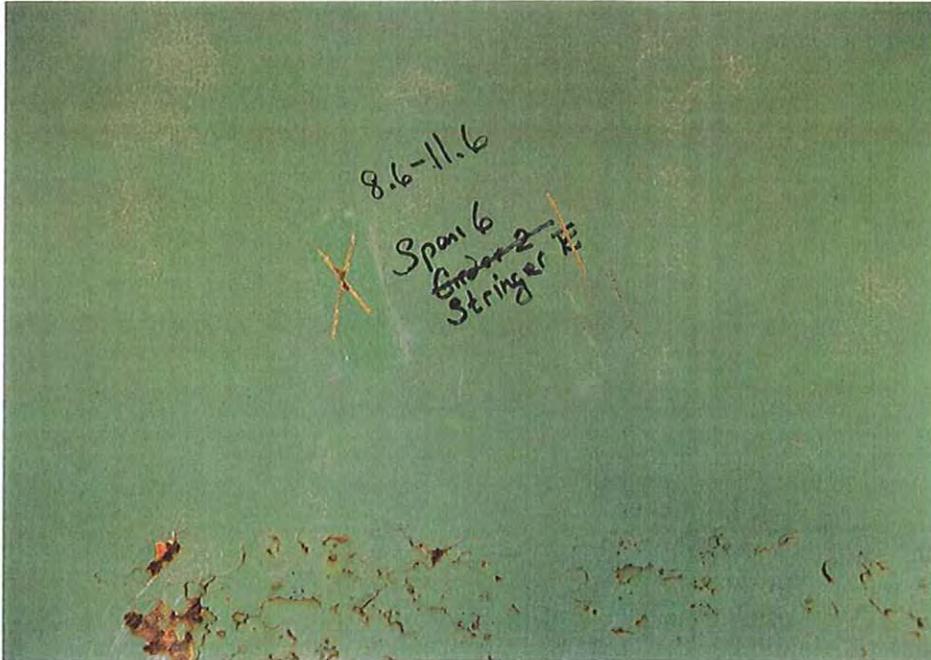
Photograph No. 7

Condition of the web on Stringer E in Span 6. Note areas of fractured coating. Film thickness is 8.6 to 11.6 mils and adhesion is satisfactory, though the surface has chalked.

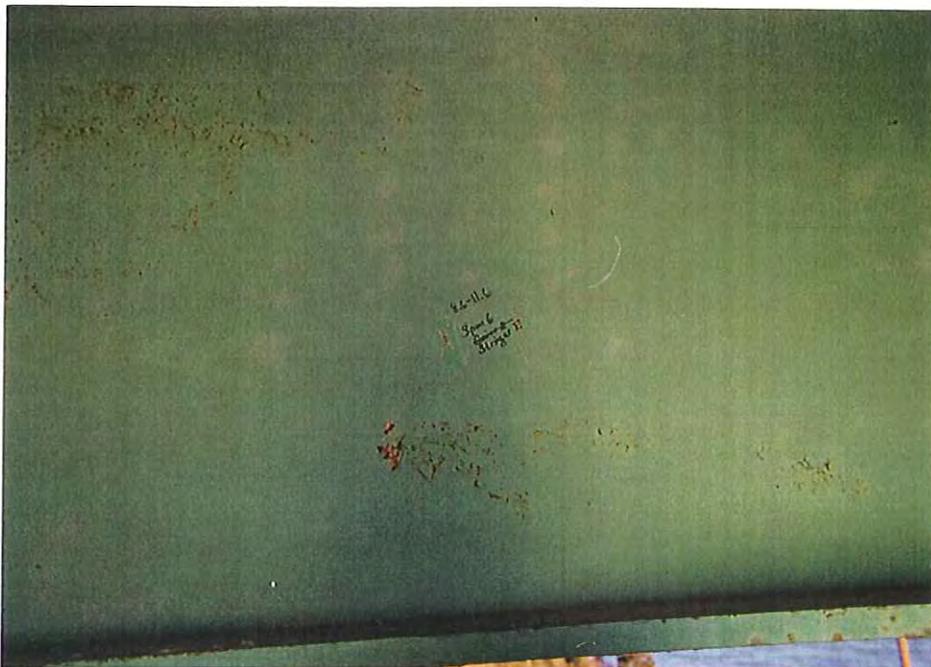
Photograph No. 8

This is a more distant view of the area shown in Photo No. 7

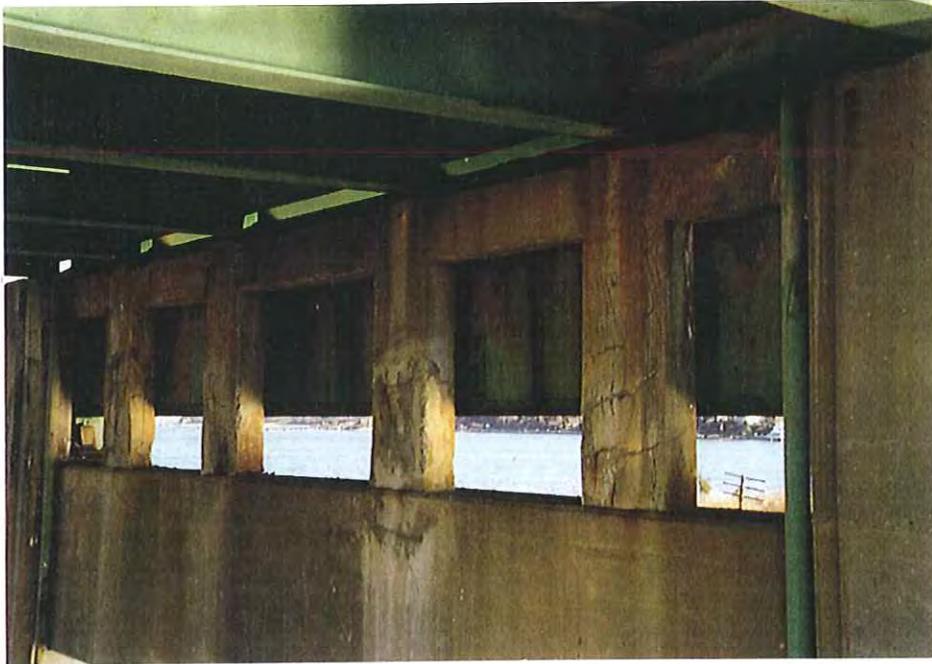
Photograph No. 9

Shown is the west-side of Pier 6. Note the poor condition and of the concrete pier and coating material on the floor beam.

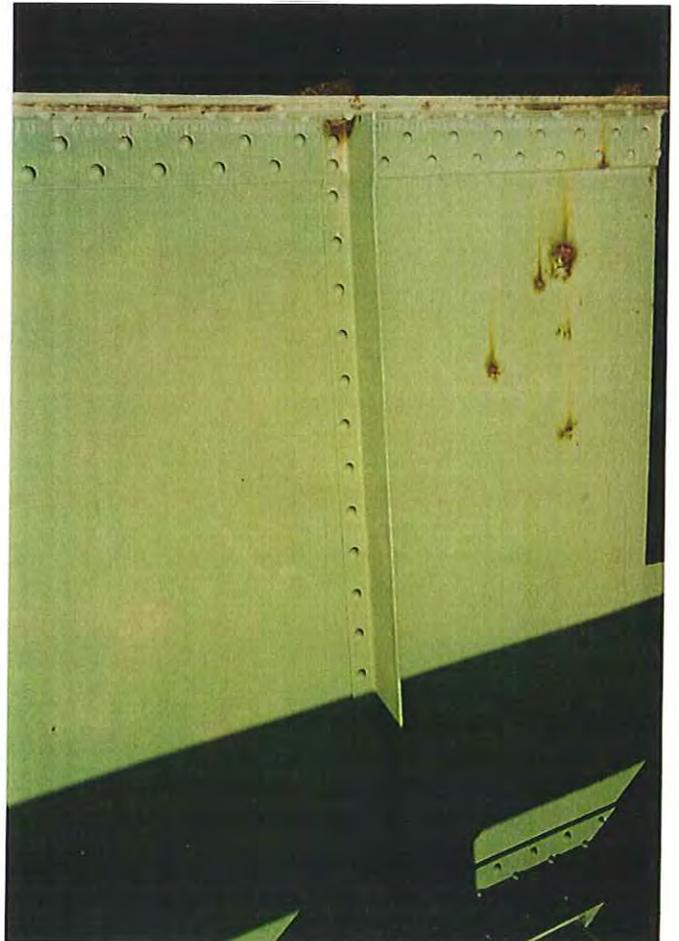
Photograph No. 10

Note areas of coating breakdown and rusting on the south fascia of the main girder at Pier 6. Also note corrosion along the bottom flange

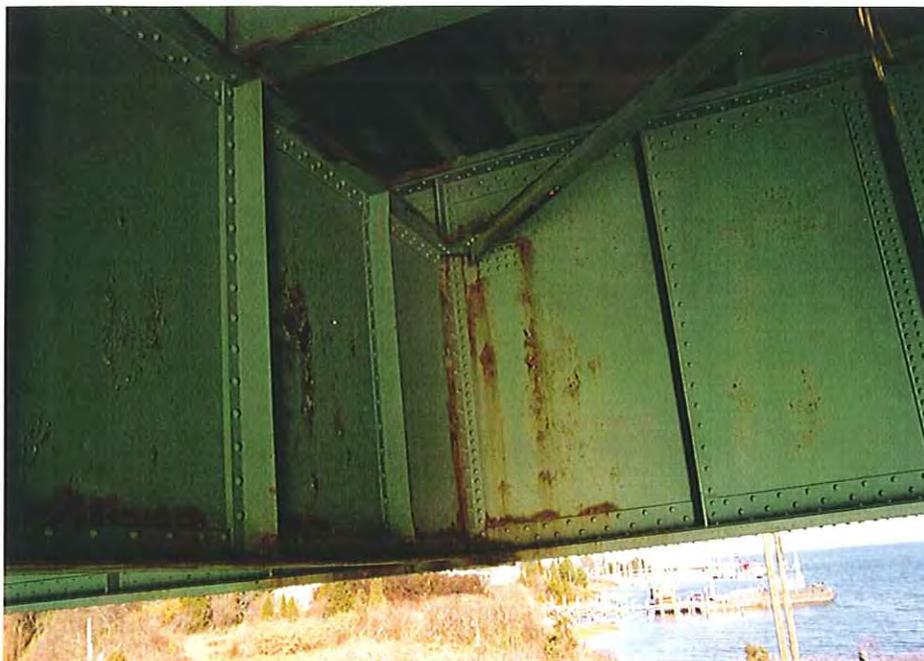
Photograph No. 12

Inside main girder Span 7. Note coating breakdown and rusting on the built-up floor beam and main girder, north side of the bridge.

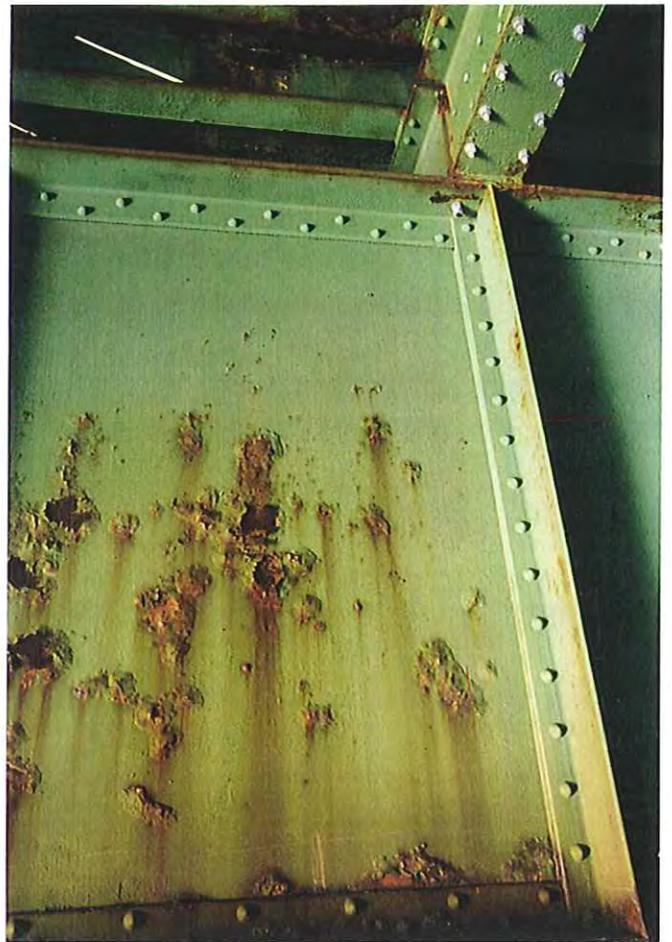
Photograph No. 13  
Another built-up floor beam in Span 7  
Note extensive coating breakdown and  
rusting in the center portion of the beam,  
which is exposed to water run-off.

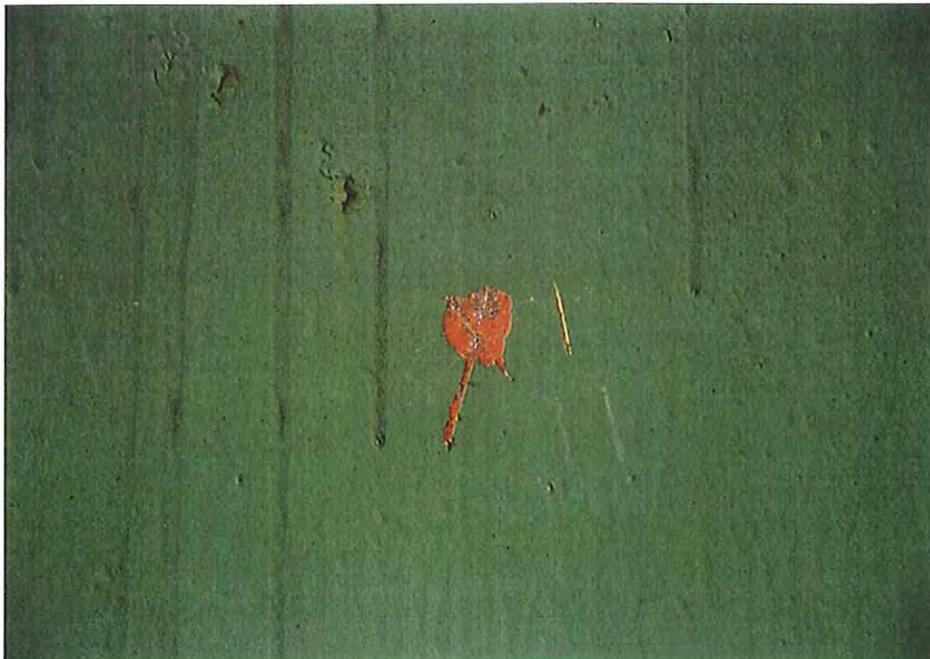
Photograph No. 14  
Shown is a floor stringer in Span 7. Although the coating is not peeling, adhesion is not optimum. When tested, fracture occurs within the orange primer.

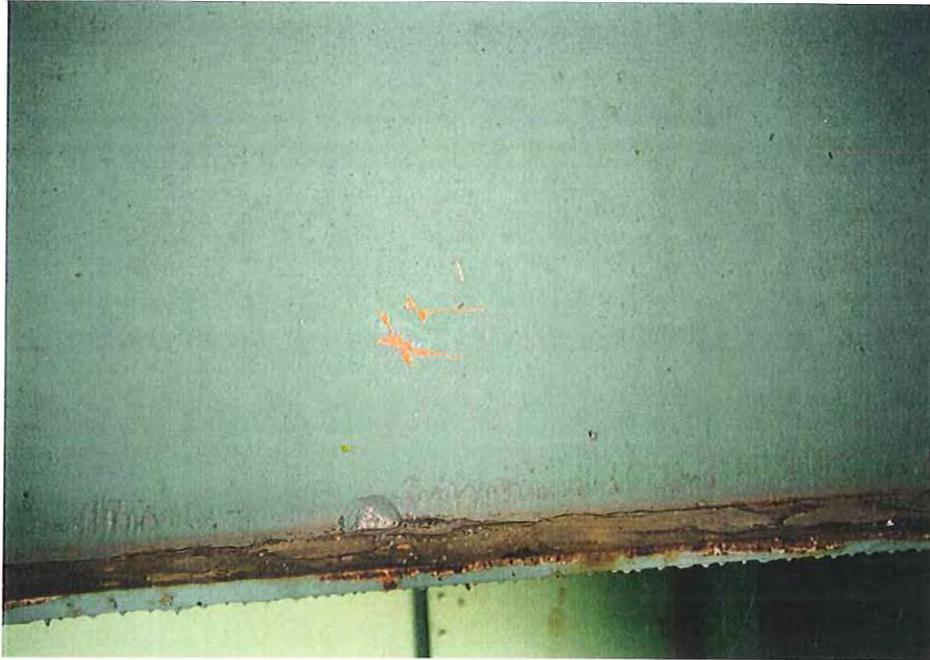
Photograph No. 15

Shown is another floor stringer in Span 7. Note that coating adhesion is fair to poor and there is corrosion along the bottom flange.

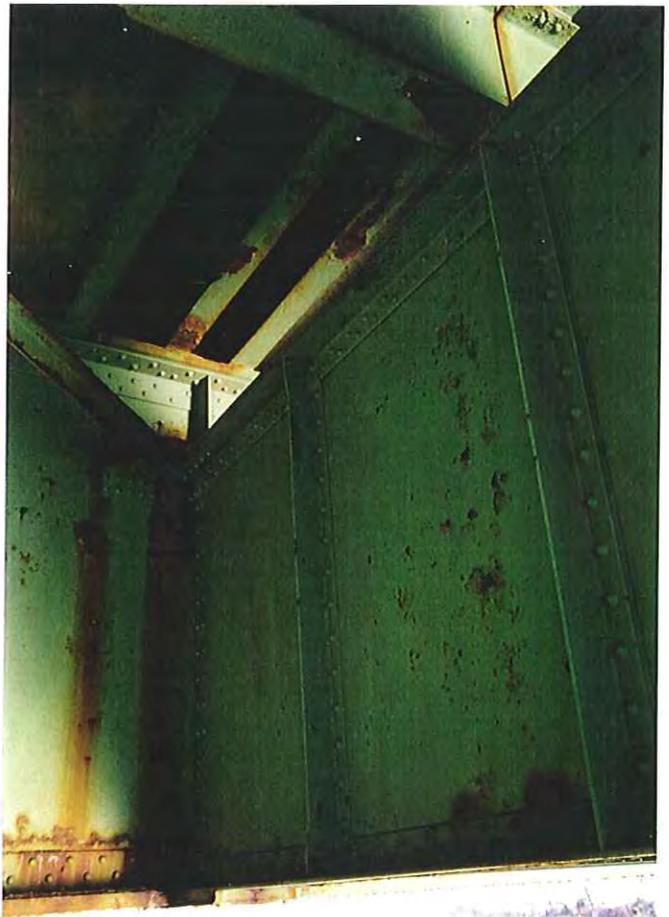
Photograph No. 16

Another area inside Span 7. Note coating breakdown and rusting on the built-up floor beam and main girder, north side of the bridge.

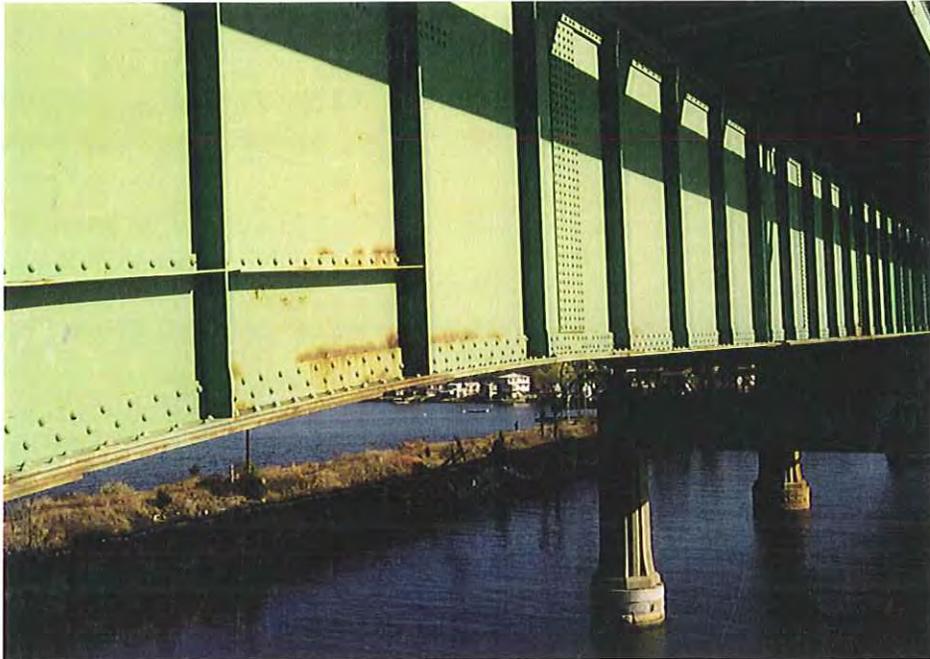
Photograph No. 17

South outside fascia of Bay 1, Span 8. Note rust along the edge of the bolted plate on the main girder at the bottom of the web.

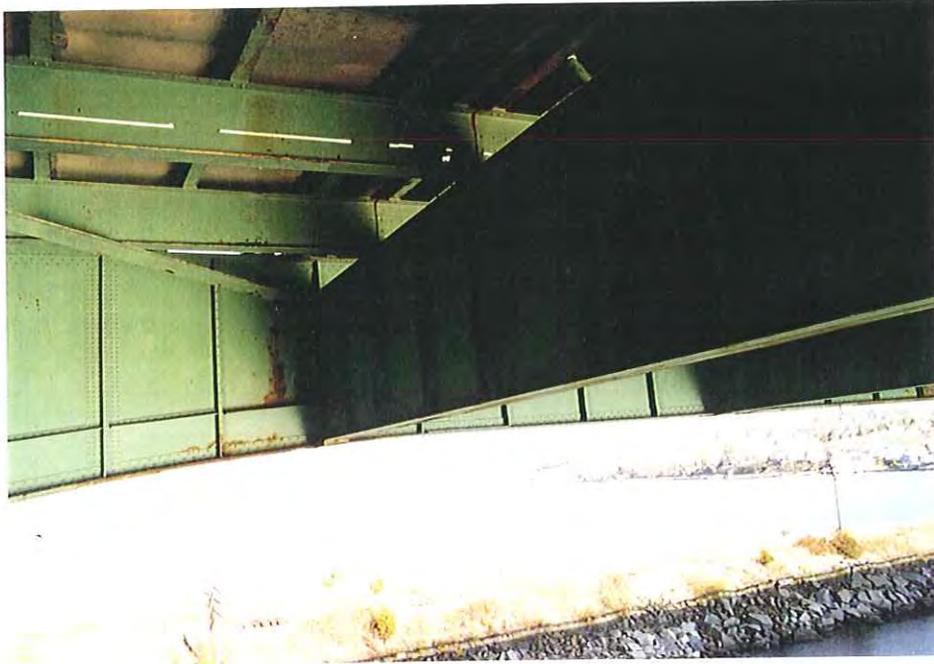
Photograph No. 19

Same span as shown in Photo 18, but to the right. There is widespread general coating breakdown, though it is difficult to see due to the lighting.

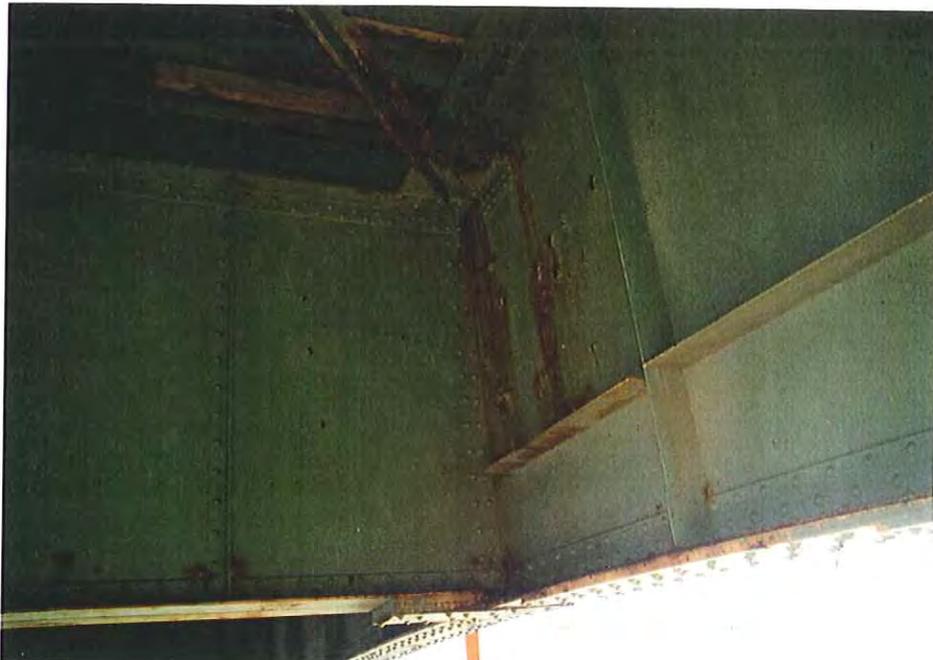
Photograph No. 20

Another photo of Bay 1, Span 8 is shown. Note coating breakdown on the webs and corrosion on the flanges.

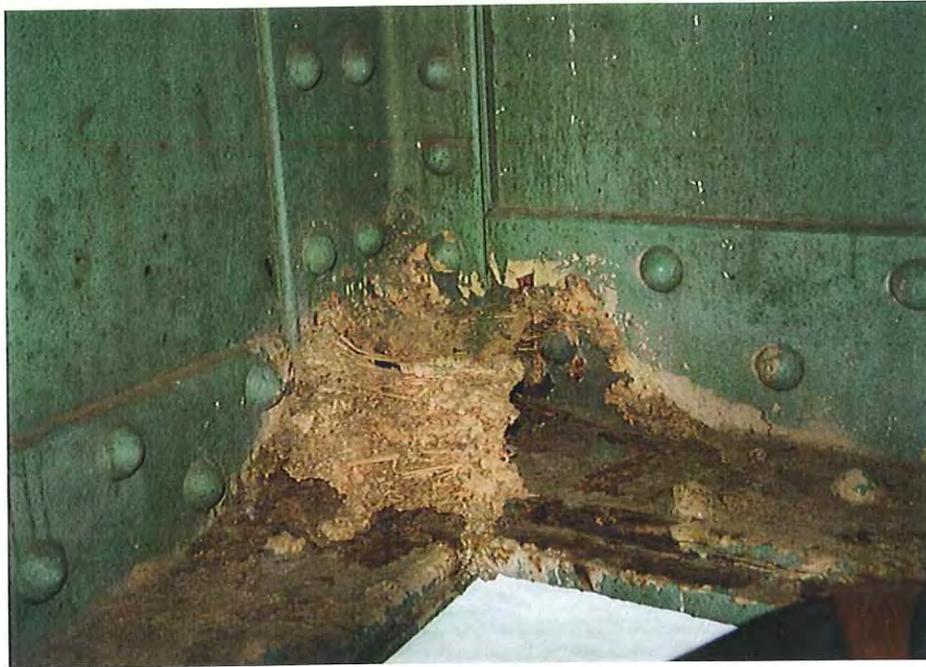
Photograph No. 21

A bird nest is shown that has some green paint applied to the top. Surface preparation was obviously less than specified when the bridge was last cleaned.

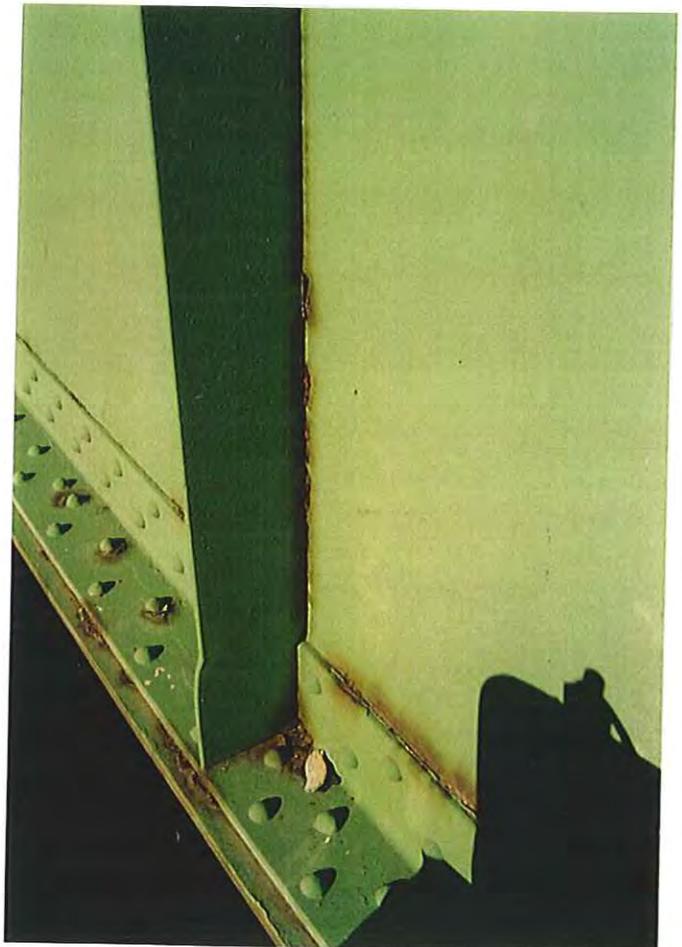
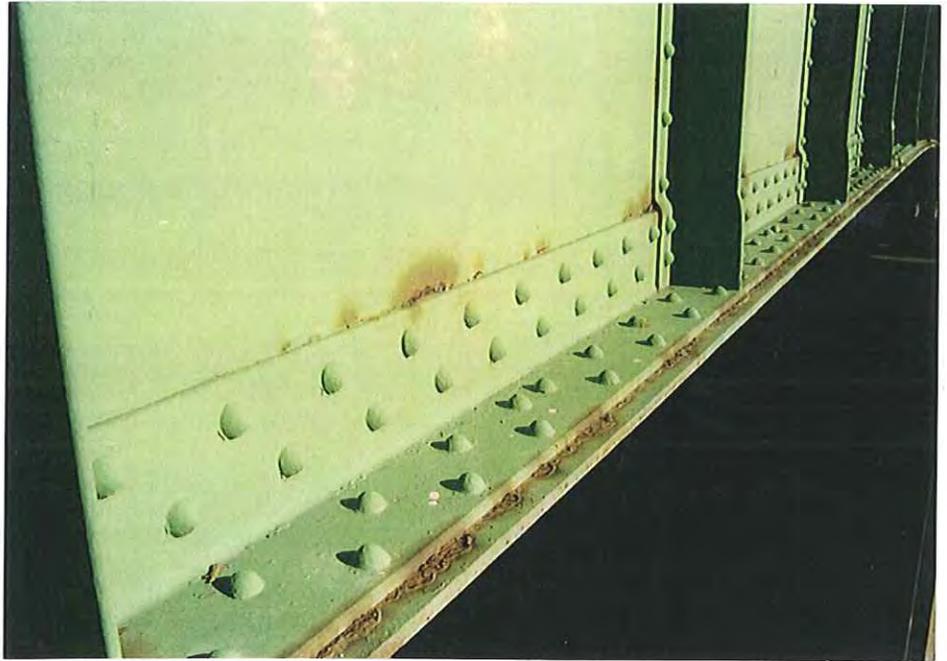
Photograph No. 22 and No. 23

Note pack rust developing along the bolted angles at the bottom flange and along the stiffeners. These photographs were taken on the south fascia of Span 8.

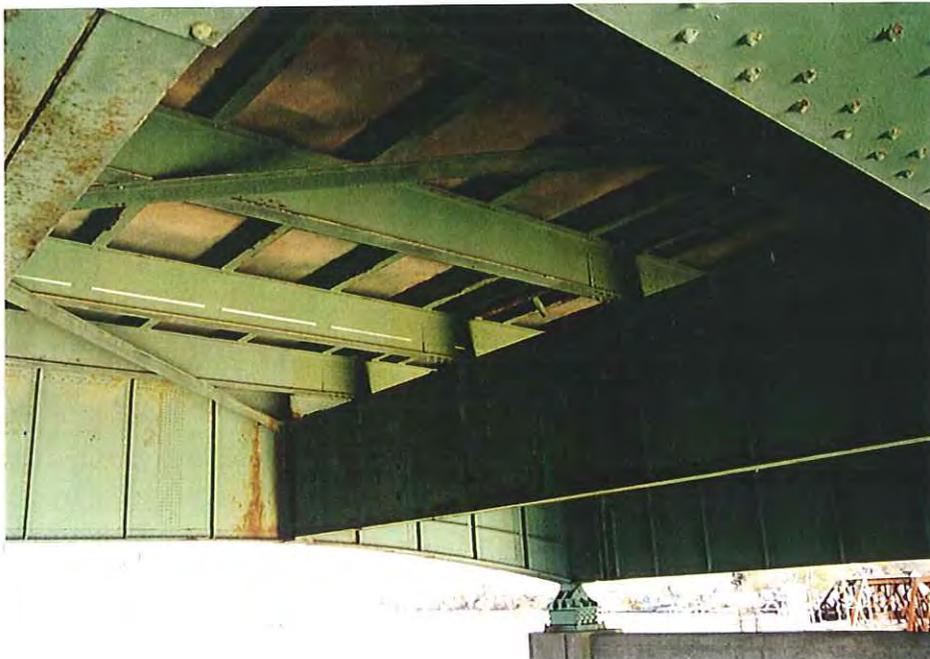
Photograph No. 24  
Note generalized coating breakdown and rusting on steel in Span 8, west of Pier 8.

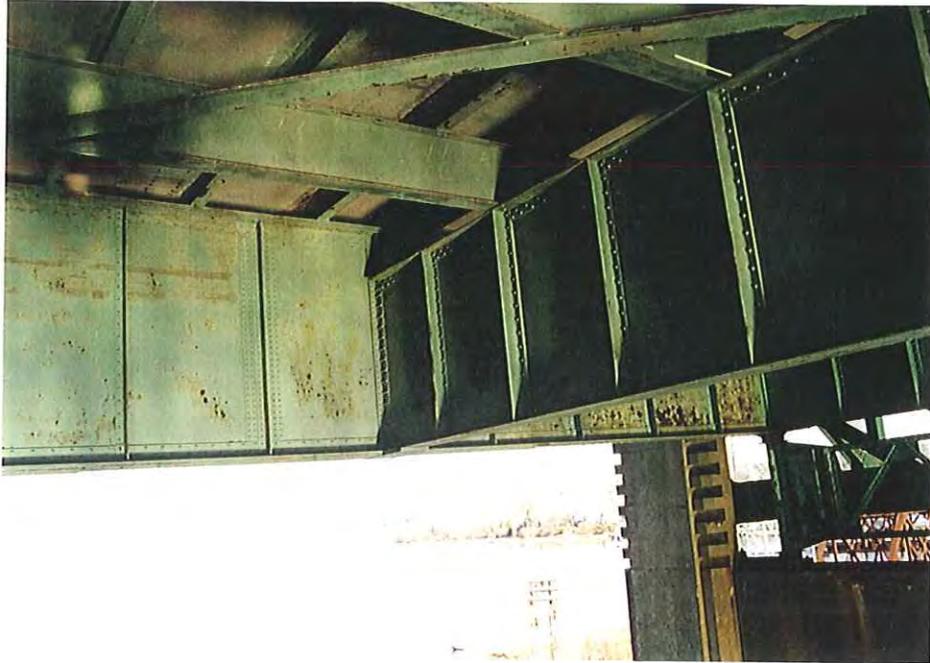
Photograph No. 25

Note generalized coating breakdown and rusting on steel in Span 9, west of Pier 9.

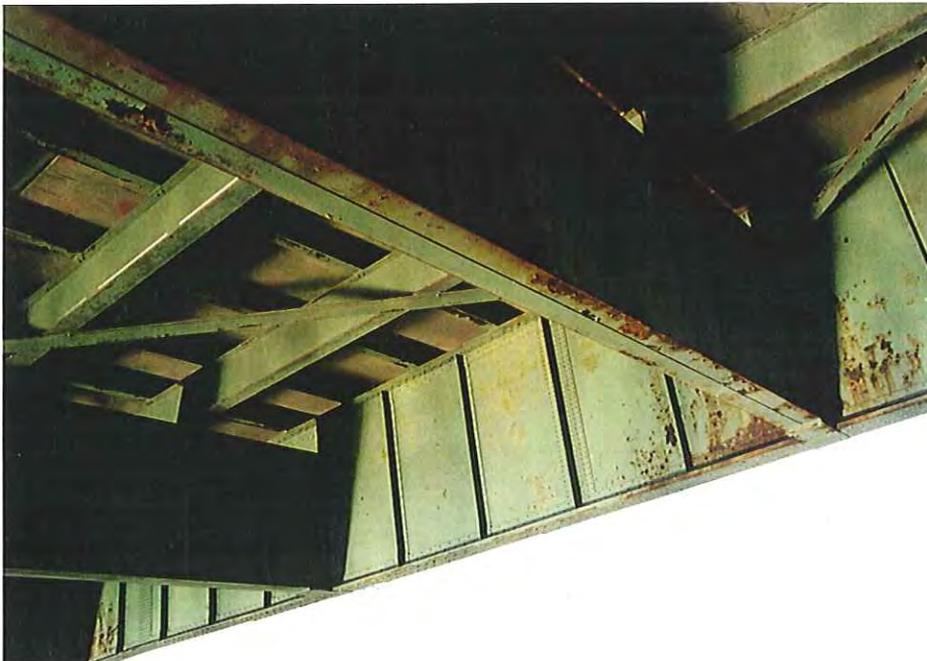
Photograph No. 26

Another photo showing poor coating condition in Span 9.

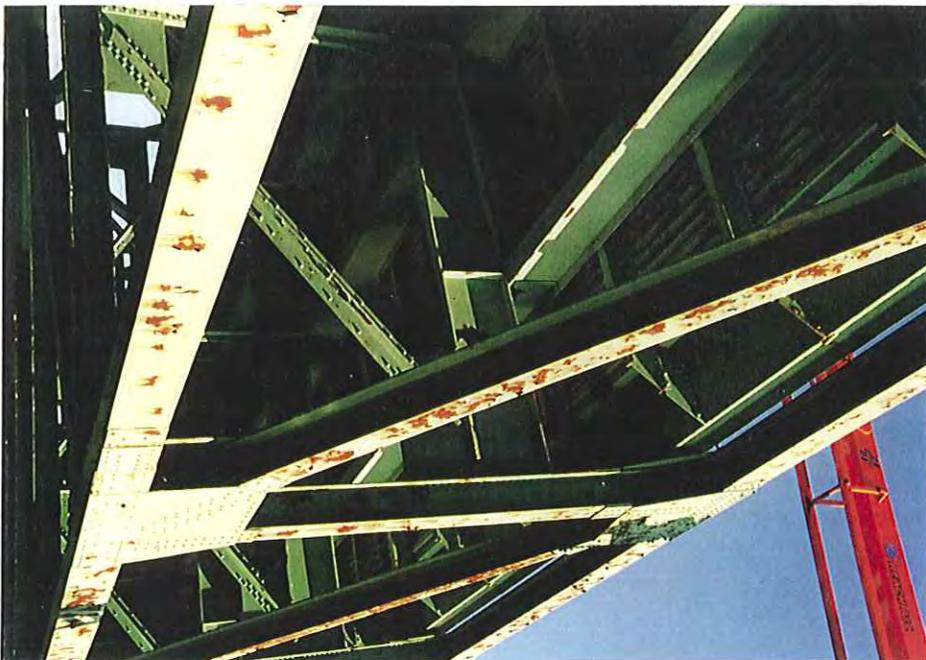
Photograph No. 28  
Coating breakdown and rusting on the bottom flanges of members in Span 10.

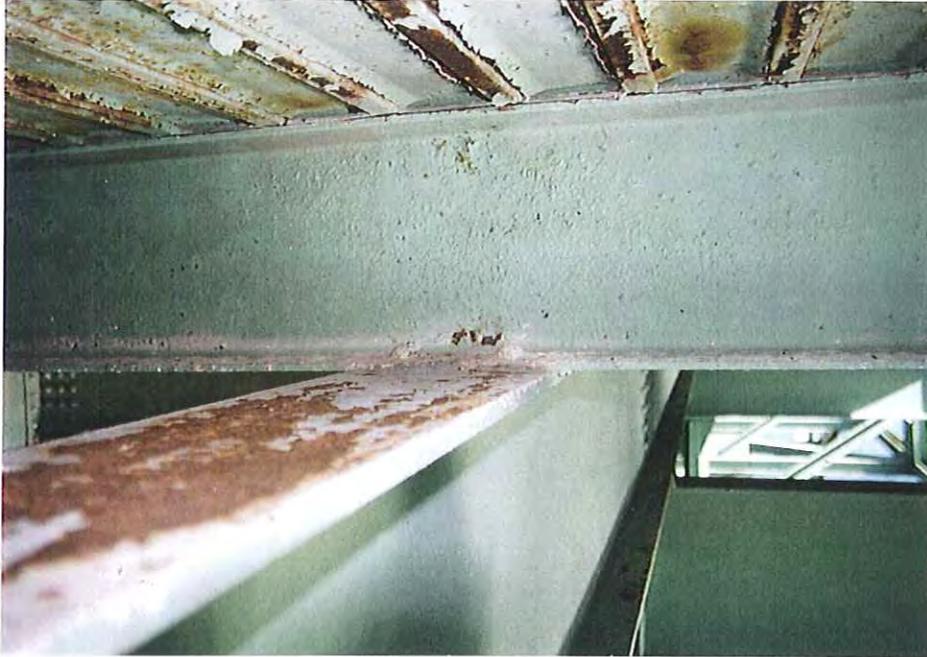
Photograph No. 29

Note rust and coating deterioration on the floor stringer and floor beam in Span 10. The cracked and embrittled coating on the floor stringer was typical throughout Spans 8, 9, 10, 11, and 12.

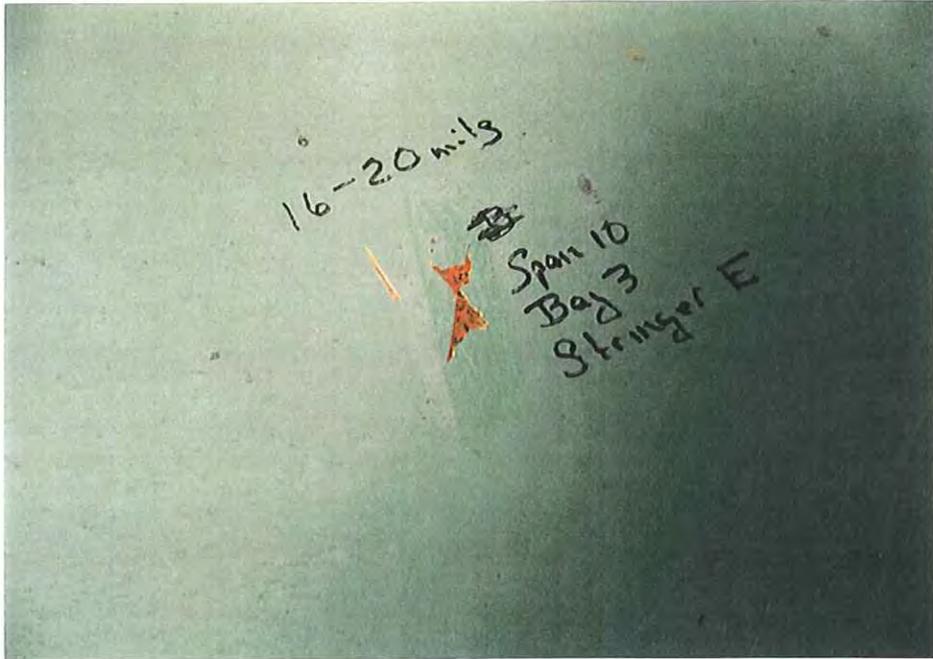
Photograph No. 31

This shows poor adhesion on a floor stringer in Bay 3, Span 10.

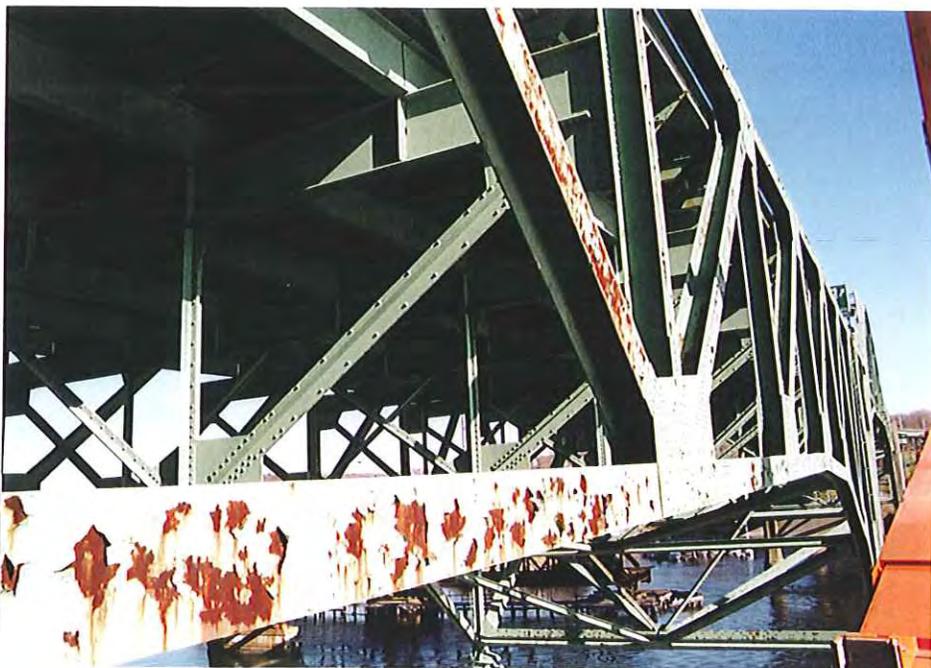
Photograph No. 32

Outside fascia of Span 10 has extensive coating breakdown and rusting.

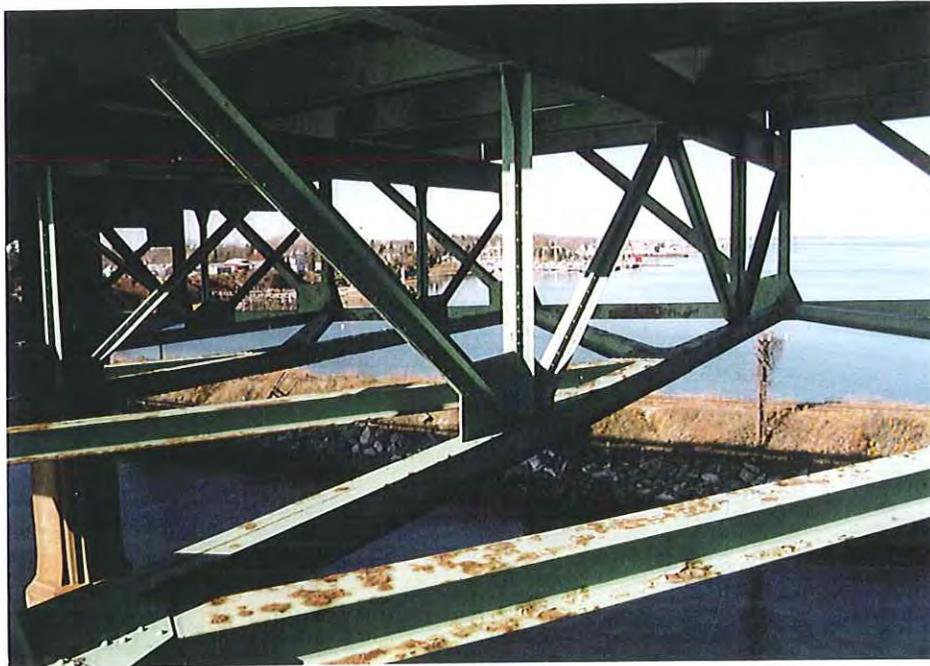
Photograph No. 33  
Note corrosion on many interior members of Span 10.

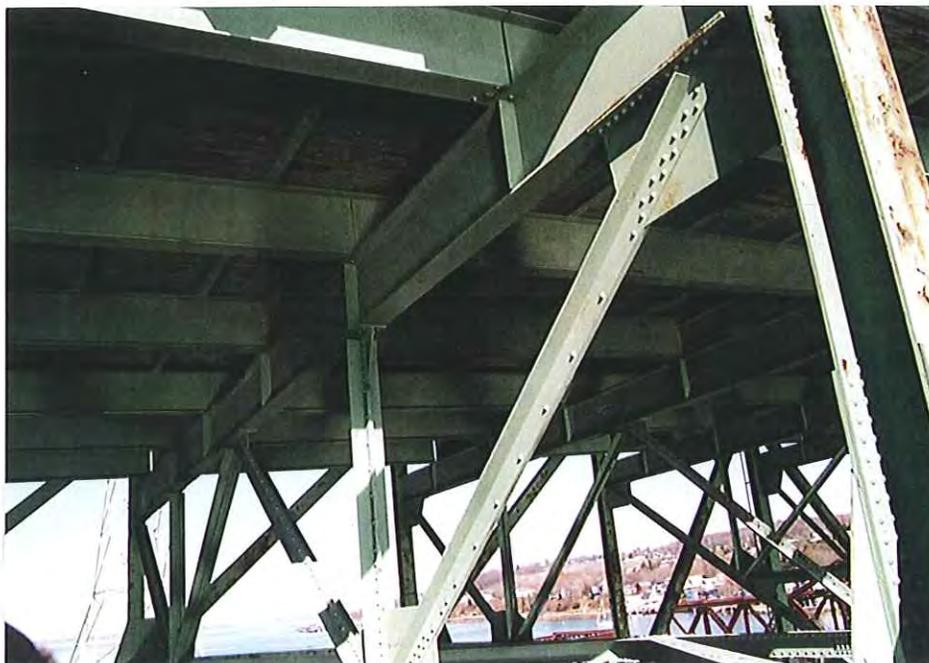
Photograph No. 34  
Note the condition of the coatings in Span 10 is generally better in the area closer to Pier 10. However, it is still brittle and adhesion is fair to poor.

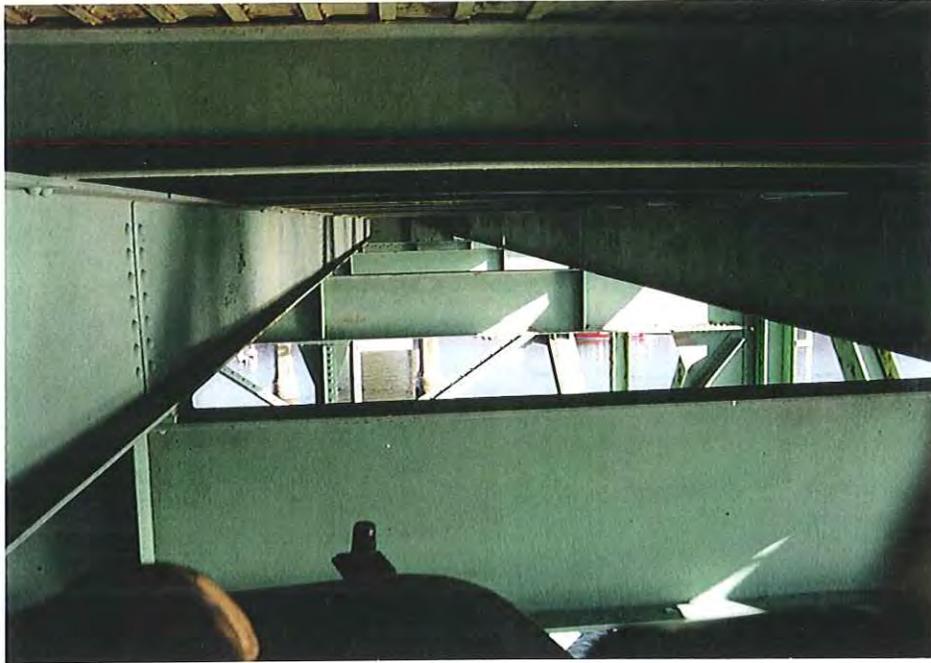
Photograph No. 35

This photo, taken in Span 10 toward Pier 10, shows a coating system that is better than condition found on the vast majority of the bridge.

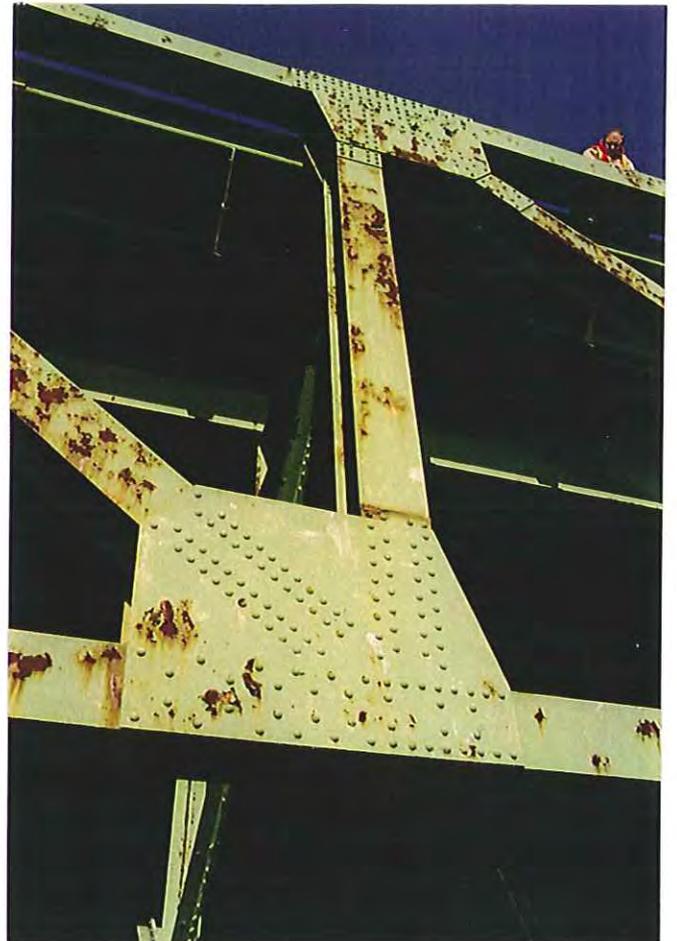
Photograph No. 36

Shown is extensive corrosion on the exterior south side of Span 10, just west of Pier 10.

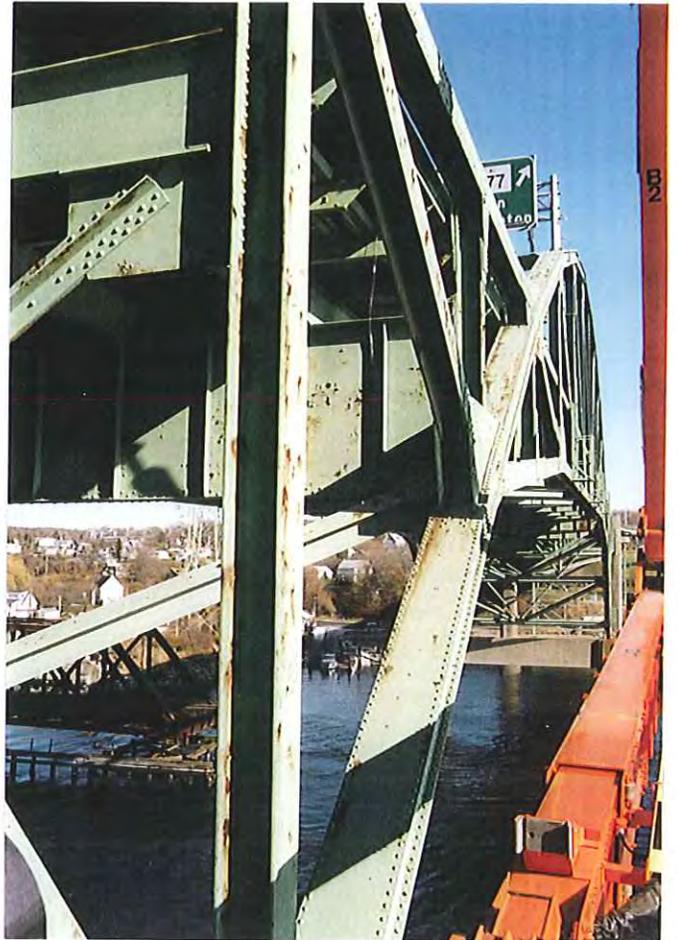
Photograph No. 37  
Shown is the south west end of the arch in Span 11. Note widespread coating breakdown.

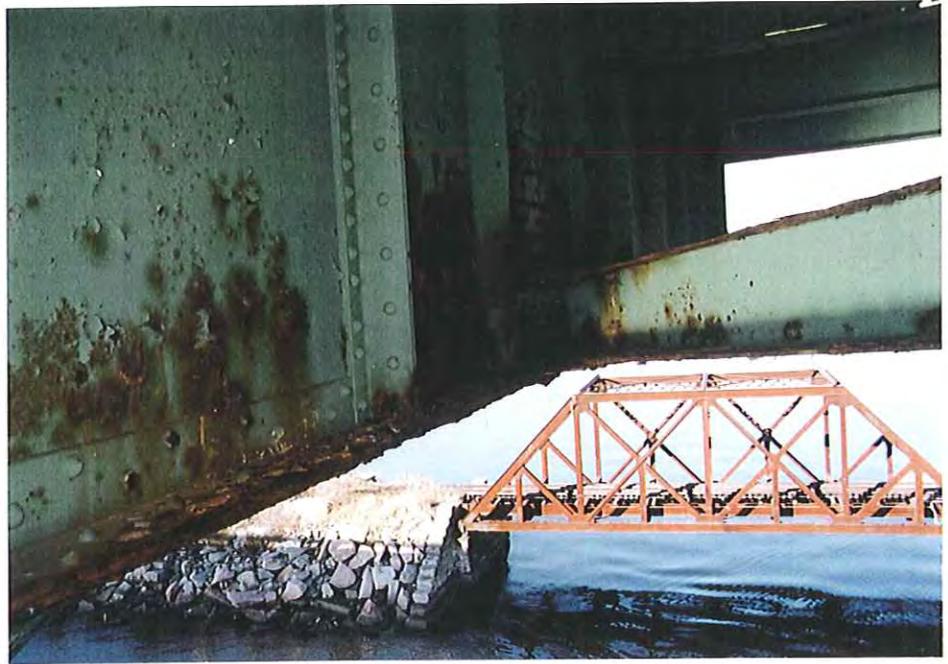
Photograph No. 39  
Note the extensive corrosion  
on the floor beam and attached  
lateral.

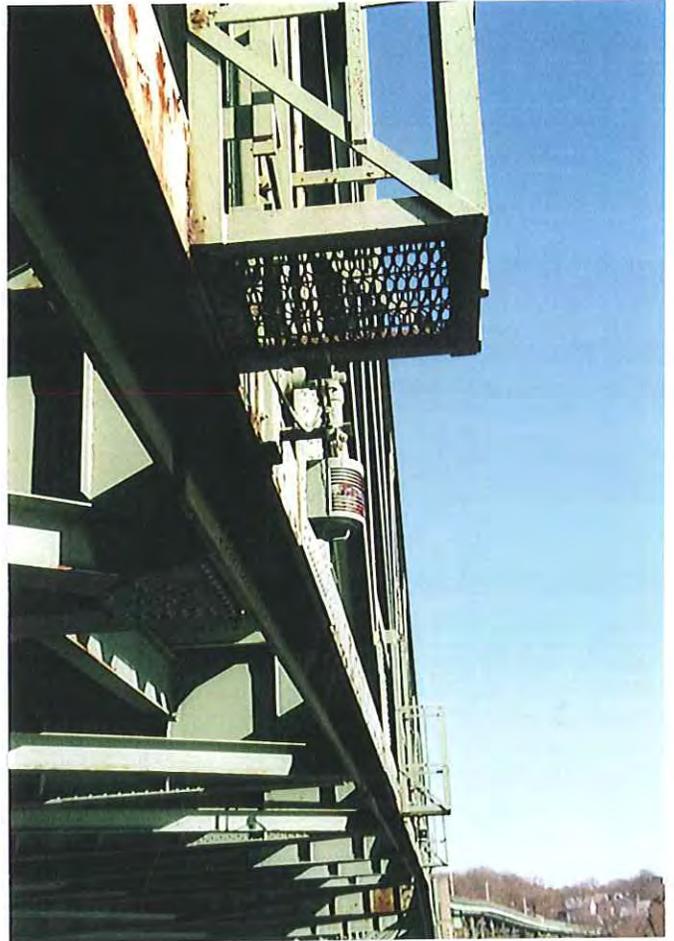
Photograph No. 41  
This photo shows coating breakdown  
and poor workmanship that resulted in  
the signal light being sprayed with green paint.
