**0031N OLD SAKONNET RIVER BRIDGE DEMOLITION**

NOTICE TO PROSPECTIVE BIDDERS

ADDENDUM NO. 1 Prospective bidders and all concerned are hereby notified of the following changes in the Plans, Specifications, Proposal and Distribution of Quantities for this contract. These changes shall be incorporated in the Plans, Specifications, Proposal and Distribution of Quantities, and shall become an integral part of the Contract Documents.

The purpose of the examination was to determine the condition of the coating system in order to provide recommendations for maintenance coating work. This report includes background information, observations and data from the field investigation, laboratory results, a discussion of the findings and recommendations for maintaining the protective coating system on the bridge. Photographs depict typical coating conditions.

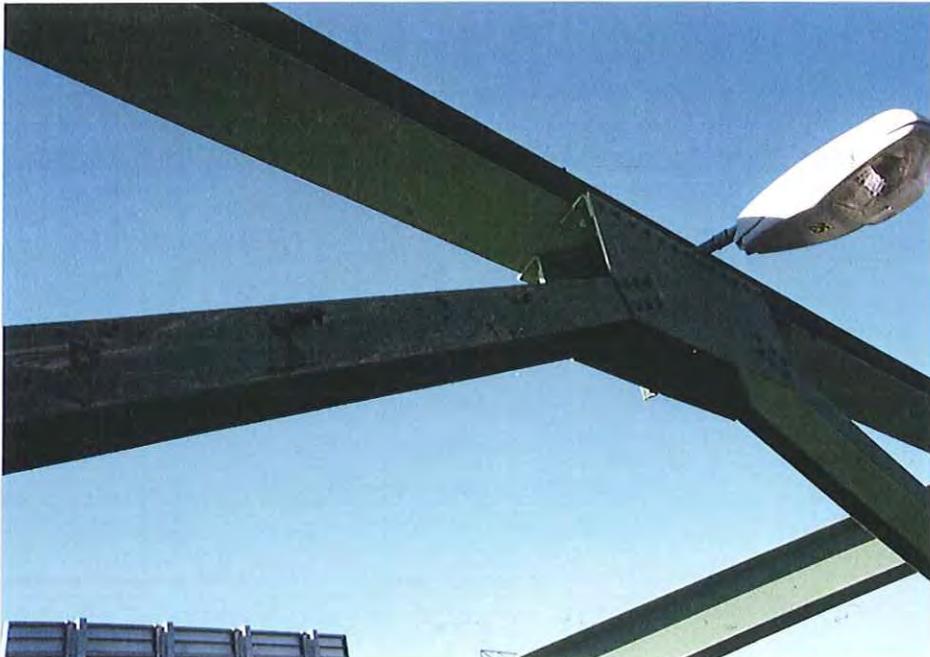
Photograph No. 42  
The coating breakdown shown on this overhead member in the arch is typical.

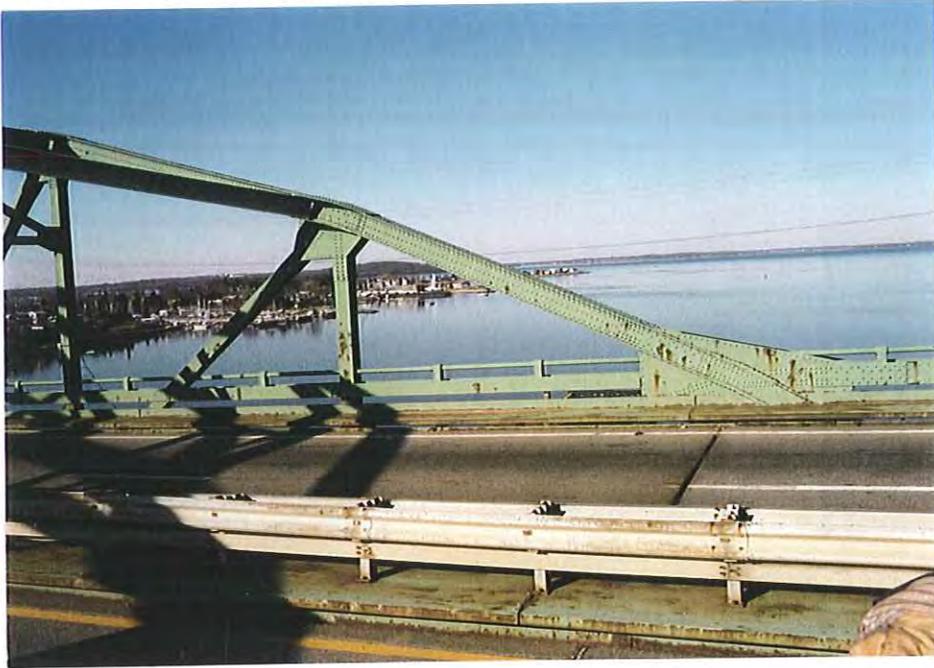
Photograph No. 43

This photo shows coating breakdown on the east end of the arch above the roadway, and the condition is similar to that shown in Photo No. 42

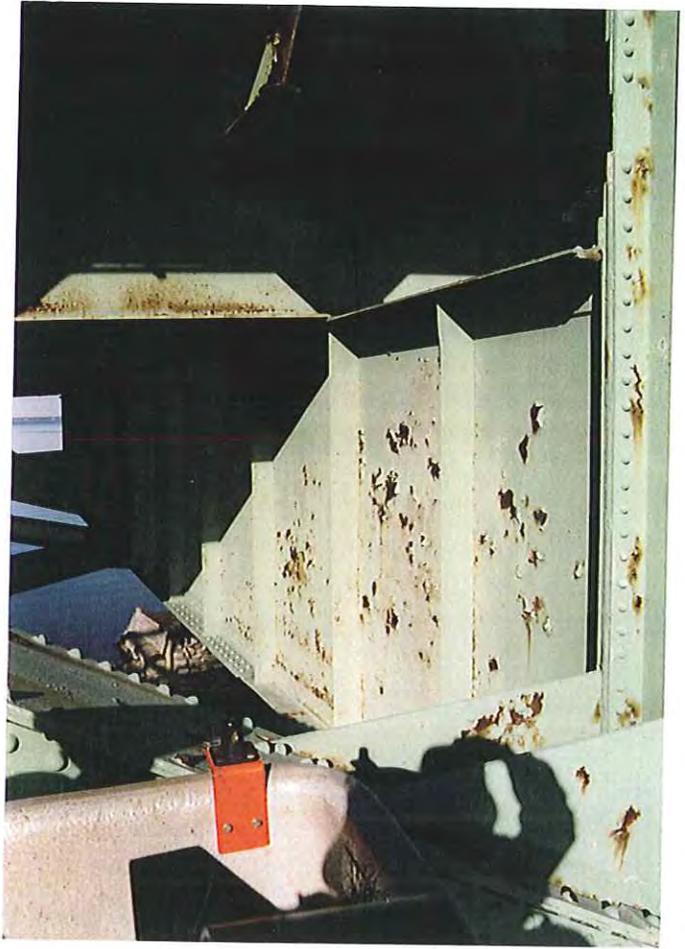
Photograph No. 45  
Coating breakdown on the  
floorbeam west of Pier 11 in Span 11.

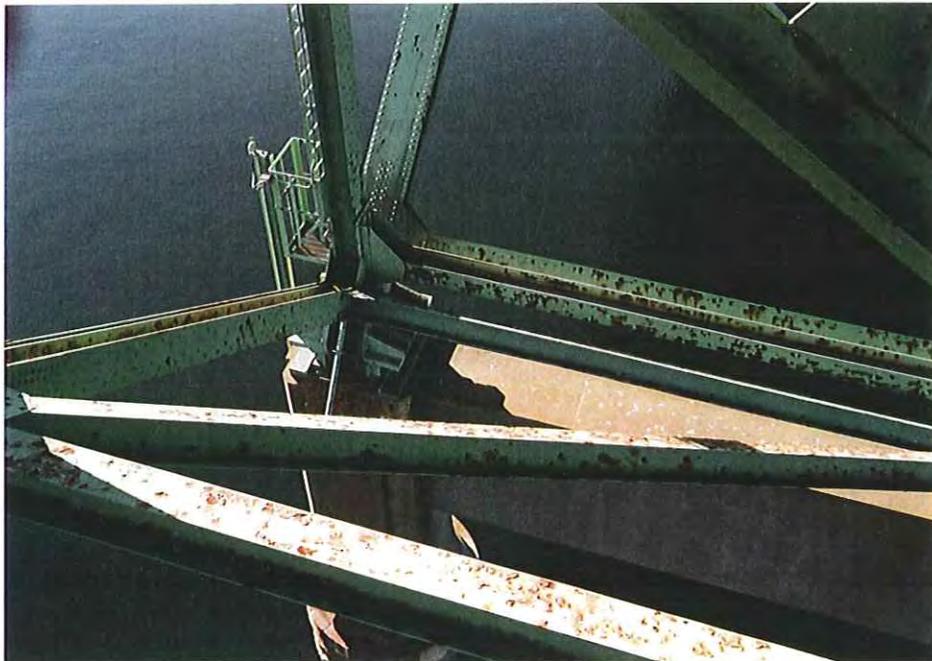
Photograph No. 46  
Coating breakdown on interior steel near Pier 11.

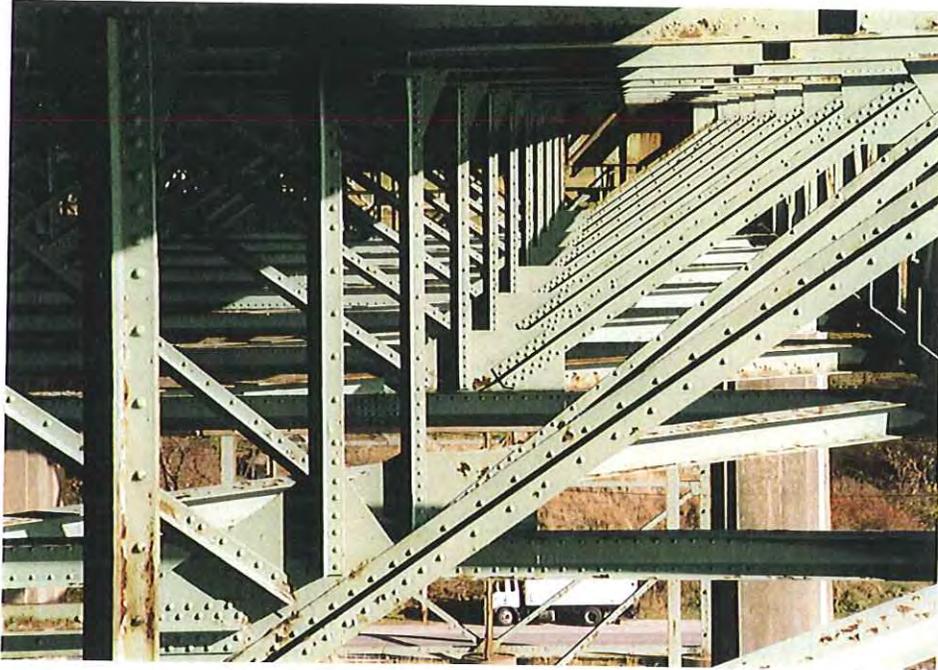
Photograph No. 47  
A view of the steel beneath Span 12.  
Note areas of breakdown and rusting.

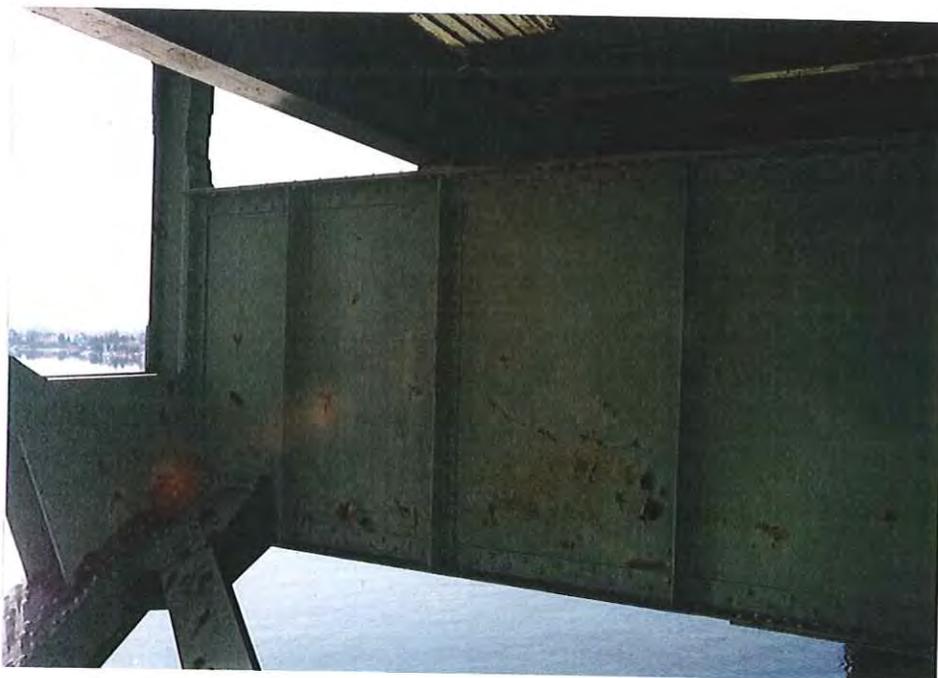
Photograph No. 48  
Coating breakdown in Bay 2, Span 12 on the floorbeam and attached steel.

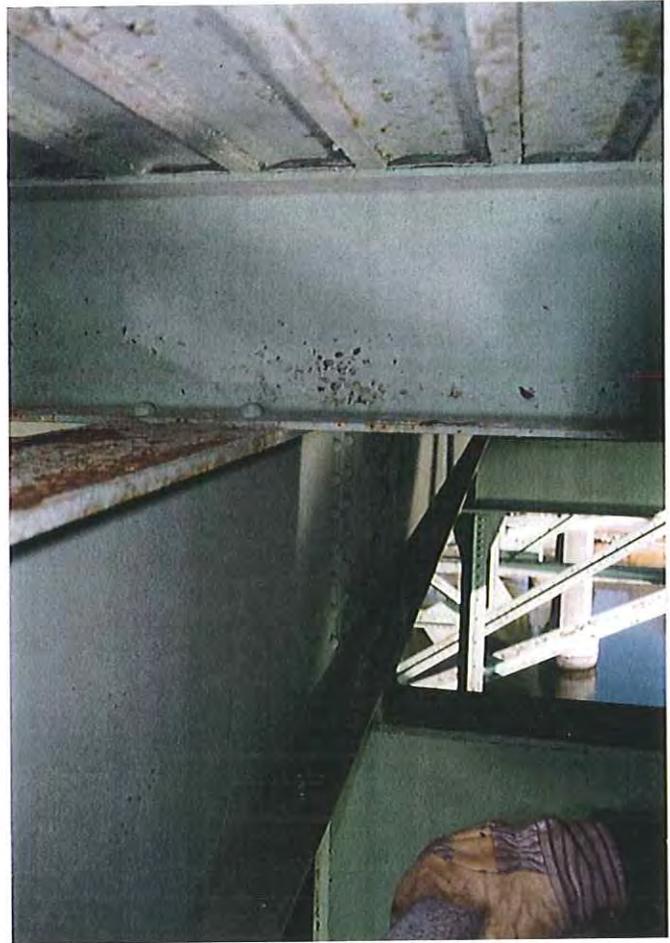
Photograph No. 49  
Shown is corrosion on the top flange  
of a floorbeam in Span 12 and also  
on the web of the floor stringer.

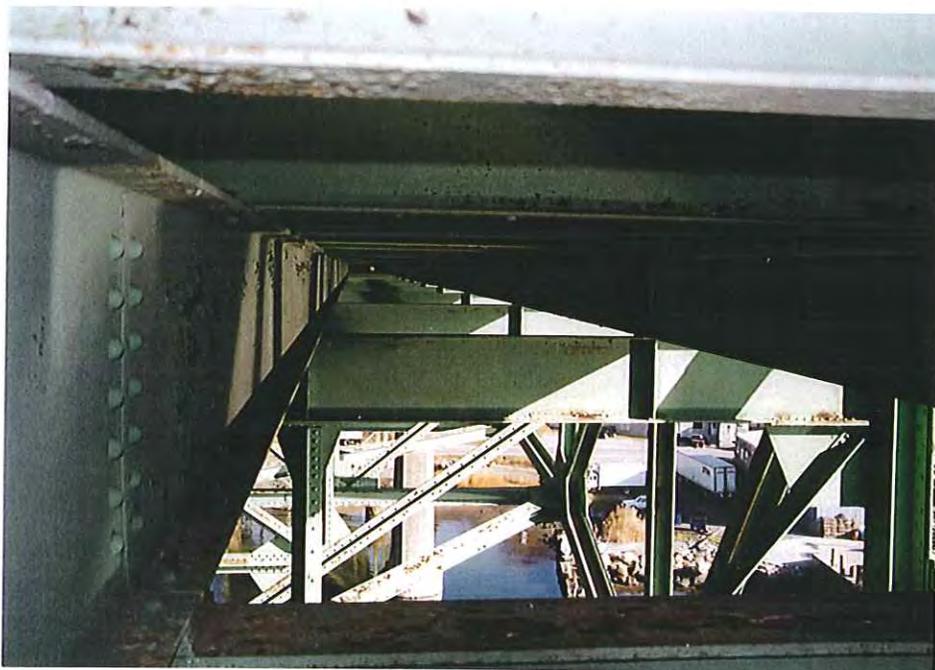
Photograph No. 50  
This photo shows coating breakdown beneath near Pier 11. Photo was shot west toward  
the arch.

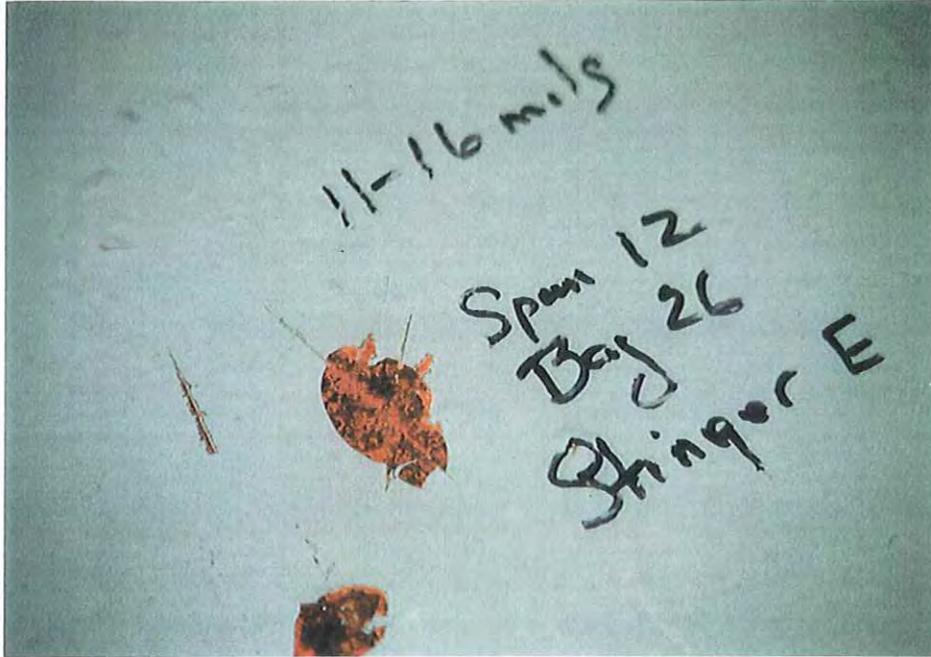
Photograph No. 51

This shows the poor adhesion on the floor stringer where the coating thickness was 11 to 16 mils. Fracture occurred in the weak orange primer.

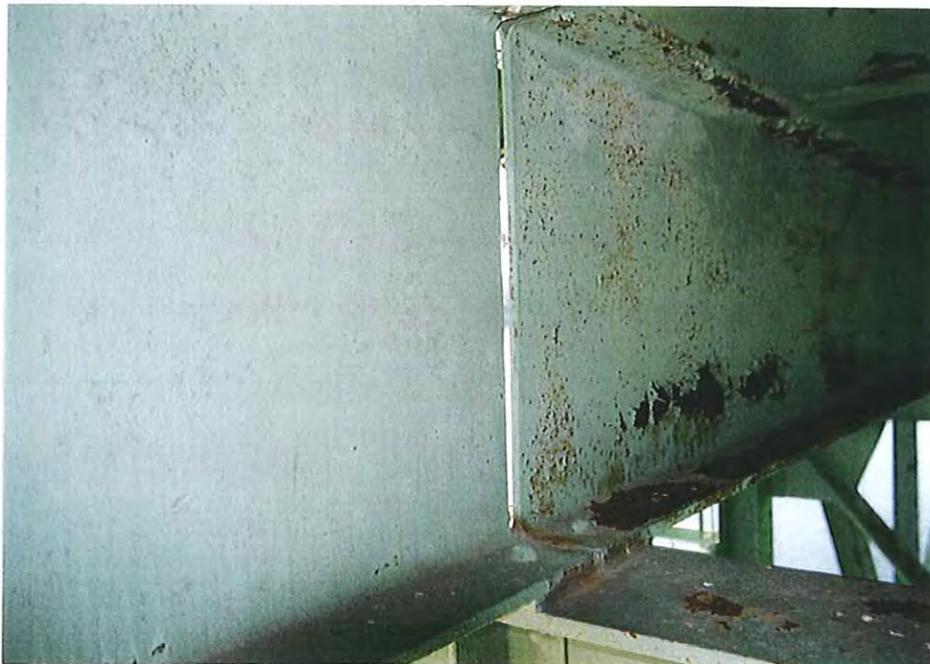
Photograph No. 52

This photo shows the difference in coating condition between two bays in the east continuous girder span.

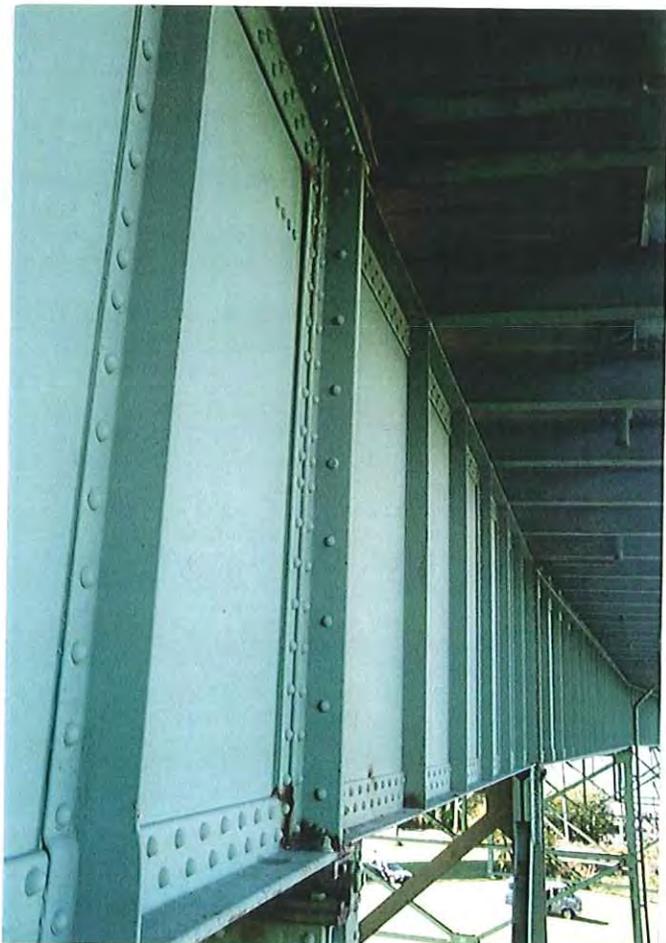
Photograph No. 54

North outside fascia in Span 23.  
Note the good coating condition.

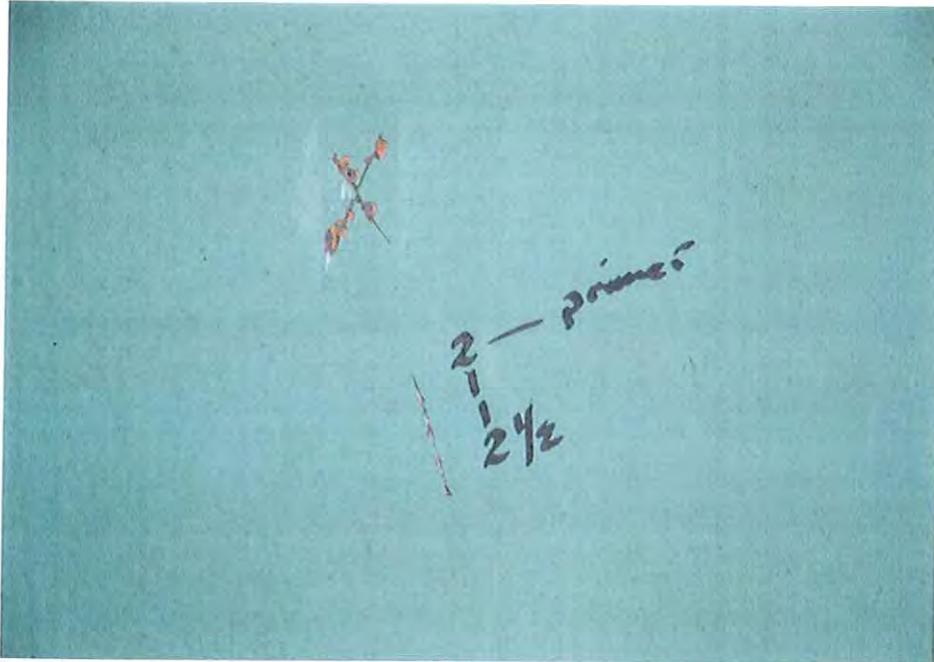
Photograph No. 55

Note fair adhesion and thickness of each coating layer. Thickness is less than most areas of the bridge.

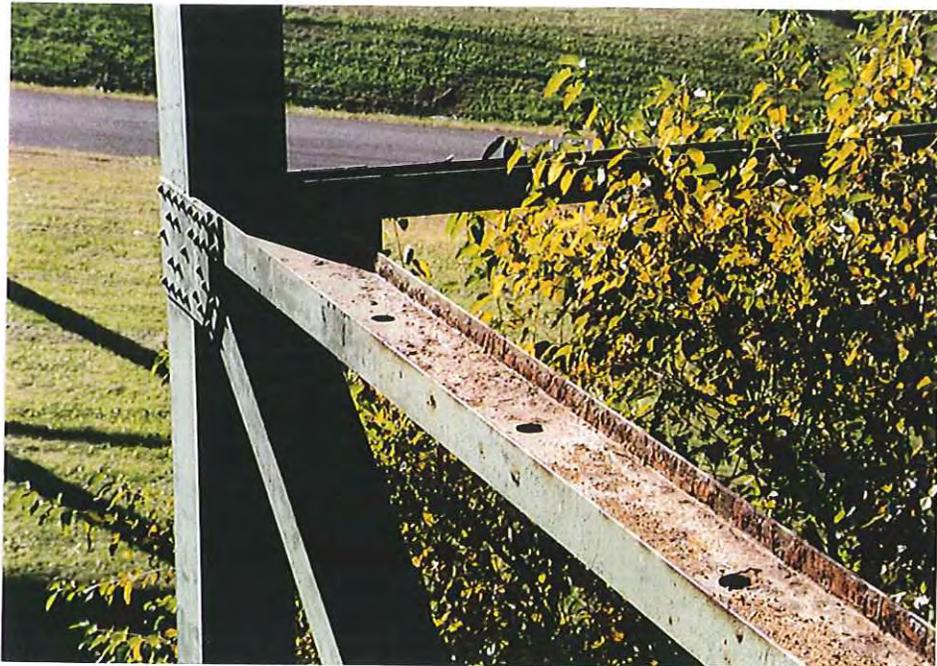
Photograph No. 56

This is the typical poor condition of the steel on Bents 19 through 27.

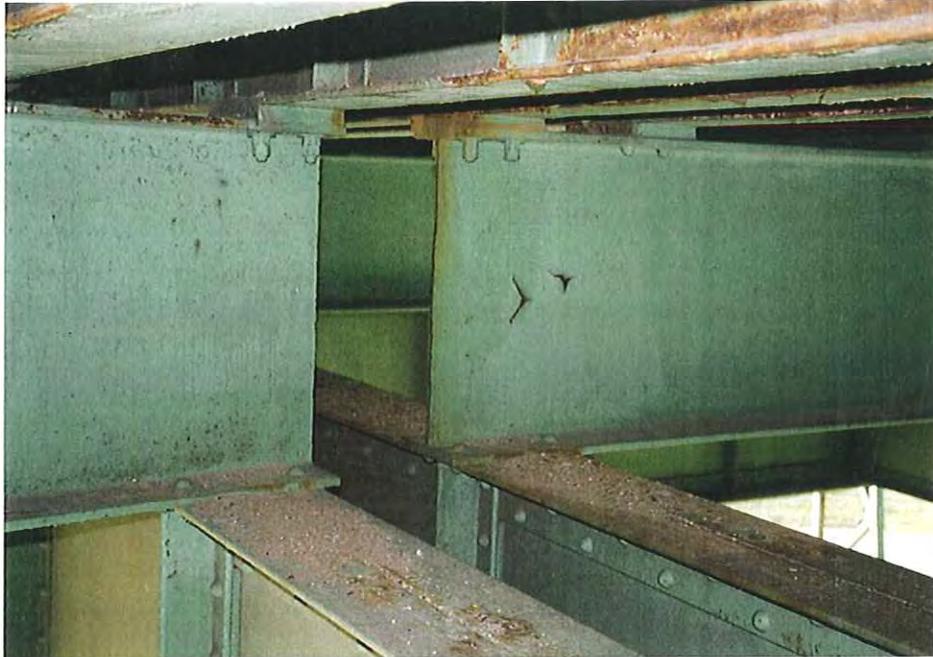
Photograph No. 57

This shows the brittle nature of the coating on the interior members in Span 19 through Span 27; it has spontaneously cracked.

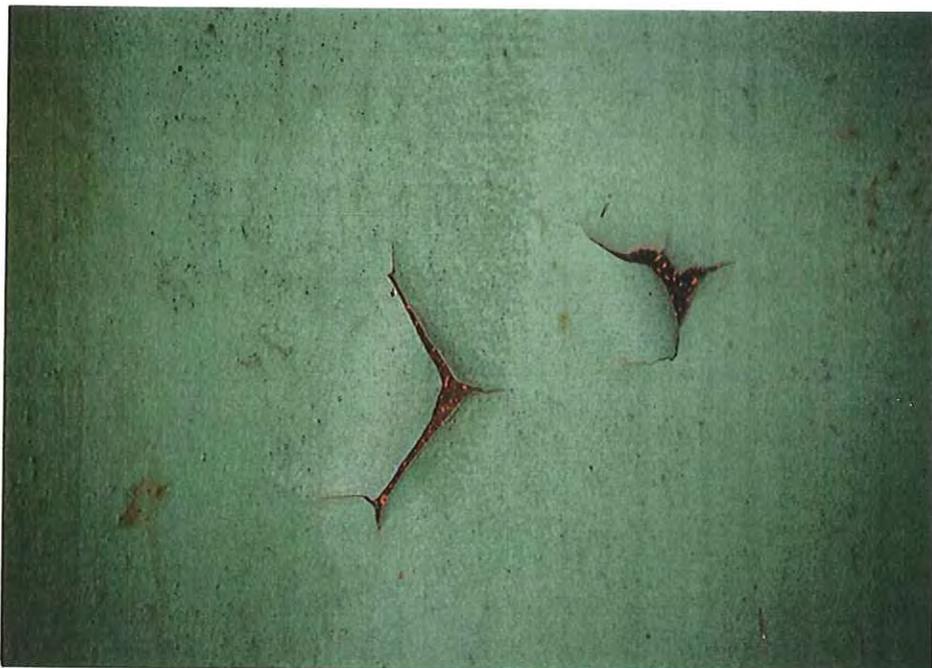
Photograph No. 58

Close-up of the cracked coating in Photo No. 57. Note fracture is in the weak orange primer.

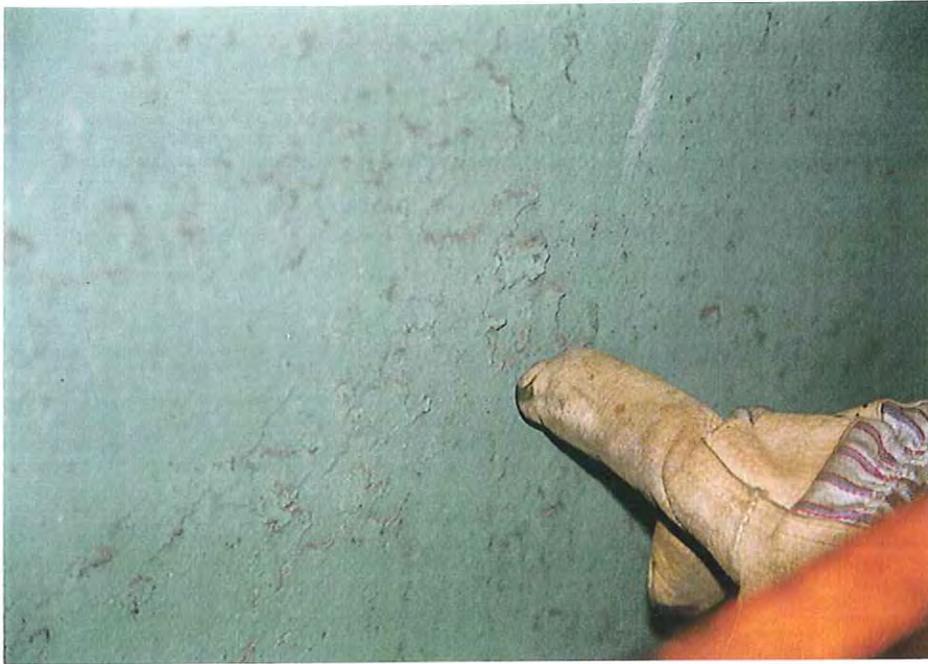
Photograph No. 59

Note islands of paint that are beginning to crack and peel.

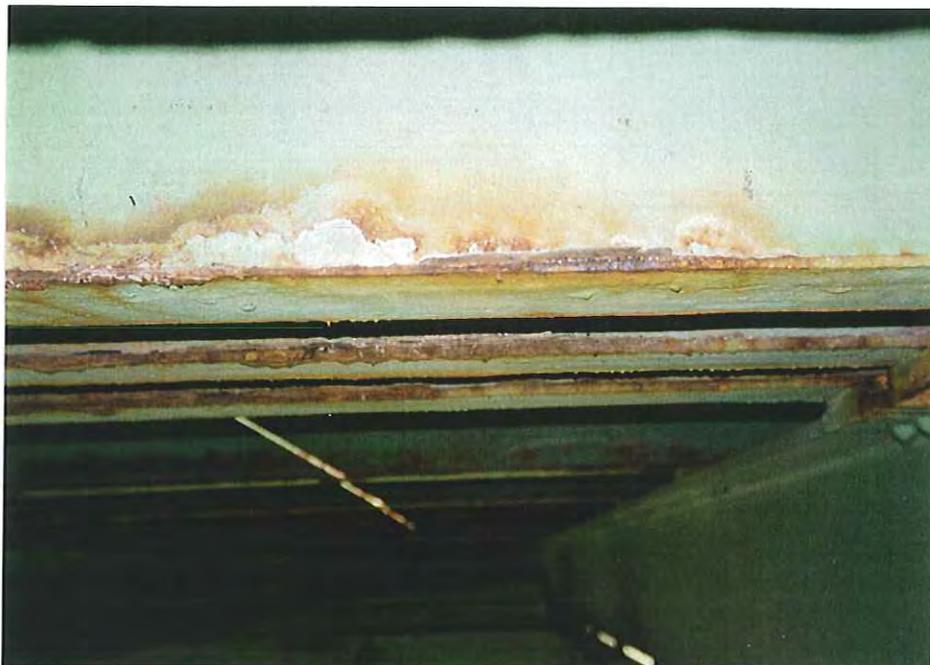
Photograph No. 60

Corrosion along the bottom flange of floor stringers in the girder approach spans on the east end of the bridge.

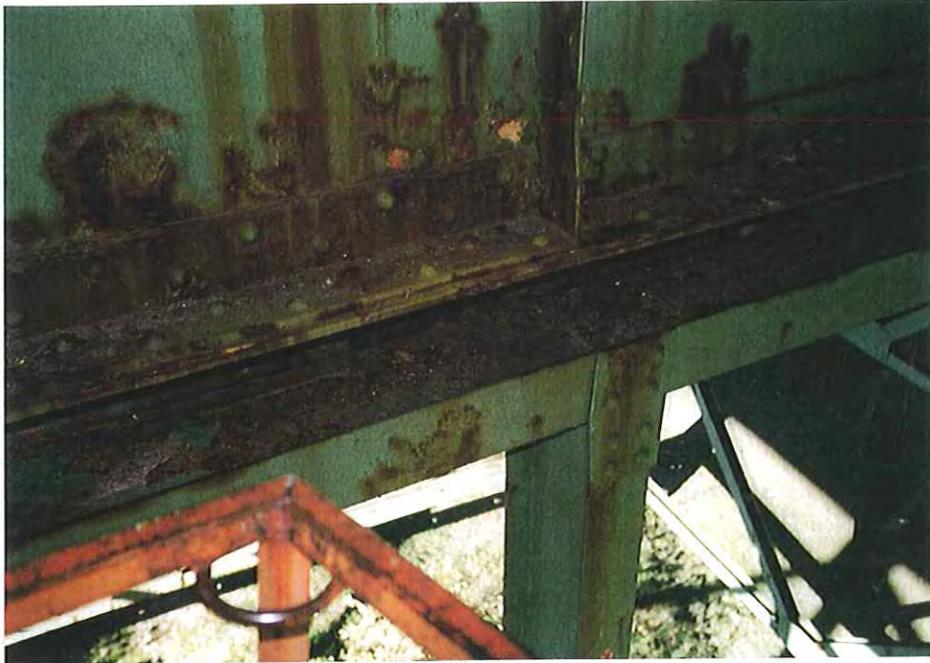
Photograph No. 61

Corrosion at the top of a bent and lower portion of a floor beam on the girder approach spans.

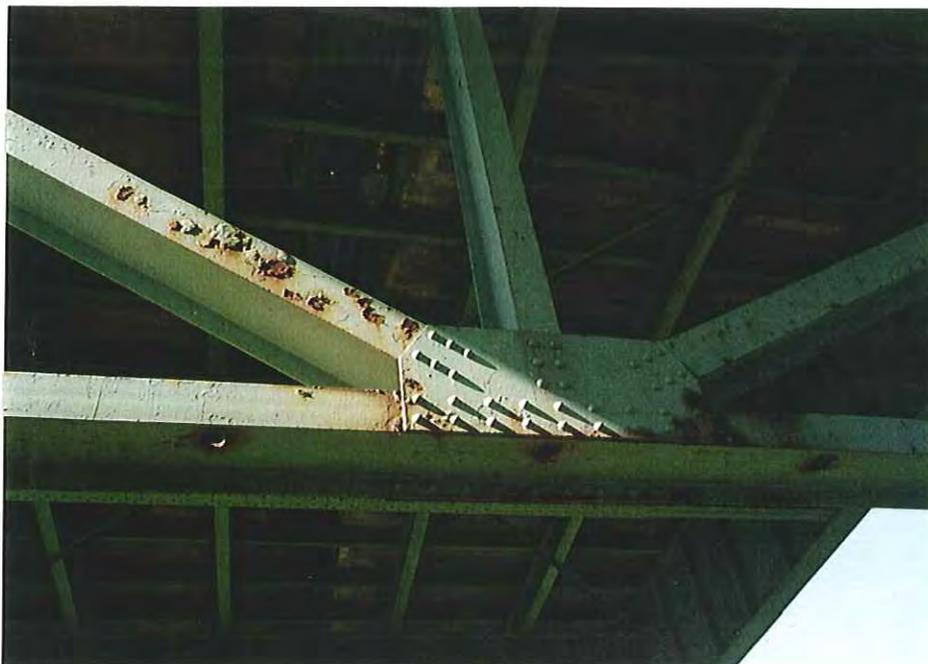
Photograph No. 62

Another view of the bents on the approach span and the typical poor coating condition.

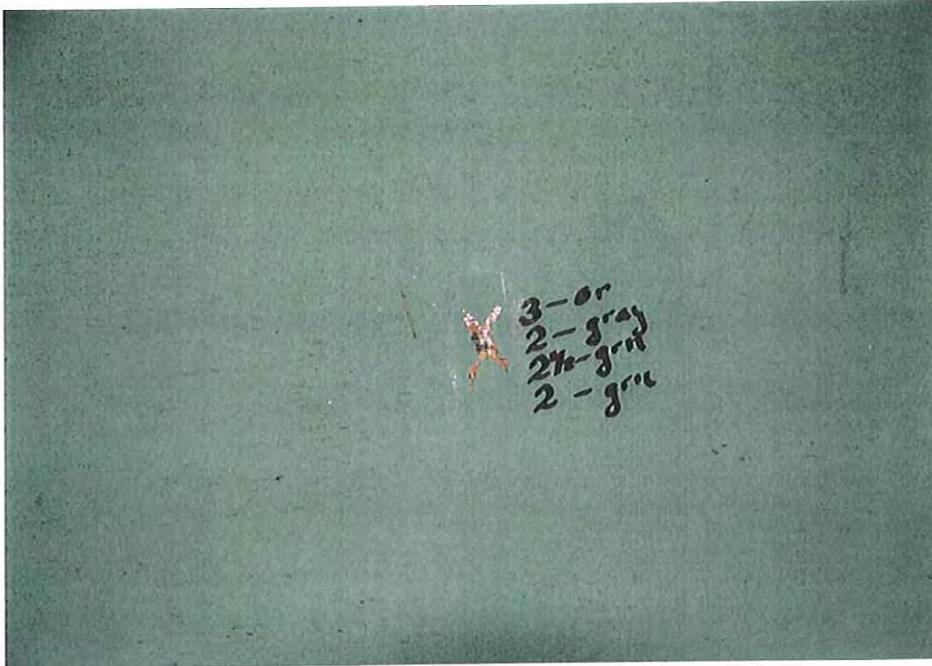
Photograph No. 65

Poor coating adhesion is shown on the fascia of Span 41, the exit ramp. Note four coating layers totaling 10 to 11 mils.

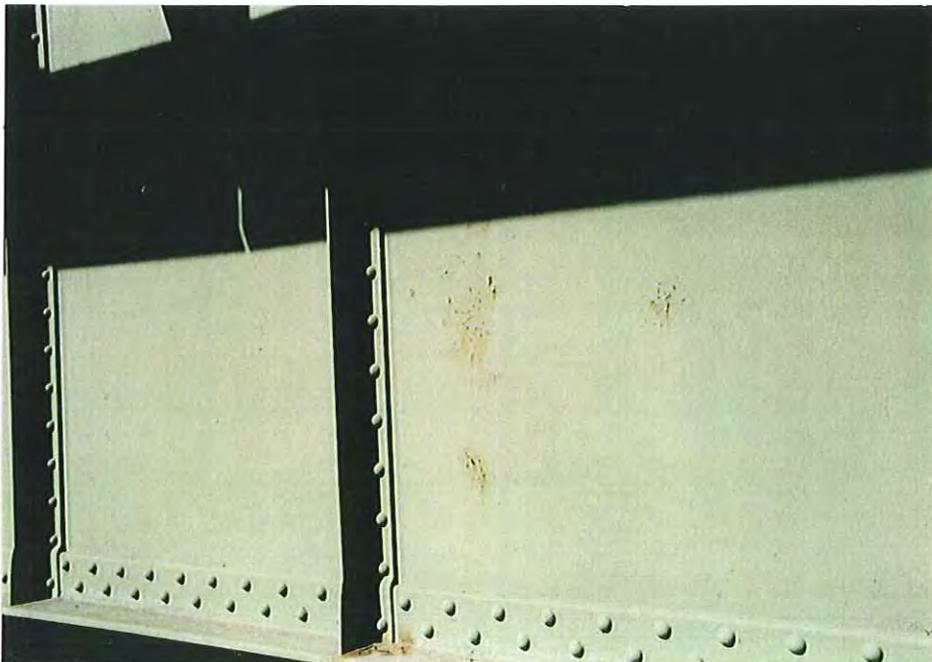
Photograph No. 66

This photo shows the poor condition of the coating on the south fascia of the exit ramp. Note the coating is beginning to spontaneously fracture in patches. This condition was observed on many areas of the bridge.

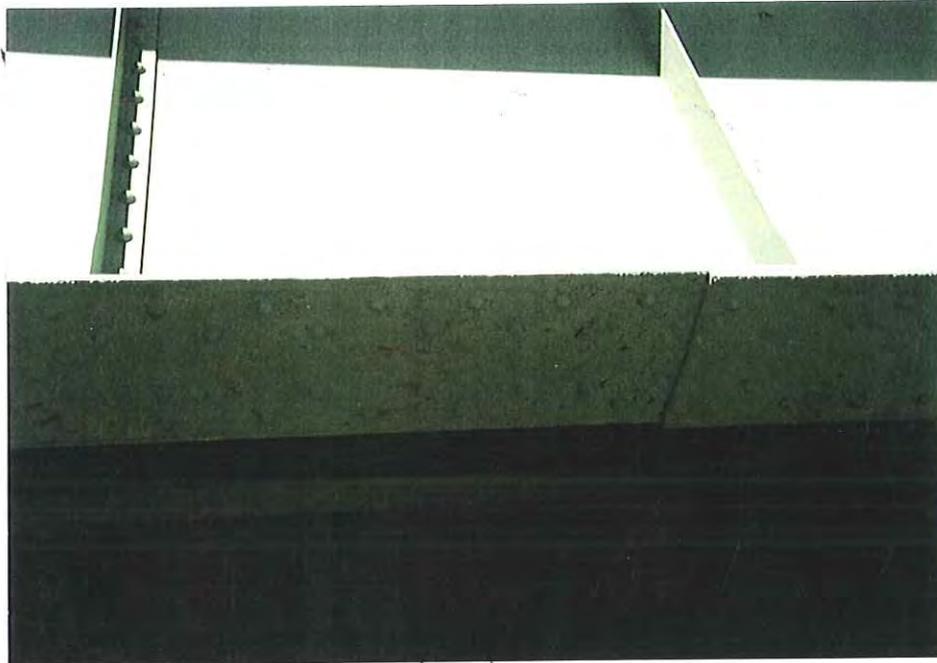
Photograph No. 67

Cracked and checked coating on the bottom flange of a connecting plate on the exit ramp.

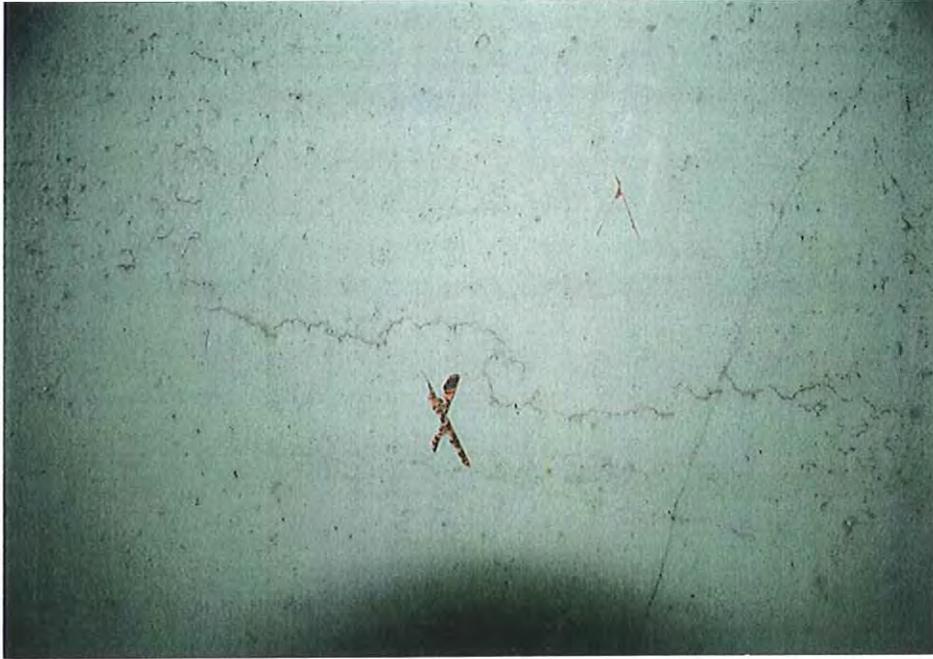
Photograph No. 69

This shows an area on the exit ramp where islands of old paint were not removed prior to the previous maintenance painting. Adhesion is fair to poor where old coating was overcoated.

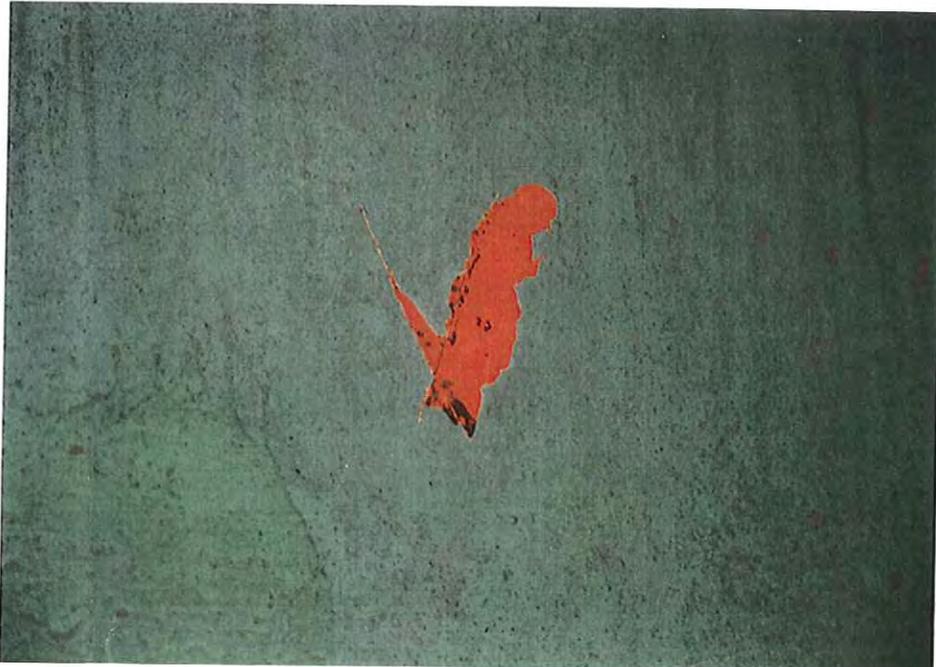
Photograph No. 70

This shows the very poor adhesion on a diaphragm in Span 29. Note how fracture occurred in the orange primer.

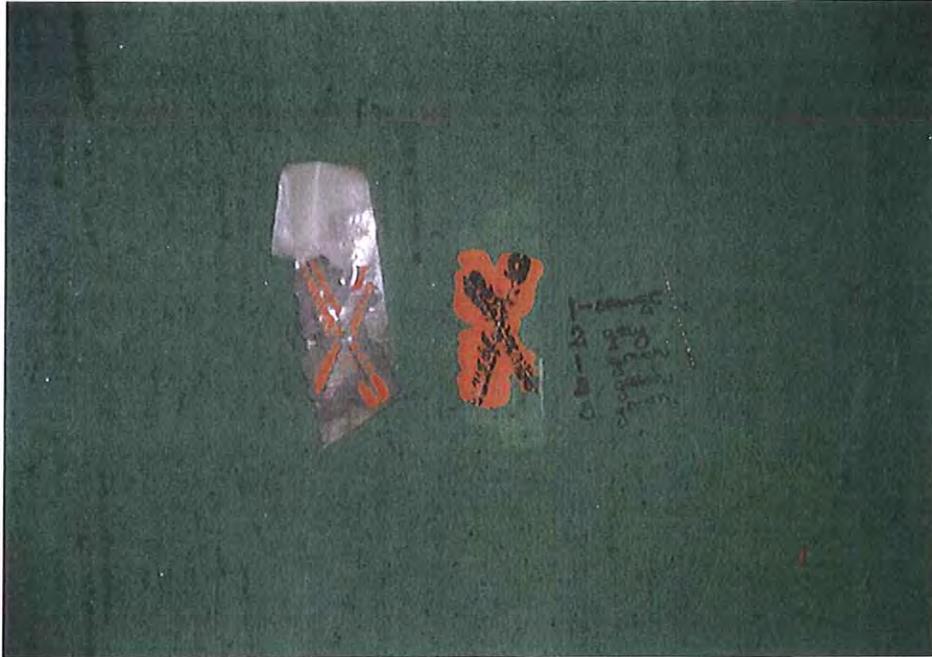
Photograph No. 71

This photograph shows very poor adhesion (0A), and lists the thickness of the various coating layers. Note fracture is occurring in the brittle orange primer.

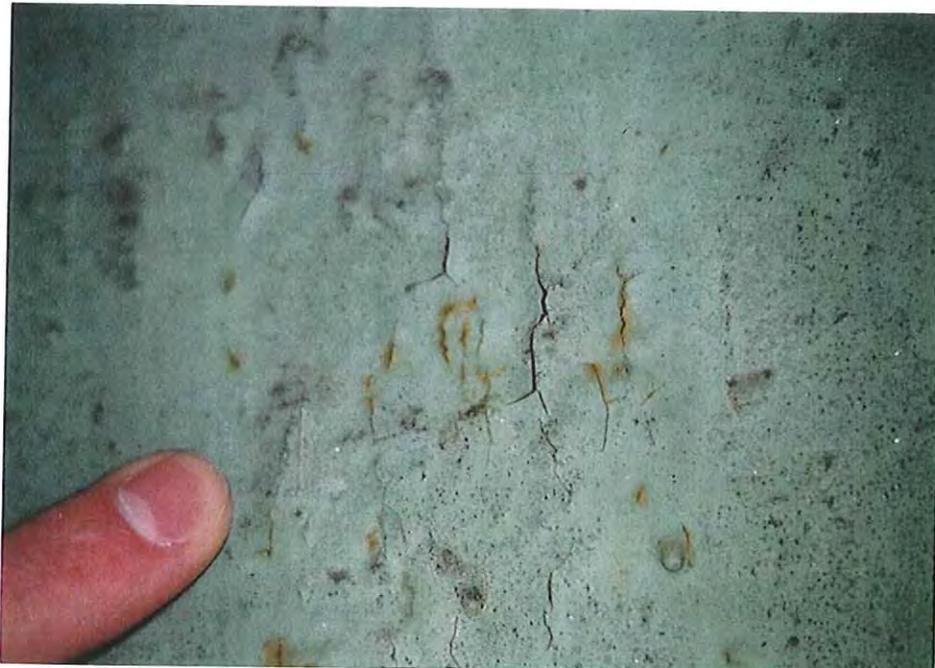
Photograph No. 72

This close-up shows the brittle condition of the coatings and accompanying micro-checking. Micro-checking was observed on many areas of the bridge, especially on the webs of the girder spans and simple beam spans.
