Request for Quote

CREATION DATE : 30-MAY-13
 BID NUMBER: 7461383-2
 TITLE: REPAIR EXISTING WATER TOWER - URI
 BID CLOSING DATE AND TIME: 24-JUN-2013 10:00:00

Water Tower Repairs

Scope of Work: URI Elevated Tank, Kingston, RI

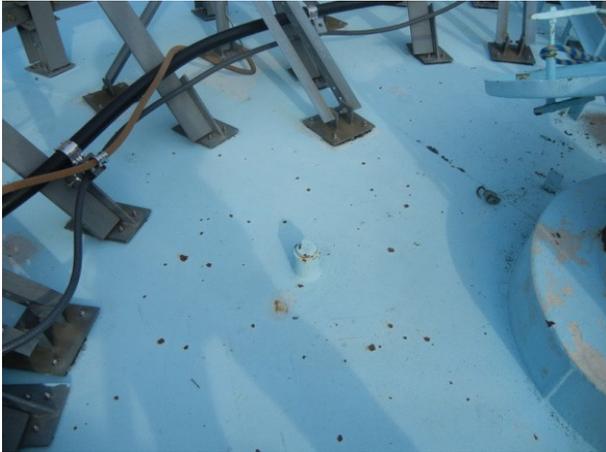
1. Pitting around top of tank

- 1.) Spot rust on the top of the tank shall be power tool cleaned to an SSPC-SP#3 quality then painted with (3) coats of a modified polyurethane primer or epoxy mastic.

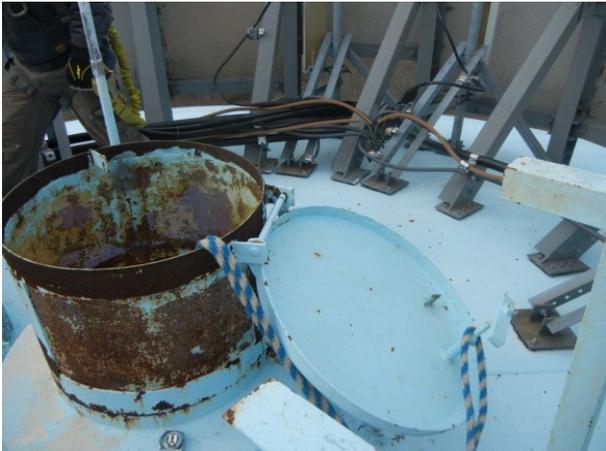
2. Top of tank dry riser hatch assembly

- 2.) The 36"Ø top dry riser perforated metal extension and hatch assembly shall be power tool cleaned to SSPC-SP#11 quality along the exterior and interior surfaces then painted with (2) coats of a modified polyurethane primer and (1) coat of polyurethane finish paint.

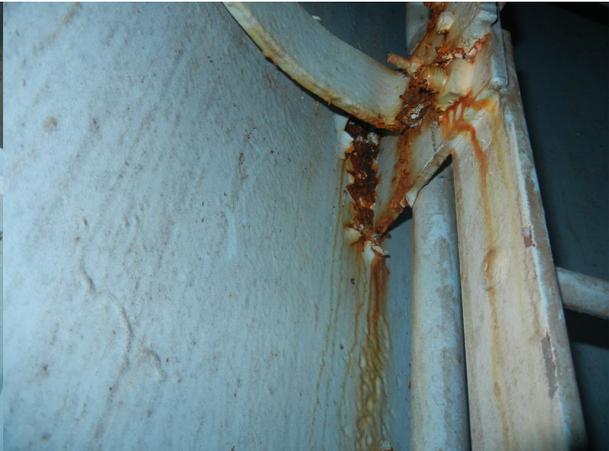
3. Dry riser access ladder connections

- 3.) The dry riser access ladder connections to the access tube including bolted connections to the ladder side rails shall be power tool cleaned to an SSPC-SP#3 quality then painted with (3) coats of a modified polyurethane primer or epoxy mastic.

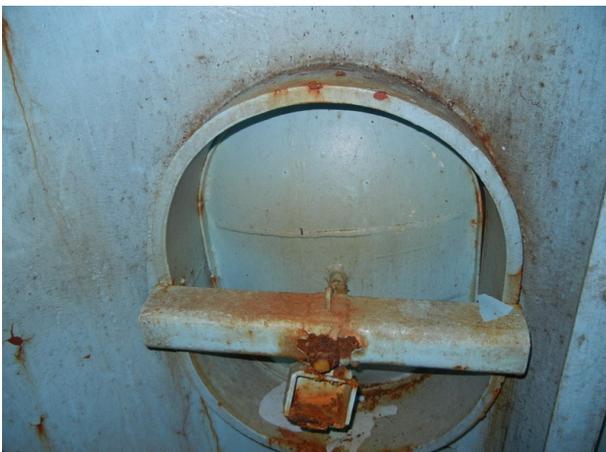
4. Bowl access manhole

- 4.) The bowl access manhole neck and retention clamp assembly within the dry riser shall be power tool cleaned to an SSPC-SP#3 quality then painted with (3) coats of a modified polyurethane primer or epoxy mastic.

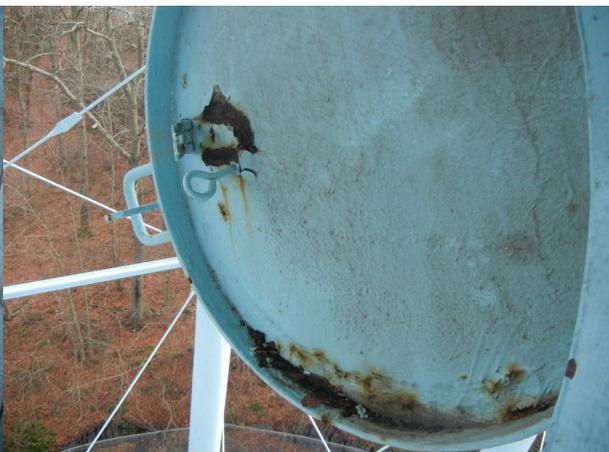
5. Painters manhole access door

- 5.) A new locking hasp shall be welded to the interior face of the dry riser painter's manhole assembly. The new hasp and adjacent surfaces shall be power tool cleaned to an SSPC-SP#3 quality then painted with (3) coats of a modified polyurethane primer. Additional welding repairs and recoating shall be performed along the associated hatch cover as needed.

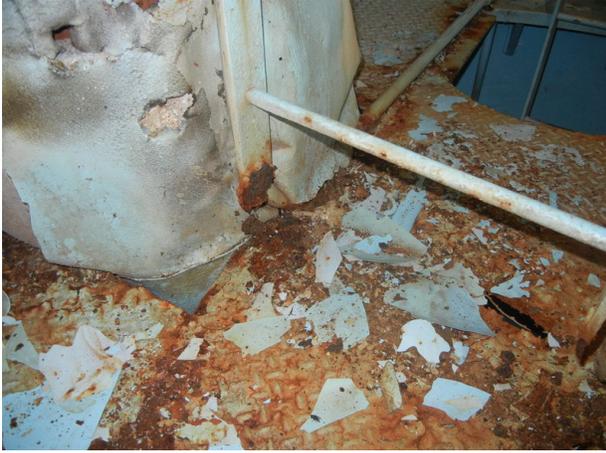
6. Ladder at condensate deck (midway point)

- 6.) New steel shall be welded to the upper dry riser access ladder to reattach it to the condensate deck where metal loss has caused it to break free. The new ladder to deck connections as well as the top face of the interior riser condensate deck shall be abrasive blast cleaned to SSPC-SP#10 quality then painted with (3) coats of a modified polyurethane primer or epoxy mastic. Additional welding repairs shall be performed along the top face of the deck to repair pitting representing a 35% or greater reduction in plate thickness in order to ensure the structural integrity of the surface.

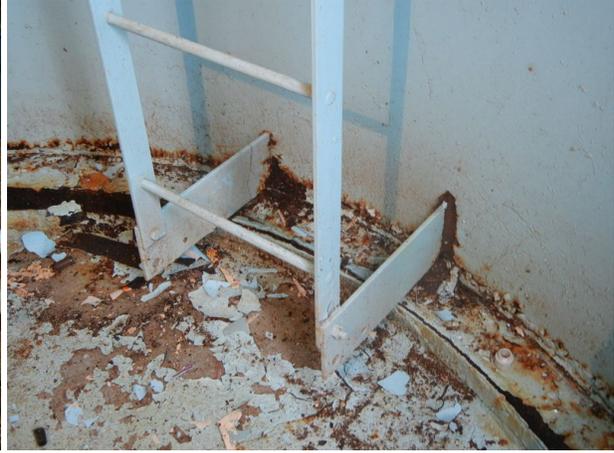
7. Ladder attachment at base plate

- 7.) New steel shall be welded to the lower dry riser access ladder to reattach it to the dry riser base plate where metal loss is present. The new ladder to base plate connections shall abrasive blast cleaned to an SSPC-SP#10 quality then painted with (3) coats of a modified polyurethane primer or epoxy mastic.

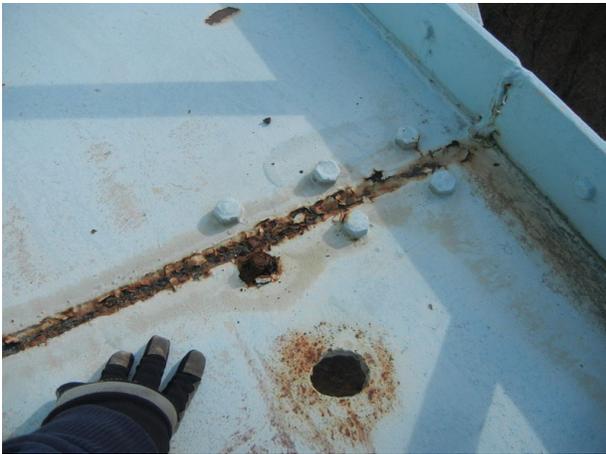
8. Balcony bolts needing seal welding

- 8.) Seal weld (3) bolts in the balcony walkway that are exhibiting significant metal fatigue. The repaired bolts shall be power tool cleaned to SSPC-SP#3 quality then painted with (2) coats of a modified polyurethane primer and (1) coat of polyurethane finish paint.

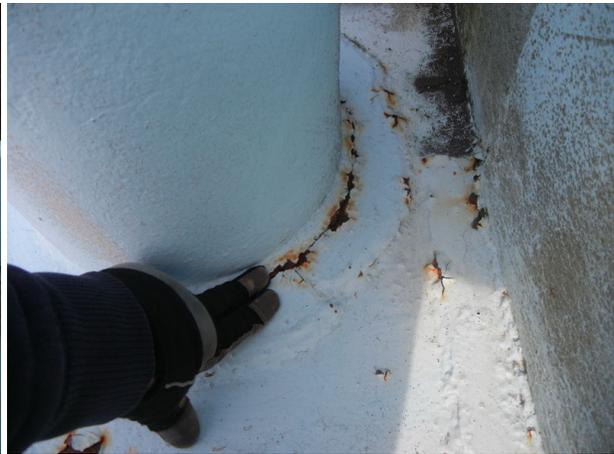
9. Crack at overflow pipe/balcony junction

- 9.) Seal weld a 10" crack along the balcony to overflow pipe junction. The repaired surfaces shall be power tool cleaned to SSPC-SP#3 quality then painted with (2) coats of a modified polyurethane primer and (1) coat of polyurethane finish paint.

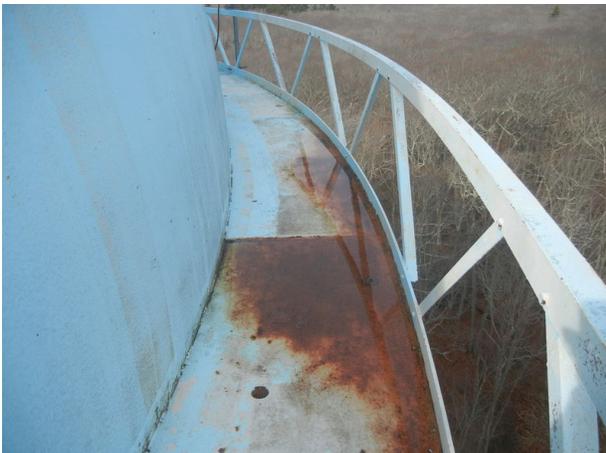
10. Drain holes needed in balcony

- 10.) Additional drainage holes should be cut into the balcony walkway surface to alleviate water retention. The accessible surfaces shall be power tool cleaned to SSPC-SP#3 quality then painted with (2) coats of a modified polyurethane primer and (1) coat of polyurethane finish paint.

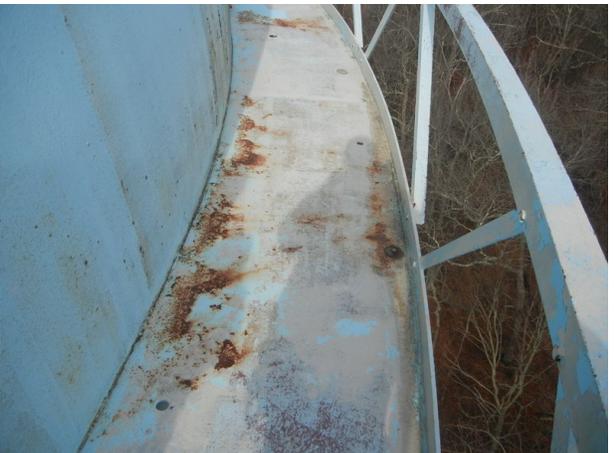
11. Balcony corrosion

- 11.) Areas of corrosion along the top face of the balcony deck shall be power tool cleaned to SSPC-SP#11 quality then painted with (2) coats of a modified polyurethane primer and (1) coat of polyurethane finish paint.

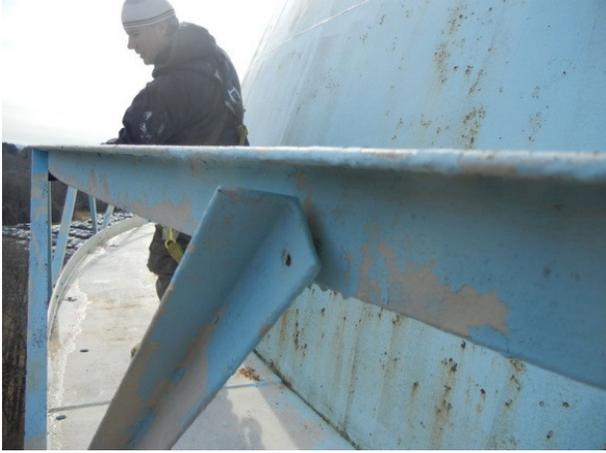
12. Handrail braces needing bolts/seal welding

- 12.) Seal weld and/or bolt in place (3) handrail diagonal braces on balcony that are no longer secured. The repaired surfaces shall be power tool cleaned to SSPC-SP#3 quality then painted with (2) coats of a modified polyurethane primer and (1) coat of polyurethane finish paint.

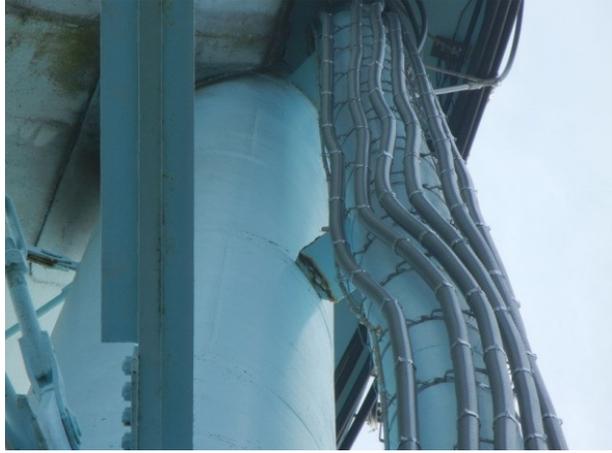
13. Overflow bracket below balcony

- 13.) The 2nd overflow pipe bracket located just below the balcony level shall be power tool cleaned to SSPC-SP#3 quality then painted with (2) coats of a modified polyurethane primer and (1) coat of polyurethane finish paint.

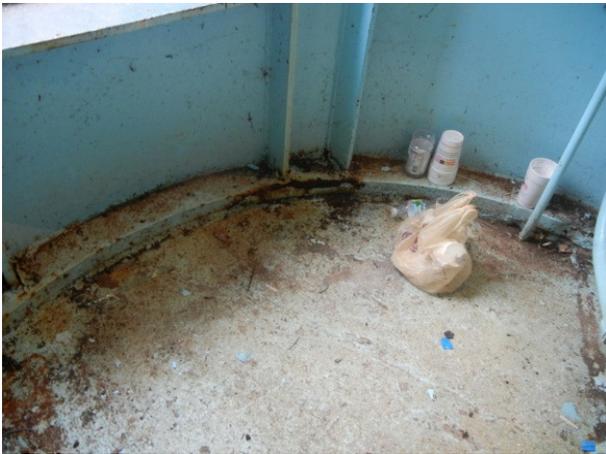
14. Interior base plate

- 14.) The interior and exterior of the base plate at the bottom of the riser inclusive of the anchor bolts shall be abrasive blast cleaned to SSPC-SP#6 quality then painted with (2) coats of a modified polyurethane primer and (1) coat of polyurethane finish paint.

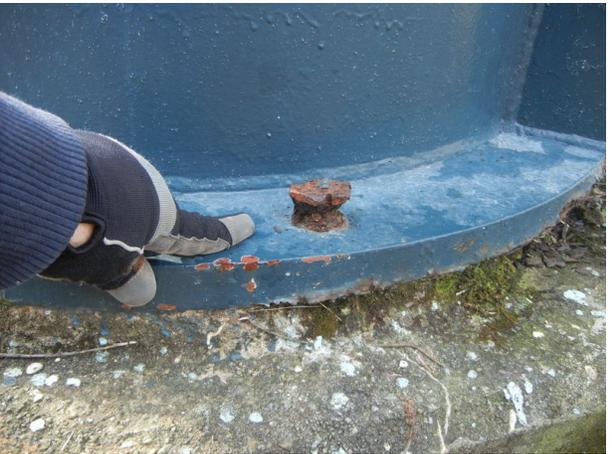
15. Column anchor bolt in need of welding

- 15.) Seal weld in place (1) support column anchor bolt where the retention nut is missing.
- 16.) All support column anchor bolts exhibiting corrosion or repair shall be abrasive blast cleaned to SSPC-SP#6 quality then painted with (2) coats of a modified polyurethane primer and (1) coat of polyurethane finish paint.

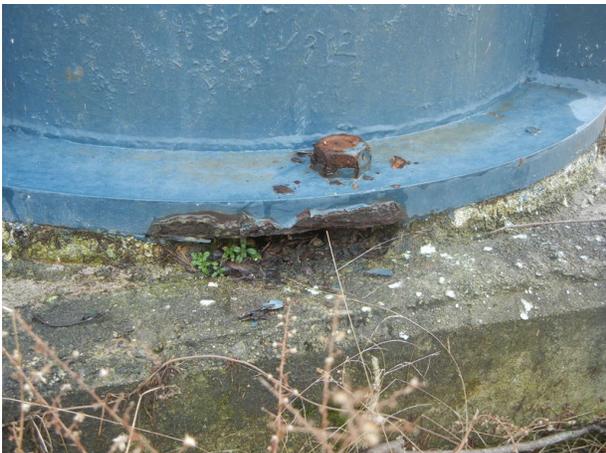
16. Column anchor bolts with corrosion

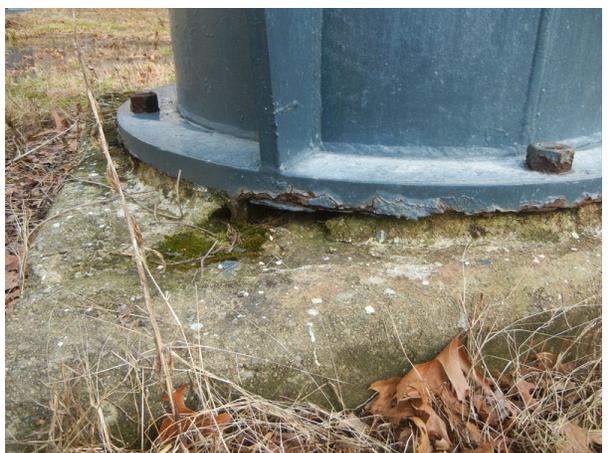
17. Column base needing grout

- 17.) Repair grout, as necessary, along the base of the tank support columns. An estimated 10 linear feet of grout repair is anticipated.
