## ADDENDUM # 4

BID # 7449531 BID TITLE: A & E -- OLD STATE HOUSE

**NEEDS ASSESSMENT FOR  
THE OLD STATE HOUSE  
150 BENEFIT ST  
PROVIDENCE, RI**

**RESTORATION AND MAINTENANCE NEEDS**

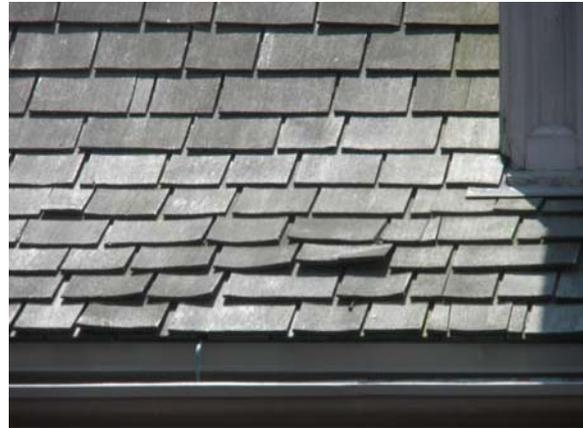
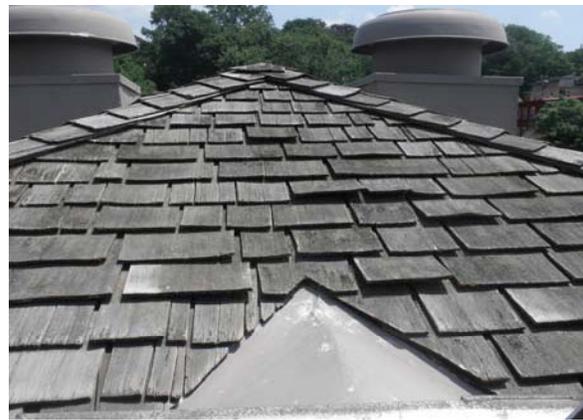
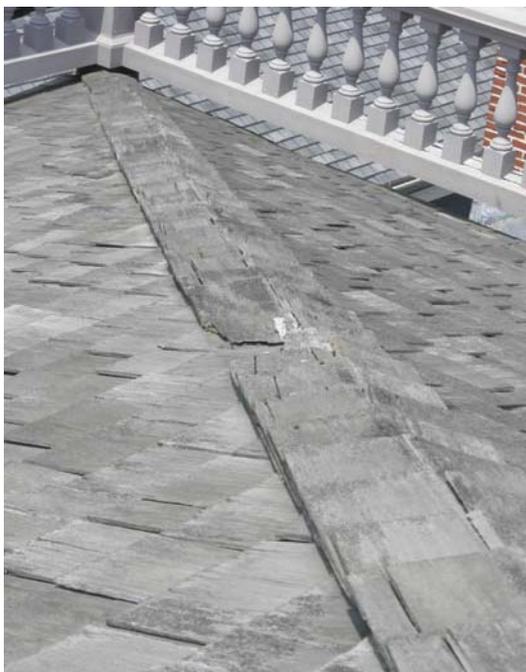
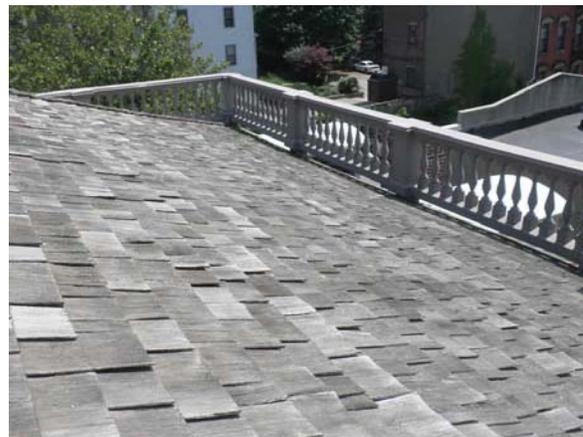
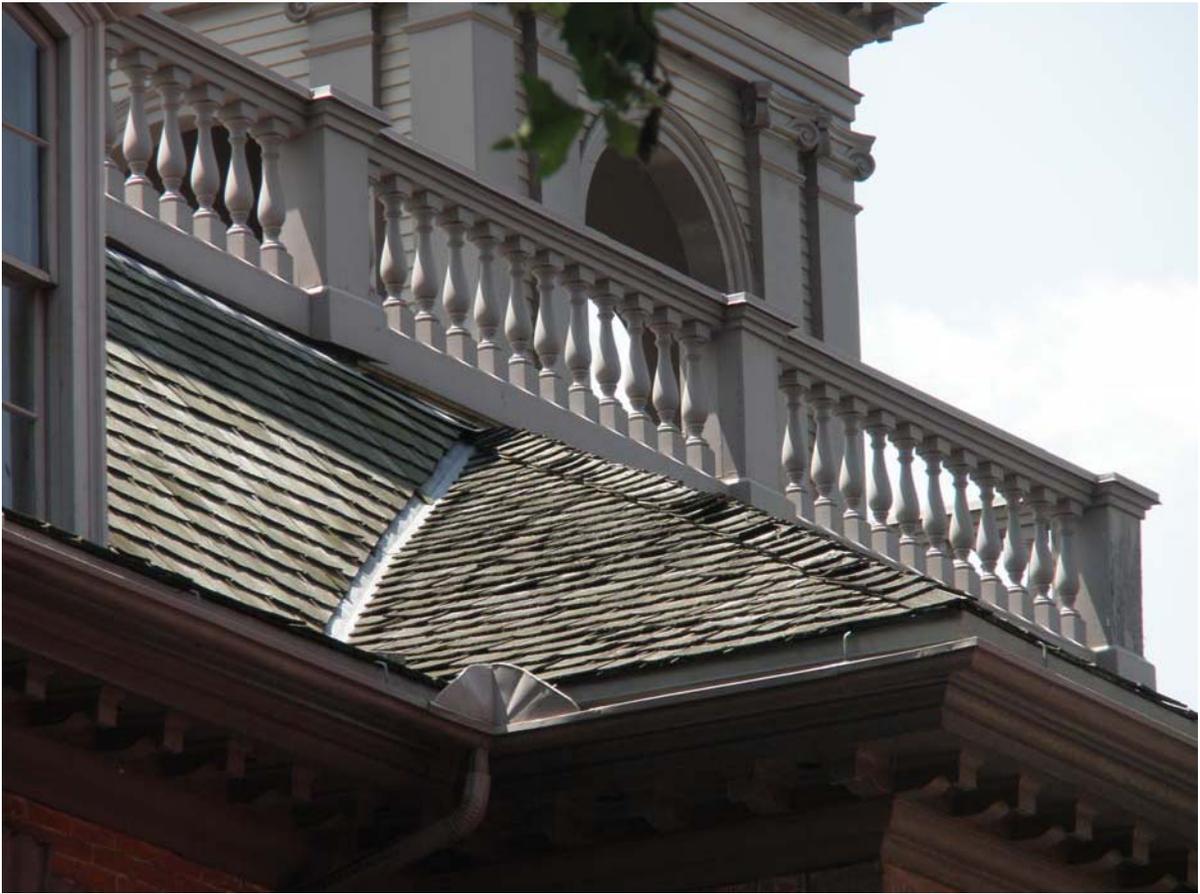
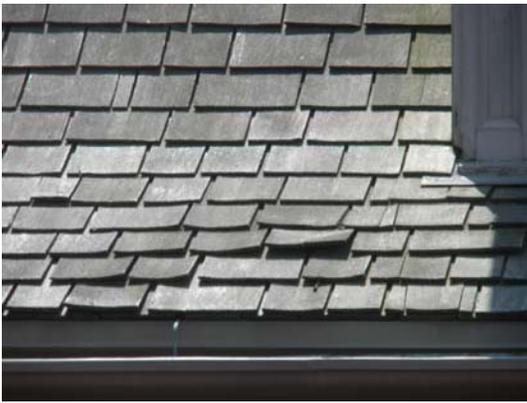
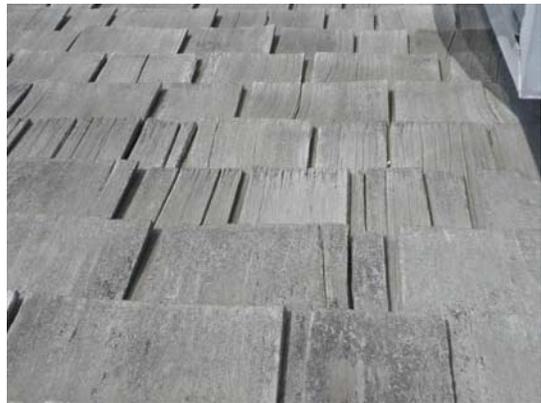
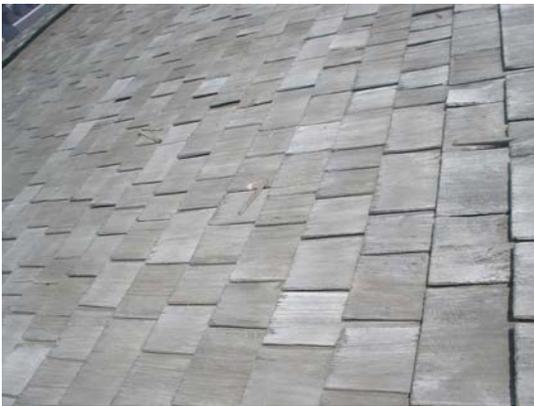
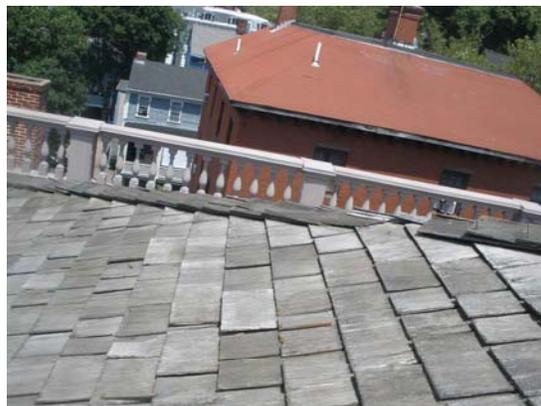
Wood Shingled Roof Replacement

The roof on the OSH was last replaced in 1981-82. This means that the existing roof has exceeded its expected 25 year life span by 5 years. The shingles are extremely dried out, warped, cupped and split. Pieces of shingle are routinely found on the sidewalk around the building. It is only a matter of time before the roof begins to leak, and we fear that a major storm with wind driven rain could breach the fragile membrane. There are also signs that the flashing around dormers is beginning to fail, as we have had leaks in those areas in recent years which has resulted in plaster damage. For these reasons, a roof replacement will be needed in the near future.

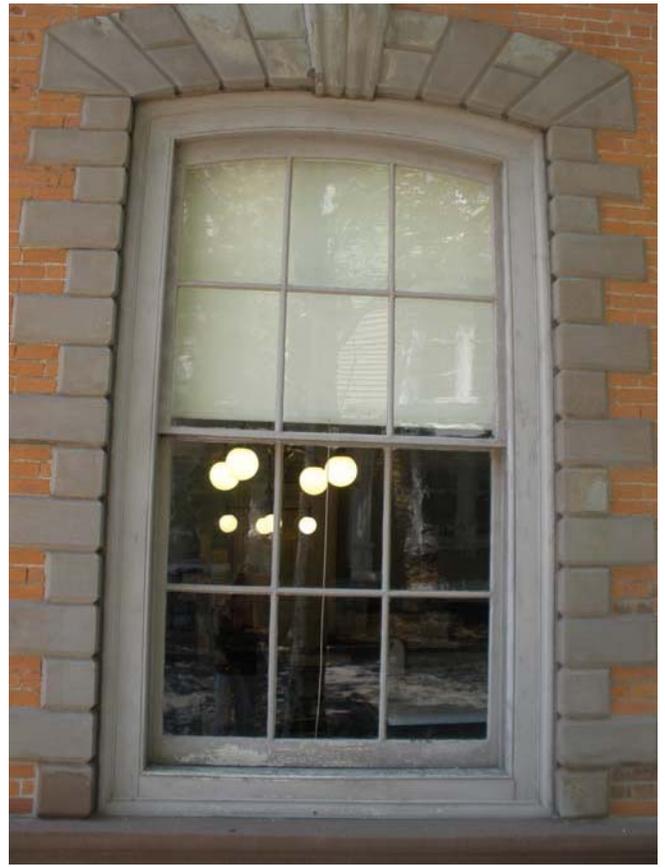
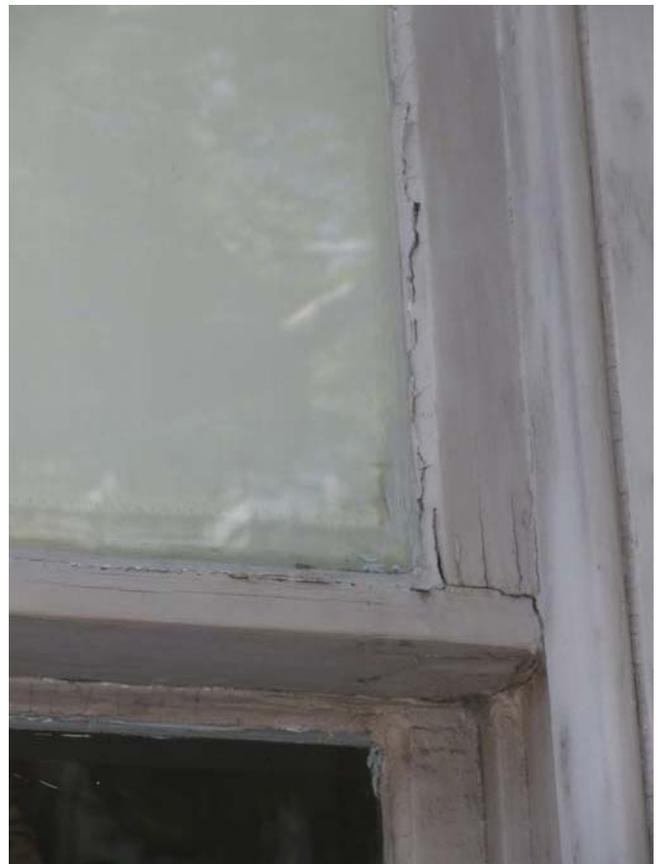
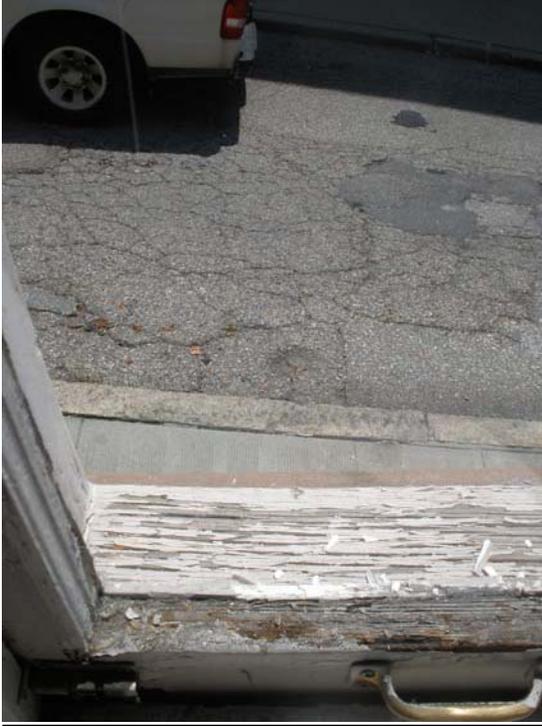
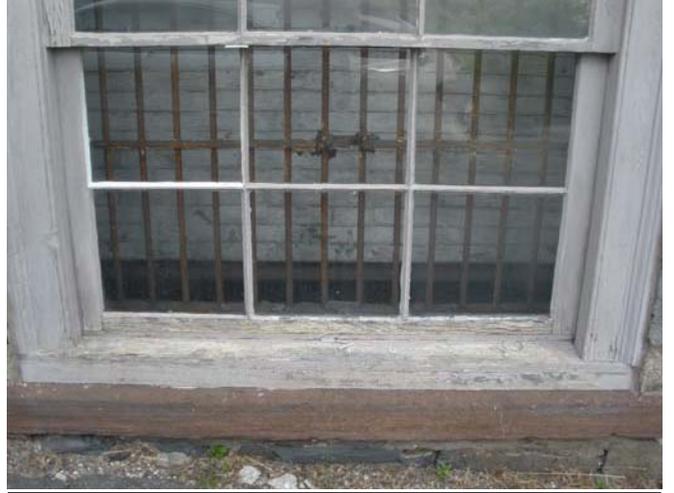
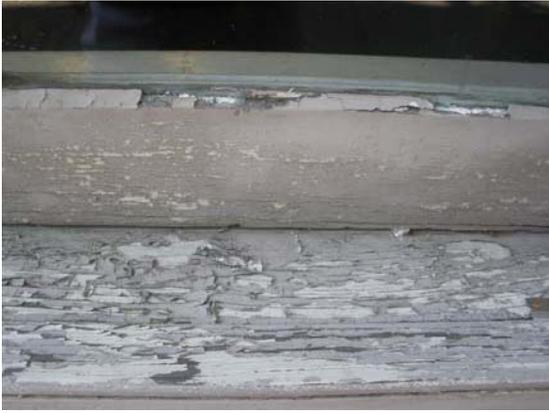
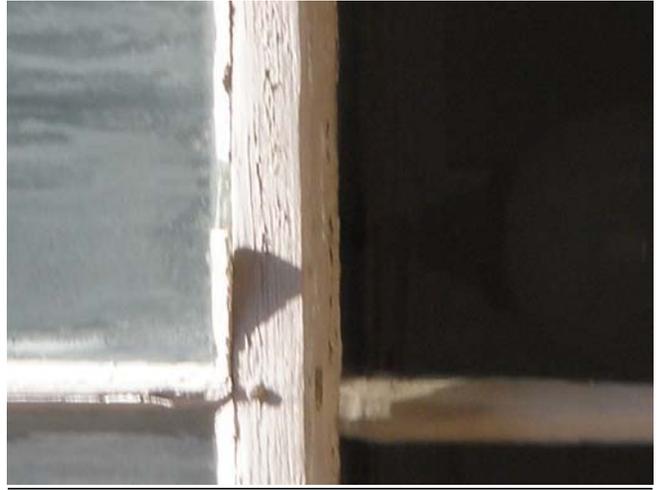
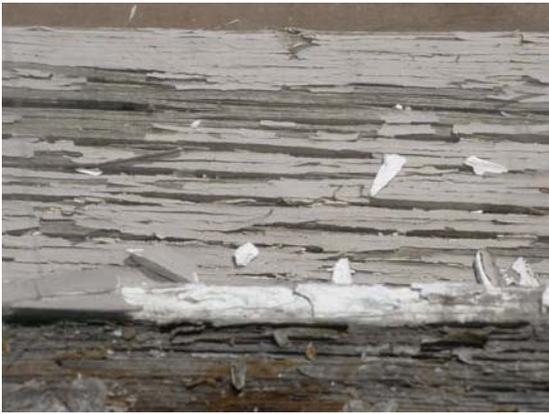
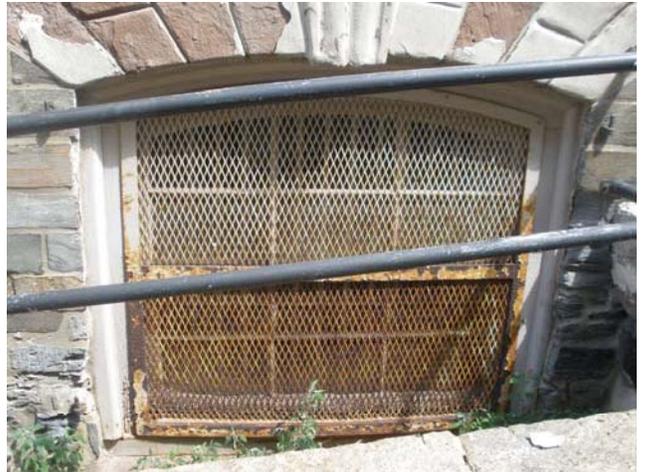
### Window and Window Sill Repairs

The wooden window sashes are all exhibiting stages of wear and weathering and are in need of work. The hardy 100 year old sash have varying amounts of deterioration and each sash should be evaluated to determine the amount of repair necessary. Sash to be repaired should be carefully removed. All loose putty and broken glass should be removed from each sash. All glass in good condition should be carefully removed and salvaged for reuse. Sash stiles and rails should be repaired or replaced as needed. Epoxy consolidation should be used where possible to repair existing sash. All other holes and cracks should be filled with putty. Paint should be carefully removed using appropriate methods to achieve a paintable surface. It is not necessary to remove all of the paint. Before reinstalling the glass a bead of glazing compound should be laid around the rabbet. The panes should then be pressed into place and secured with glazing points. Putty should not be visible from the inside of sash. When repairs have been made and before painting, dried and cracked wood should be treated with a natural wood consolidant. Cracks in sash should be filled with DAP acrylic latex caulking after priming. Two coats of finish paint should be applied. All glass should then be cleaned. Ropes/chains and weights should be repaired or replaced as needed.

Wood window sills also need attention in most cases. Many have checks, cracks and splits which will need to be epoxy consolidated. Each sill should be evaluated and repaired as needed.

Basement windows, both frame and sash are in need of repair. Each basement window shall be assessed and repaired as needed. Grilles must be removed and salvaged. The rust should be removed and grilles repainted and reinstalled.

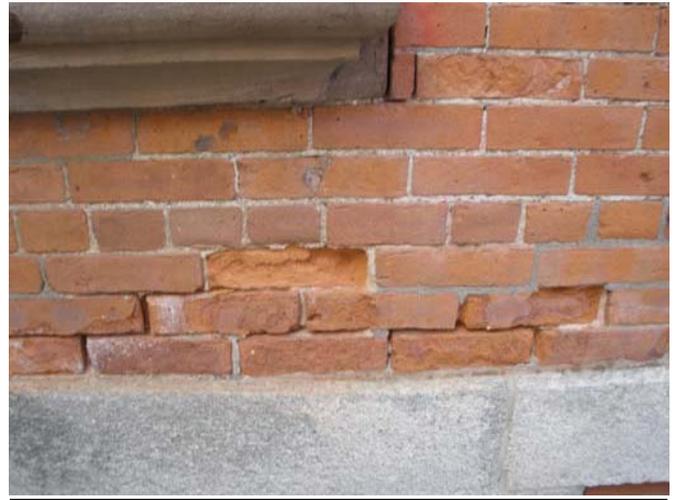
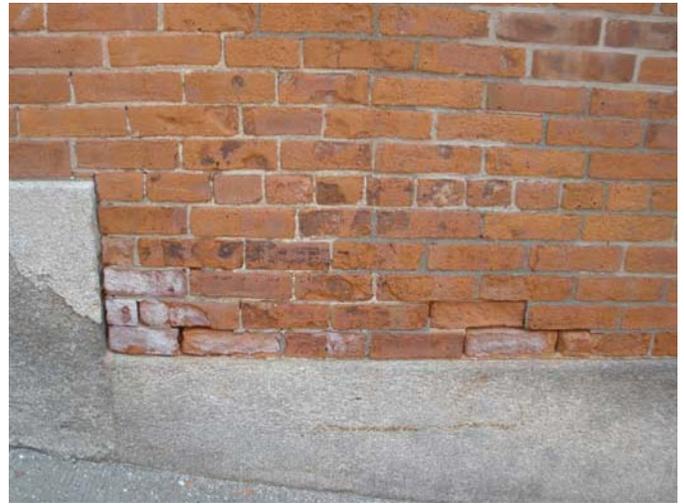
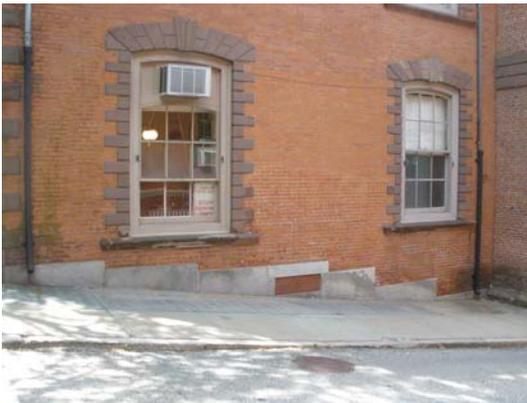
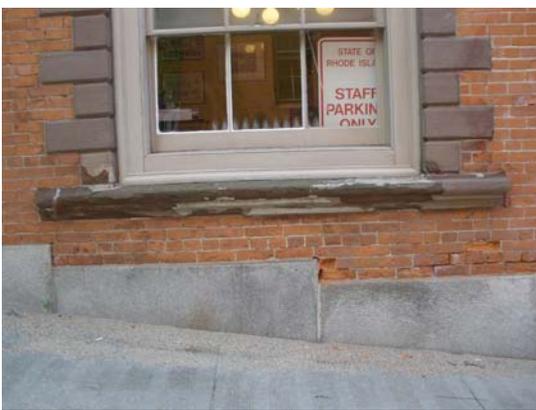
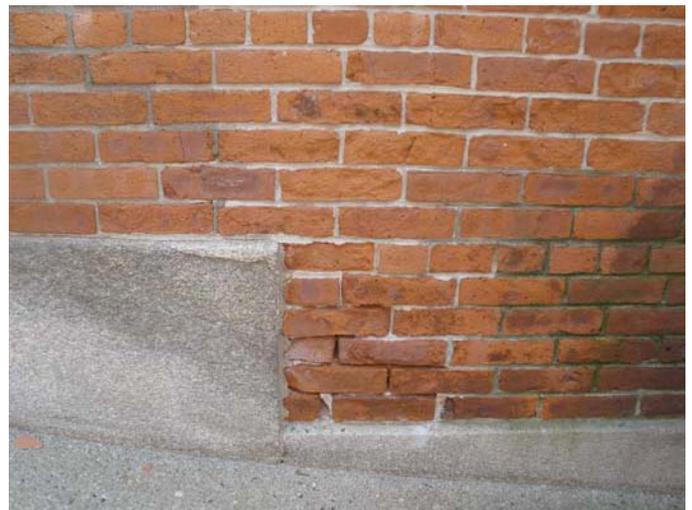
## North Brick Wall

The lower section of the north wall of the 1867 addition (Benefit Street side) has many deteriorated brick which need to be replaced. All of the brick below the first floor window sills down to the granite base should be carefully removed so as not to disturb the brick above. The brick should be replaced with new brick that matches the existing brick in size and color with mortar that matches the existing mortar. New masonry anchors must be provided in the repair. Brick samples should be provided for review and approval to the RI Historical Preservation and Heritage Commission (RIHPHC) Architects prior to the start of work. A mortar sample must be provided for review and approval by the RIHPHC Architects prior to construction.

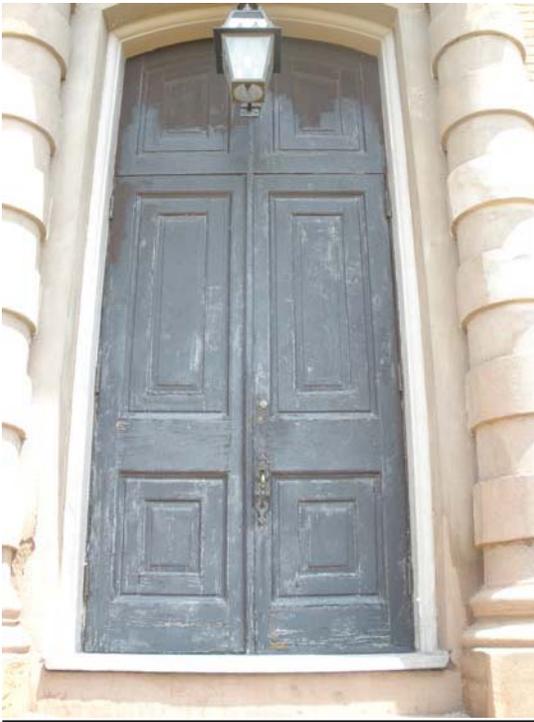
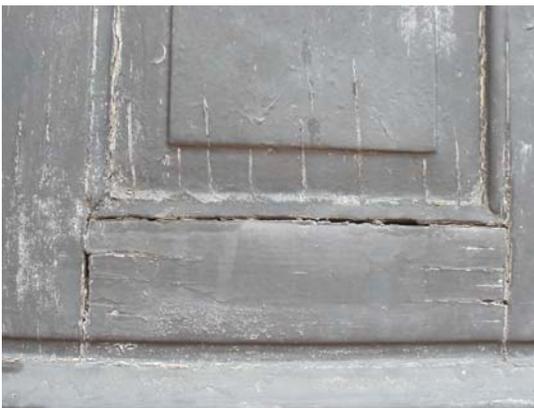
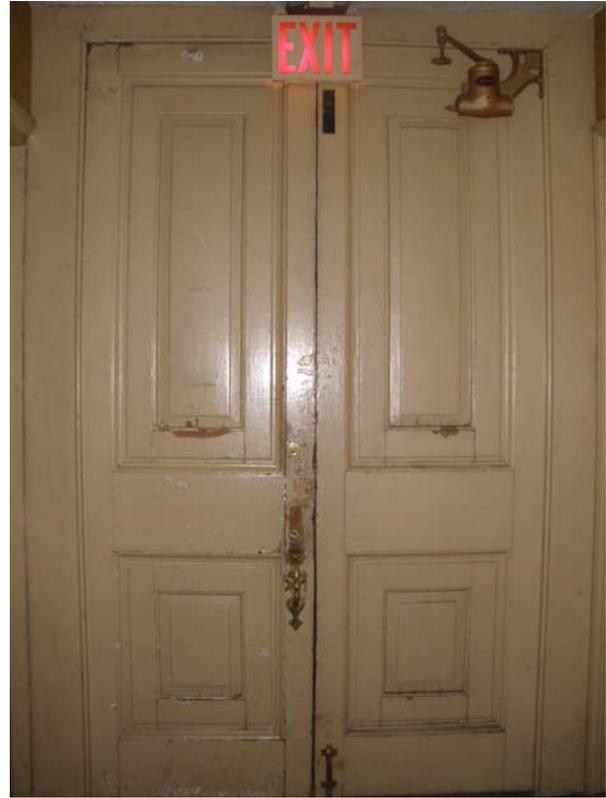
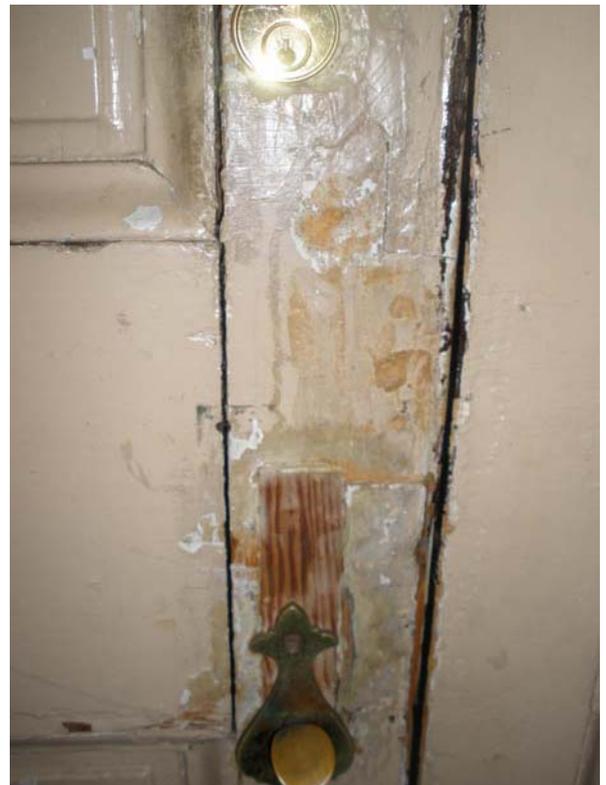
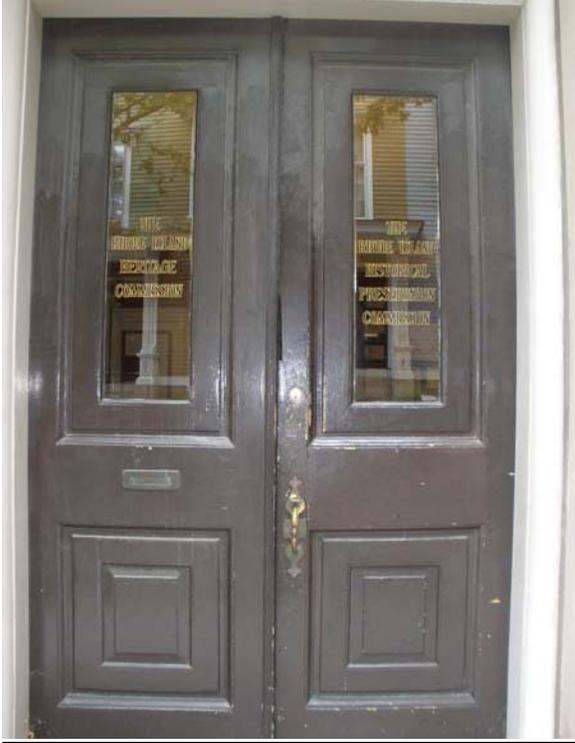
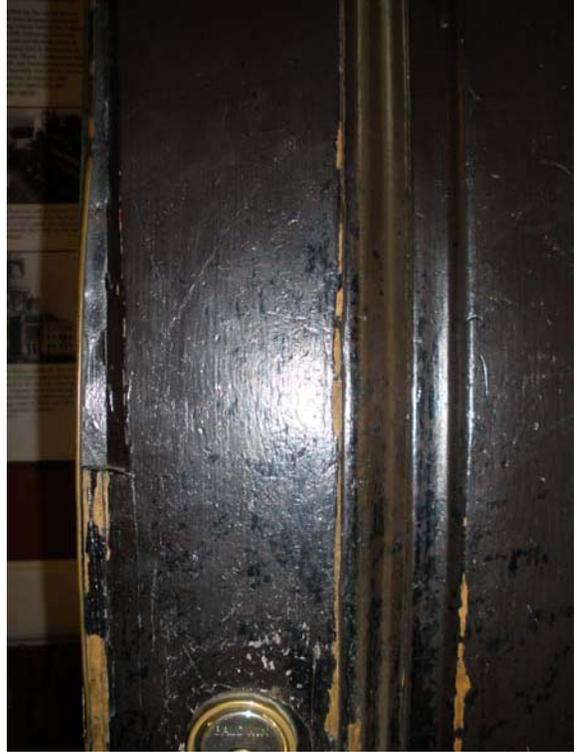
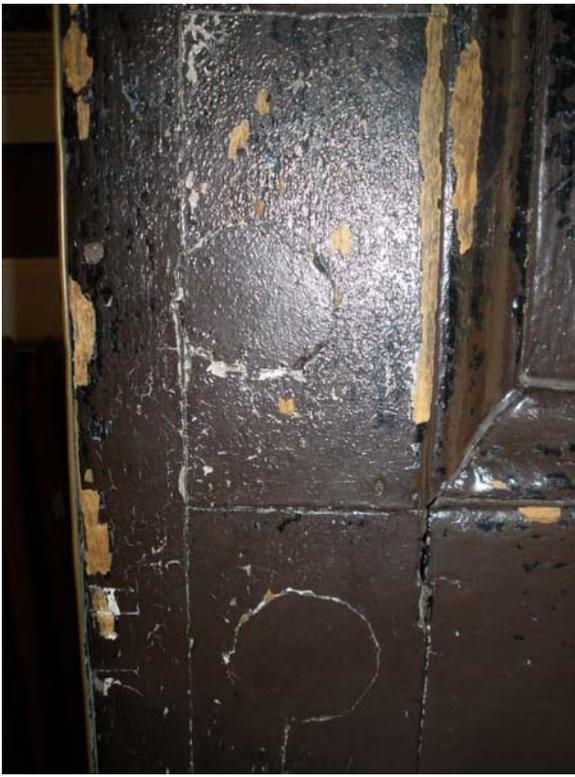
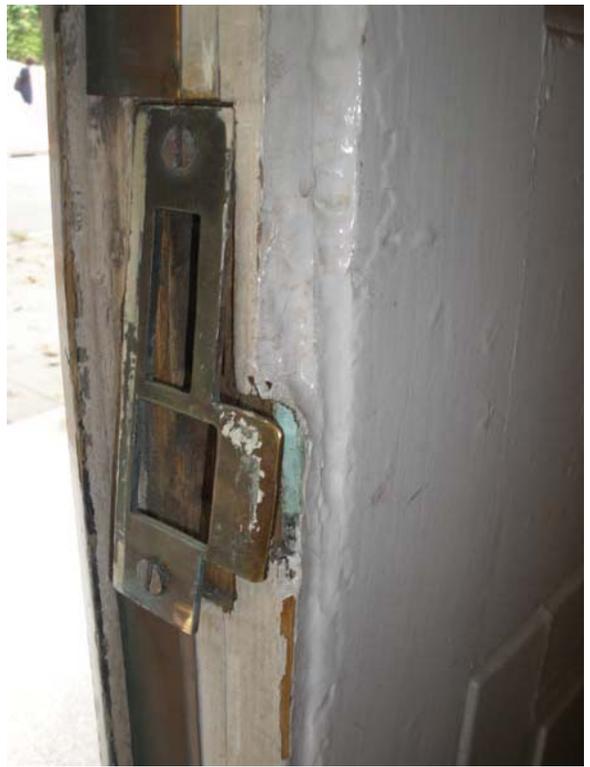
## Front and Rear Doors - Repair and Rebuilding

The Historic entrance doors of the building are in serious disrepair and need to be removed, taken apart and rebuilt. All deteriorated or split, or heavily patched members of the doors that can not be repaired should be replaced in-kind with wood that matches the original in species, thickness and profiles. All members that can be repaired should be carefully epoxied and sanded smooth. Weather-stripping should be reapplied and the door should be re-hung.

UNDER SECTION "FRONT AND REAR DOORS-REPAIR AND REBUILDING" IN "NEEDS ASSESSMENT" BROCHURE, IT HAS BEEN DETERMINED THAT FRONT DOORS SHOULD BE REPLACED. CHANGE SPECIFICATIONS TO READ "FRONT DOOR REPLACEMENT (IN KIND) AND REAR DOOR REPAIR AND REBUILDING."

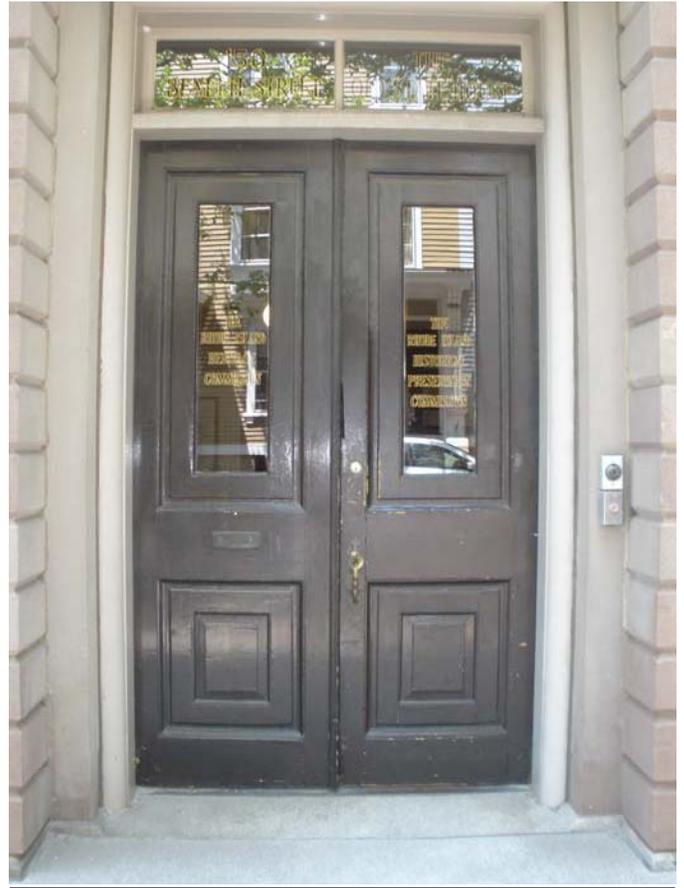
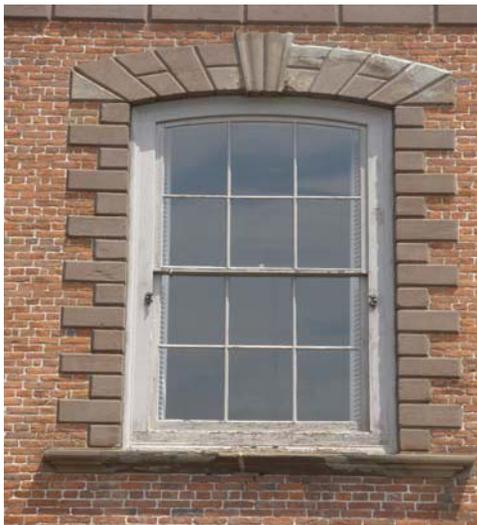
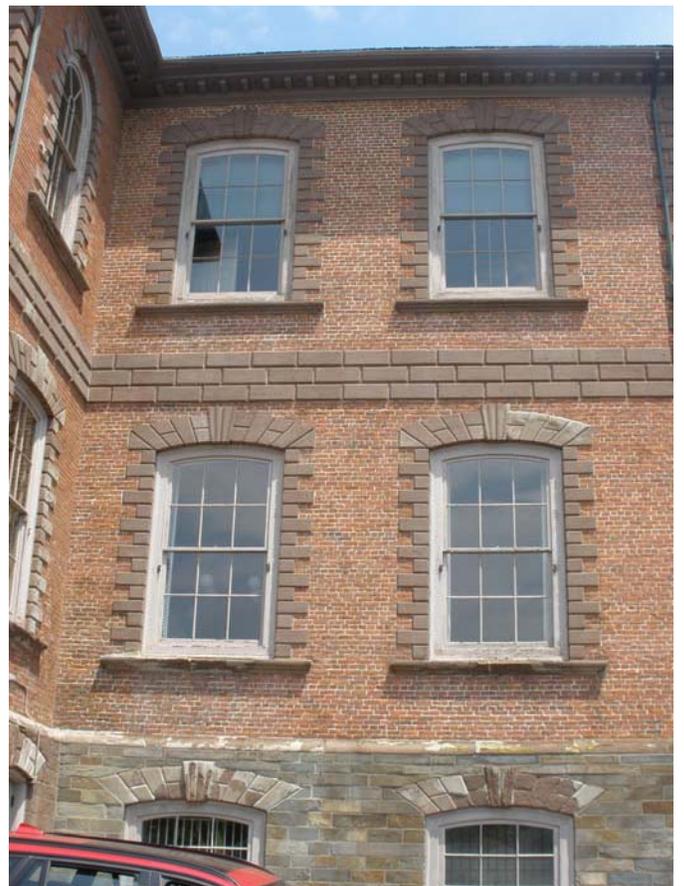
## Exterior Painting

The exterior trim on the building is all in need of painting with the exception of the upper tower. That includes all doors, window sash, door and window frames and cornices. The building was last painted in 1997. All loose, flaking or blistering paint should be carefully removed and the edges of all remaining paint should be feather sanded. All remaining painted surfaces should be lightly sanded to aid in the adhesion of the new paint. All cracks and voids should be filled with wood putty and sanded. Loose boards and nails should be renailed. Because of the nature of the work, age and condition of the surfaces involved and the historic value of the building, special care should be taken in preparation and finishing of all surfaces. Rotary sanders, high pressure water blasting, sandblasting and open flame torches to remove paint should not be permitted.

All new wood, if necessary, should be back primed and edge primed prior to installing. Before painting, all surfaces should be thoroughly washed clean with TSP and potable water. Dried and cracked wood should be treated with a natural consolidant before painting. All new wood and areas where paint has been removed to bare wood should be primed with an oil base primer, and all surfaces to be painted should receive two coats of finish. Paint should be Benjamin Moore Aura or approved equal.

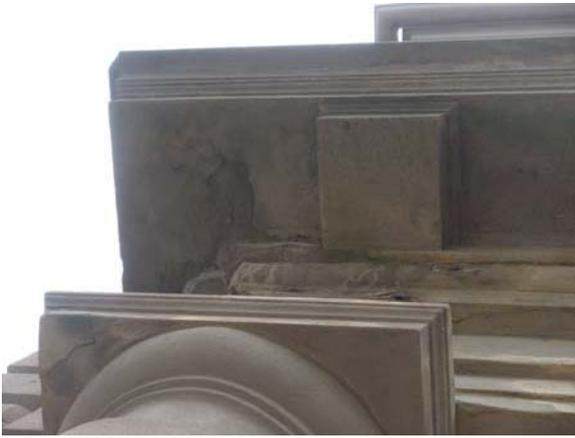
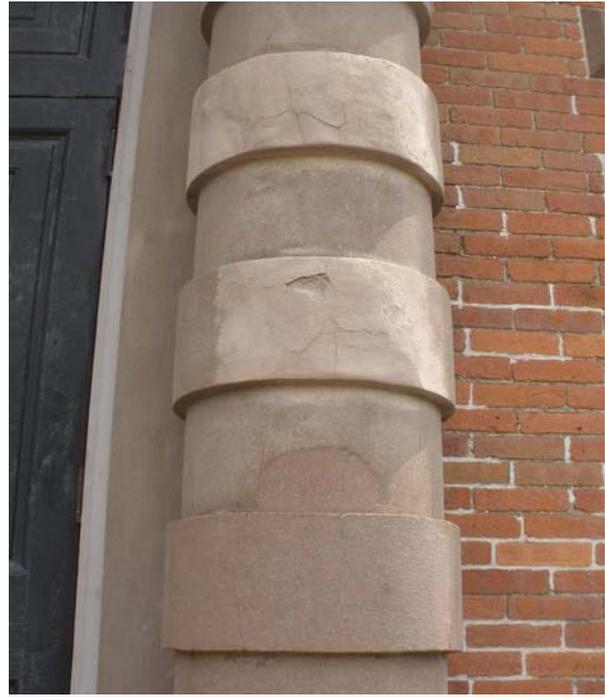
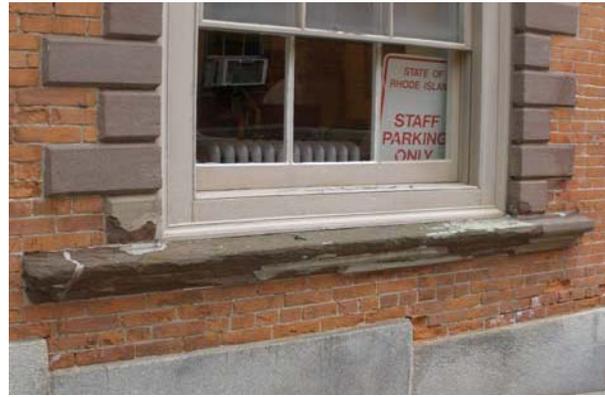
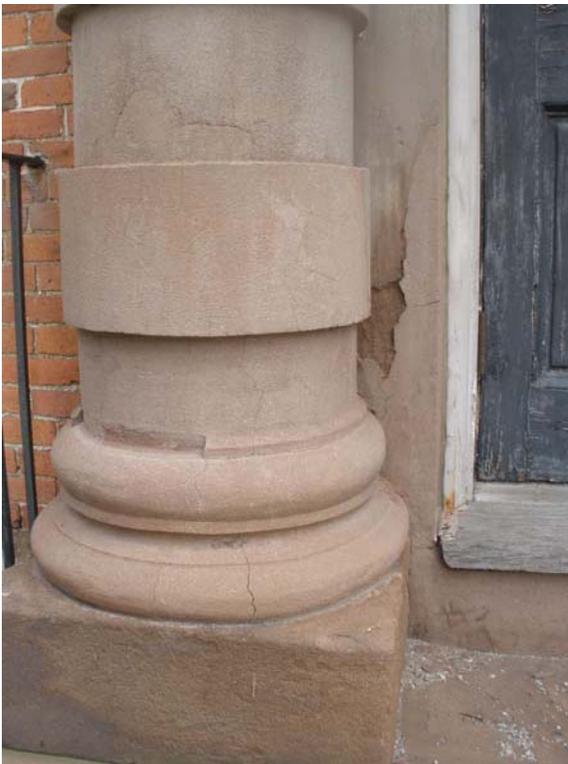
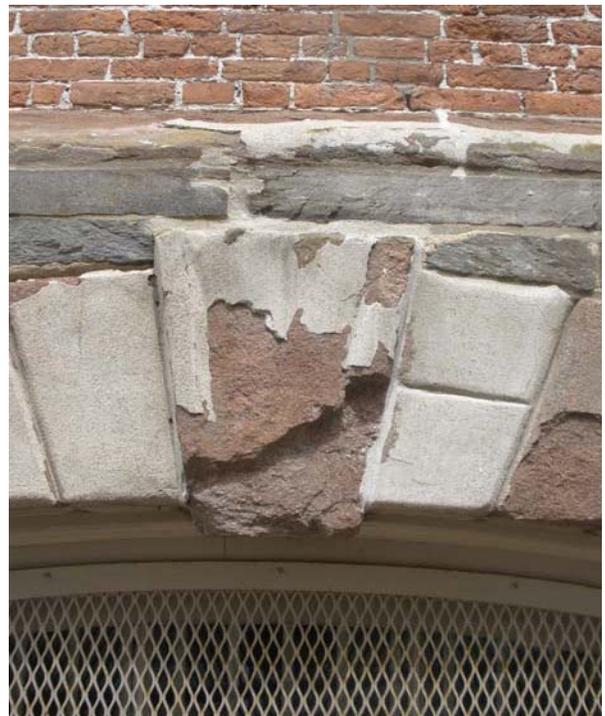
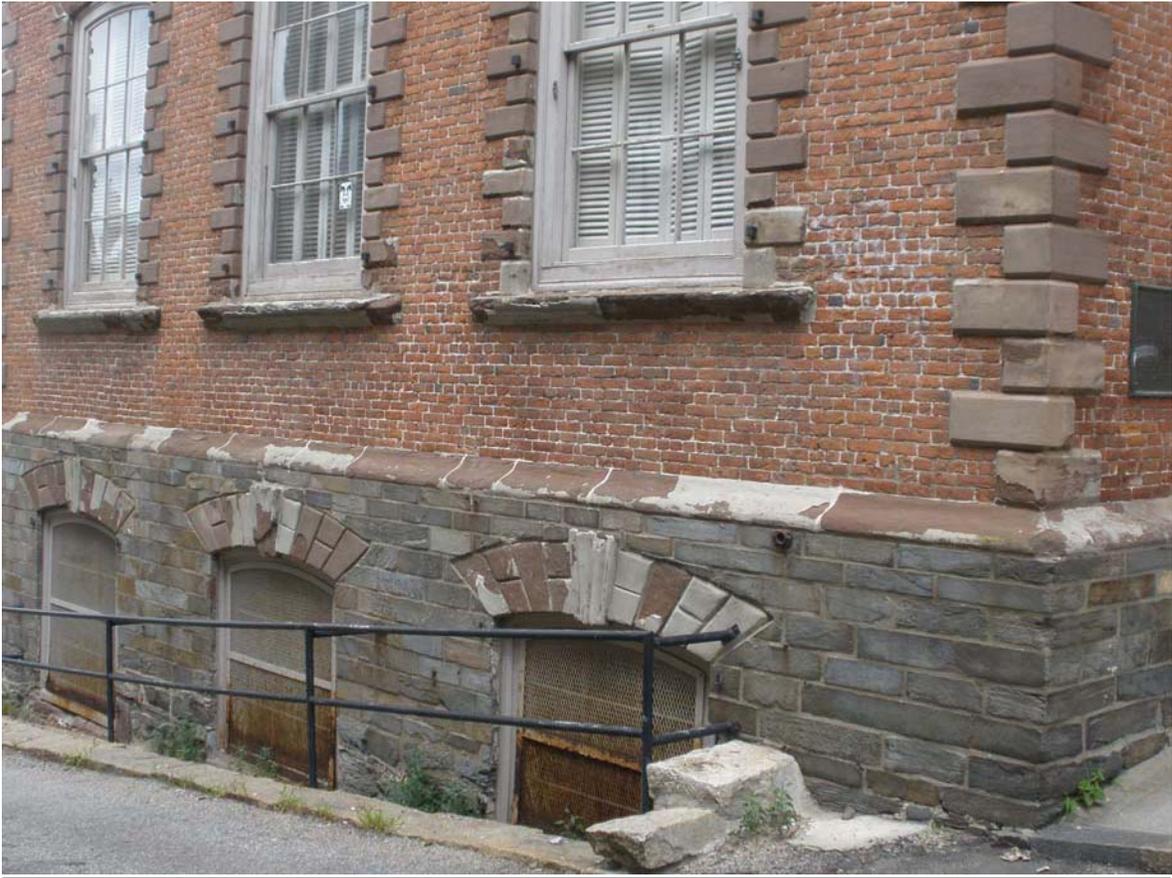
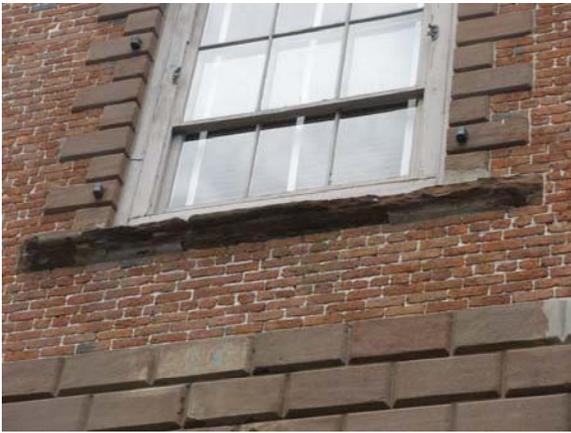
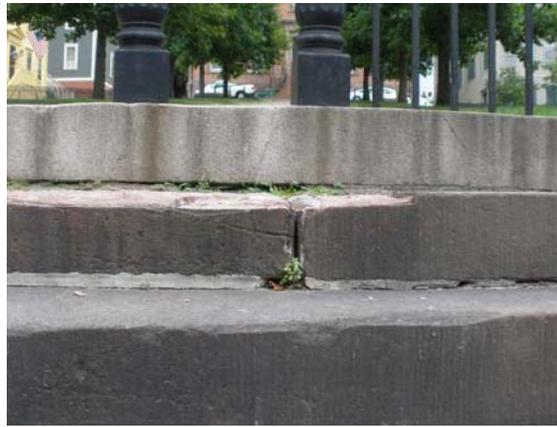
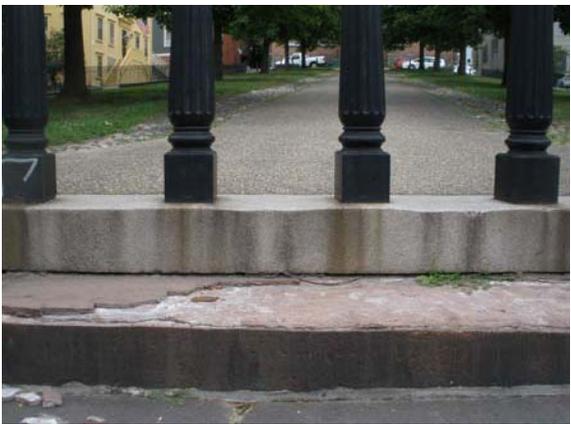
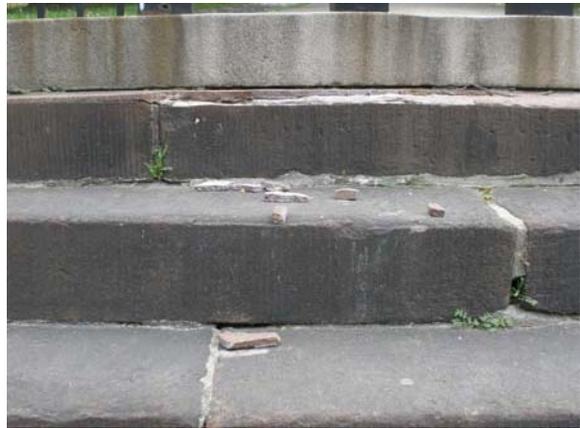
## Brownstone Repairs and Replacement

Deterioration of the brownstone masonry trim on the building has been a problem of long-standing. Patching of the most deteriorated features has been done as recently as the late 1990's. Additional patching and selective replacement of brownstone is needed to address the worst areas, which continue to erode and crumble off the building. This is a significant project in its own right, and requires the expertise of specialized consultants and contractors who are experienced in this kind of masonry repair.

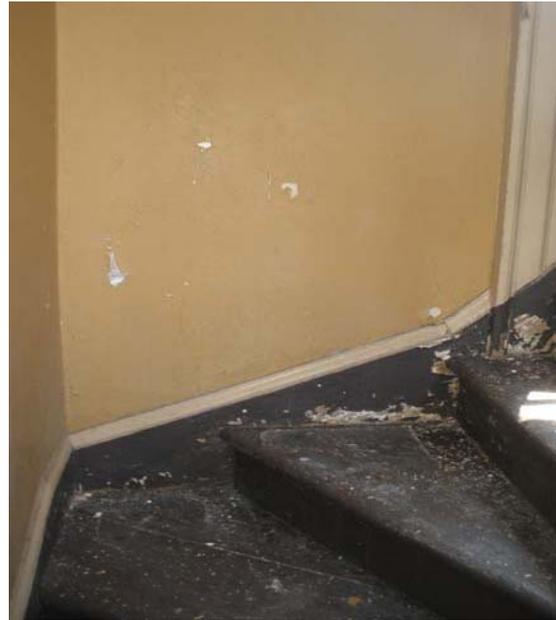
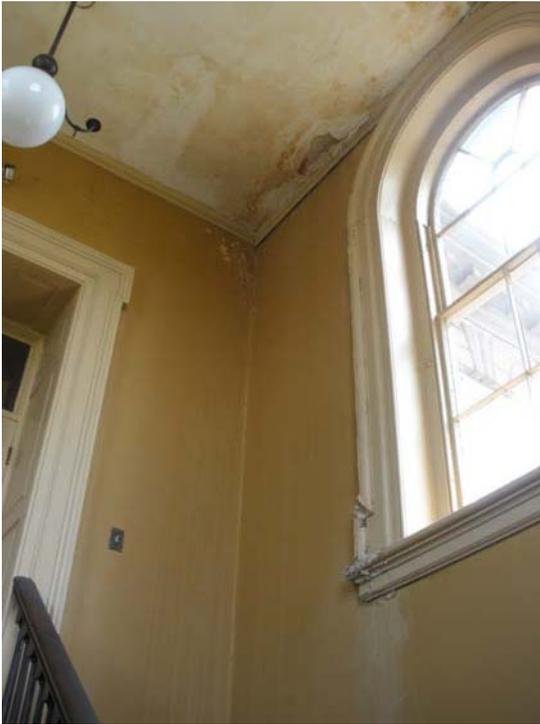
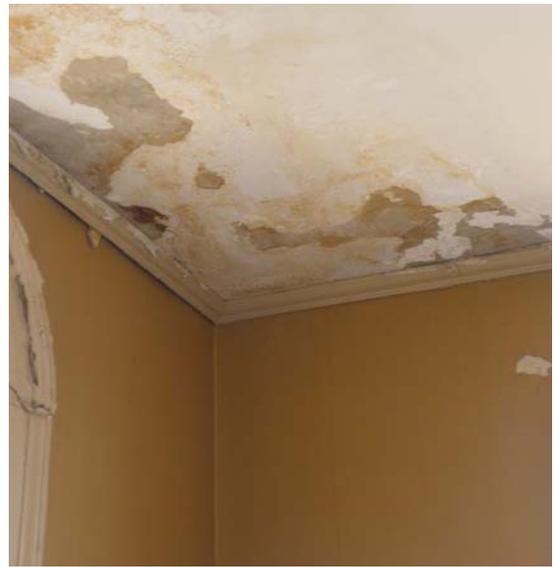
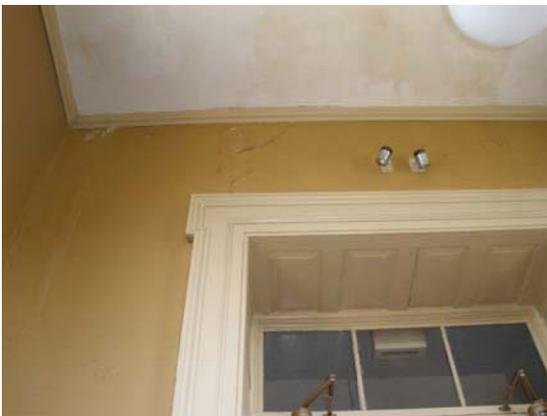
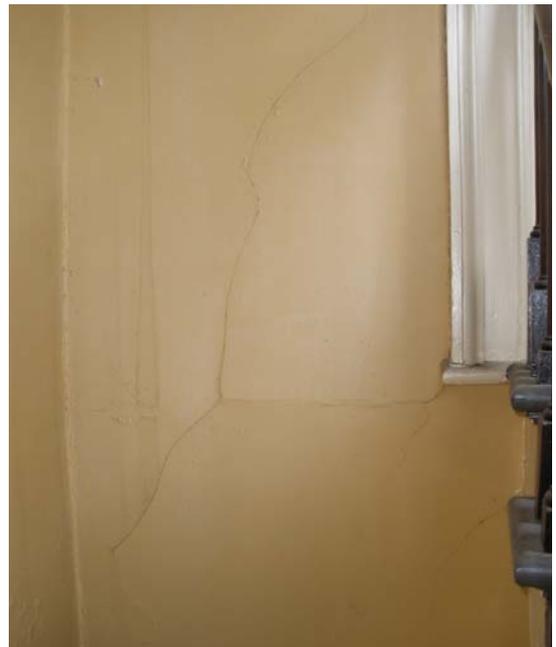
## Interior Plaster Repair at Tower

The plaster at the tower walls and ceiling is in disrepair due to continuous roof leaks that have caused serious water damage. The plaster should be evaluated. Any plaster that is beyond repair, to be determined in consultation with the RIHPHC Architects, should be removed and replaced in-kind. Plaster that can be retained and repaired should be carefully reattached and skim-coated as needed to blend with the existing/new plaster. Entire stair hall, including walls ceiling trim and stairs should be painted. Any new plaster should receive one coat of primer and two coats of finish paint. Colors will be selected by RIHPHC.

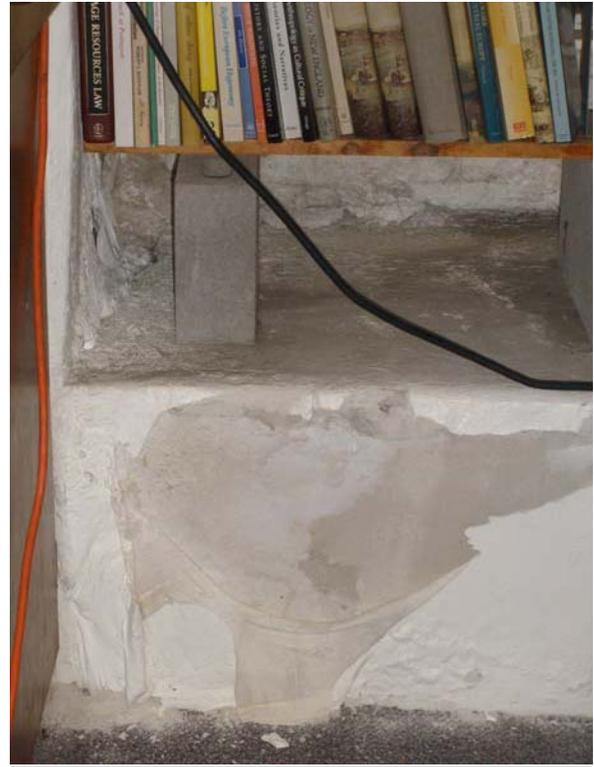
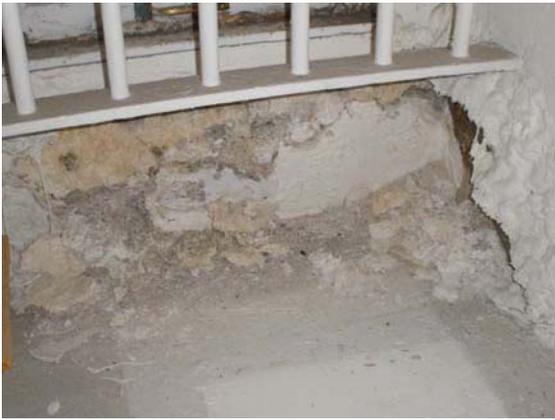
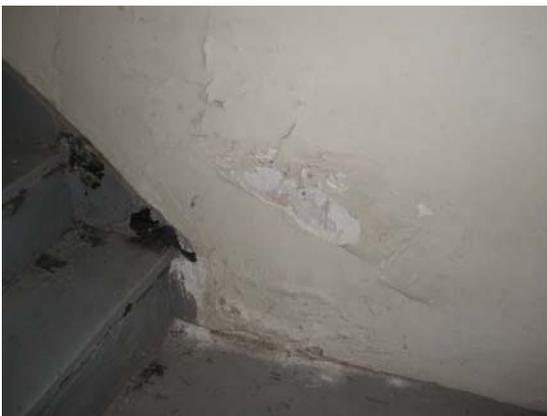
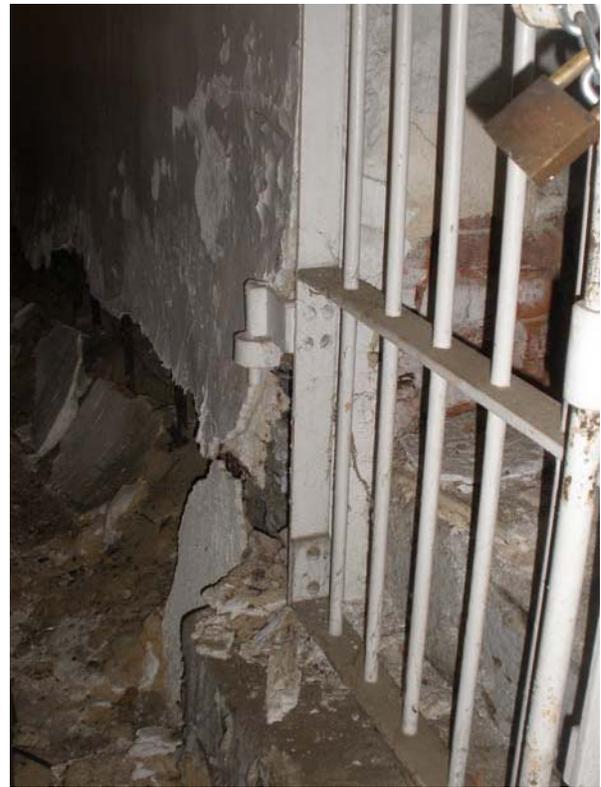
## Interior Plaster Repair at Basement

The south side of the basement is occupied by the Archeologist's Office and Repository. The plaster at the south walls is in disrepair due to water infiltration that has caused serious damage. The water infiltration problem has been addressed but the plaster has not been repaired. Any plaster that is beyond repair should be removed and a vapor barrier between the stone and new plaster should be used to prevent dampness from the stone foundation from damaging the new plaster. Plaster that can be retained and repaired should be carefully reattached and skim-coated as needed to blend with the existing/new plaster. Nu-wal system or similar product should be applied to the plaster to prevent future cracking and spalling.

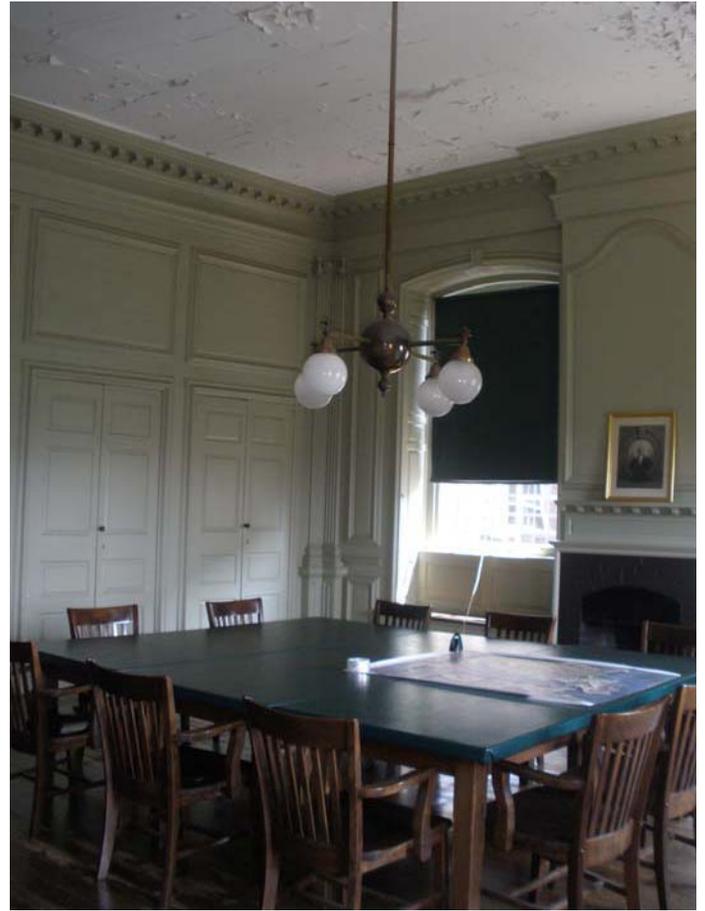
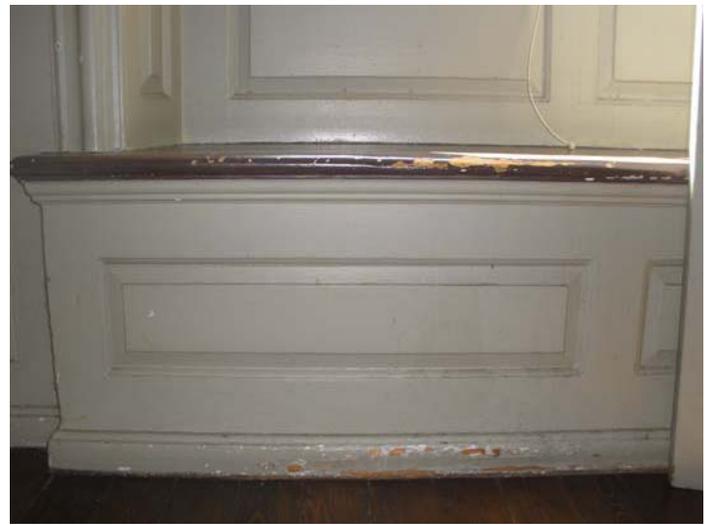
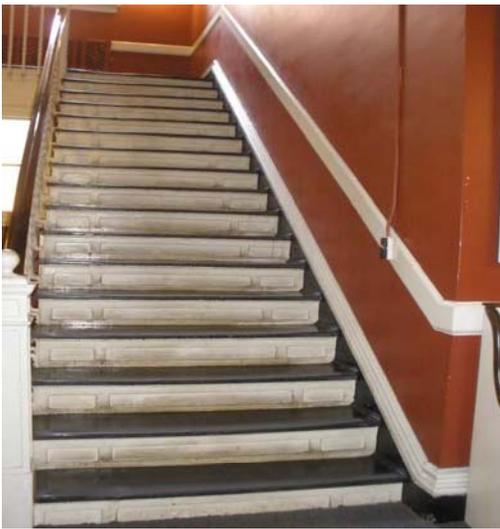
### Interior Painting

The principal public spaces of the building are all in need of painting. These spaces include the Benefit Street entry stairhall, the first floor courtroom, the second floor stairhall, the second floor paneled room (meeting room), a small second floor office and the Archeology lab in the basement. These spaces were last painted in the late 1980s. Surfaces to be painted include all doors, window sash, door and window casings, plaster walls and ceilings. All loose, flaking or blistering paint should be carefully removed and the edges of all remaining paint should be feather sanded. All remaining painted surfaces should be lightly sanded to aid in the adhesion of the new paint. All cracks and voids should be filled and sanded. Because of the nature of the work, age and condition of the surfaces involved and the historic value of the building, special care should be taken in preparation and finishing of all surfaces. Before painting, all surfaces should be thoroughly washed clean with TSP and potable water. Dried and cracked wood should be treated with a natural consolidant before painting. All new wood and areas where paint has been removed to bare wood or plaster should be primed with an oil base primer, and all surfaces to be painted should receive two coats of finish. Paint should be Benjamin Moore Aura or approved equal.
