## ADDENDUM # 4

BID # 7449531 BID TITLE: A & E -- OLD STATE HOUSE

**NEEDS ASSESSMENT FOR  
THE OLD STATE HOUSE  
150 BENEFIT ST  
PROVIDENCE, RI**

**RESTORATION AND MAINTENANCE NEEDS**

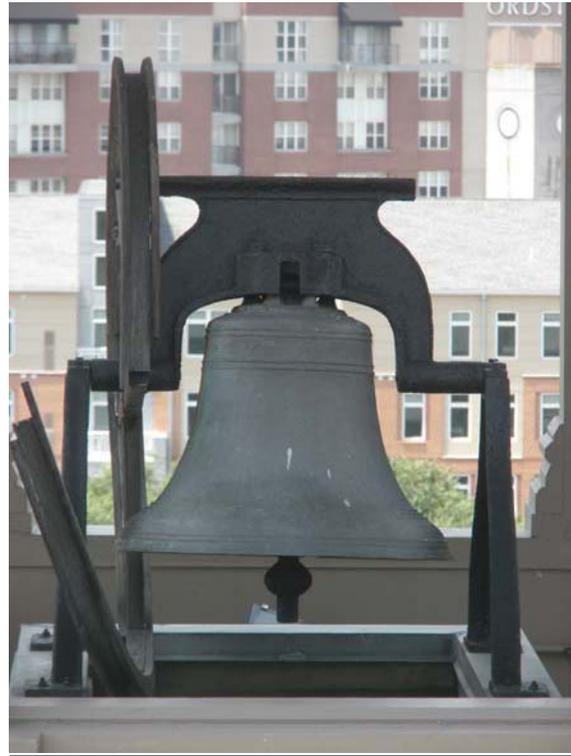
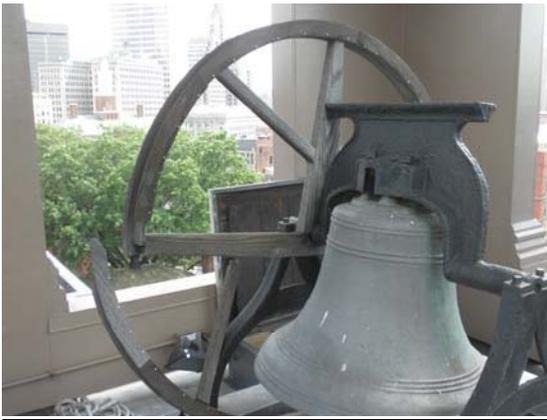
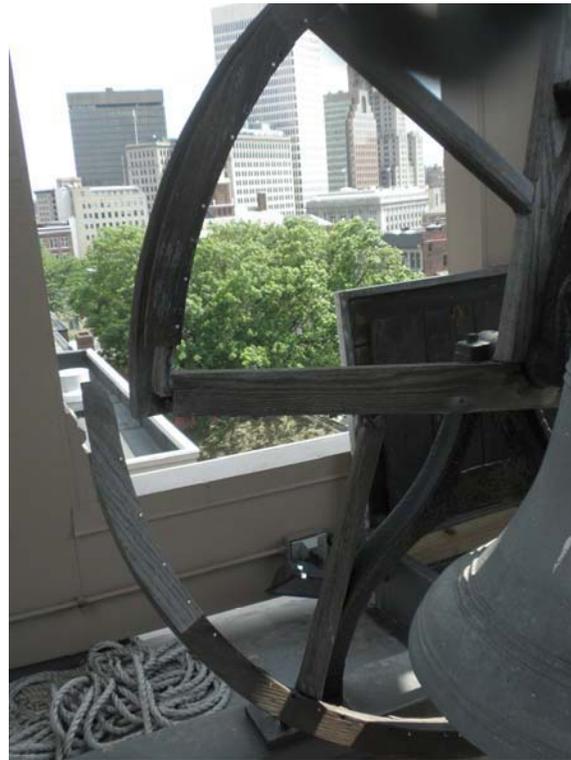
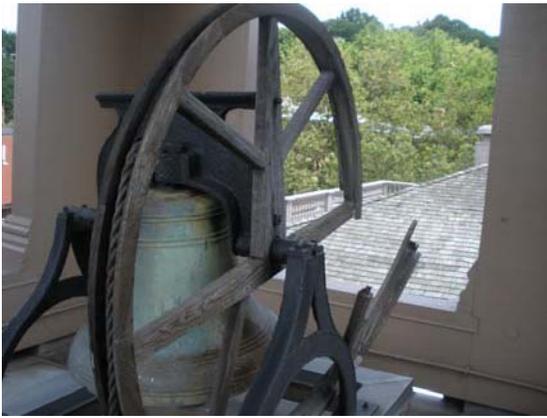
## Bell Carriage

The Bell carriage in the tower which operates the bell is in serious disrepair. Repairs that have been made in the past are now failing. It may be necessary to replace the entire wheel and any other wooden components of the carriage. The new wheel must replicate the existing in size, configuration and wood species if possible. If any of the existing wheel can be salvaged and reused, it should be incorporated into the new wheel. The new components should be installed in the bell tower and the bell should be attached and made to work.

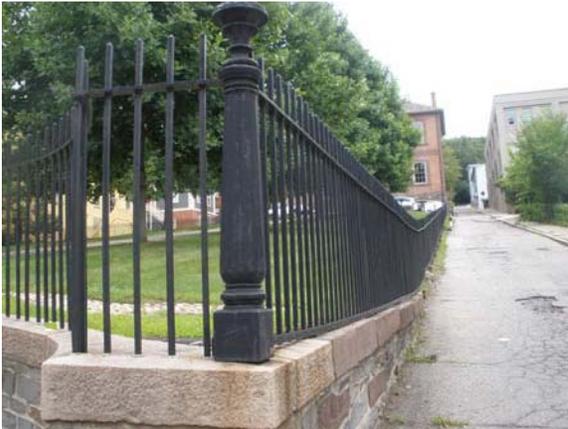
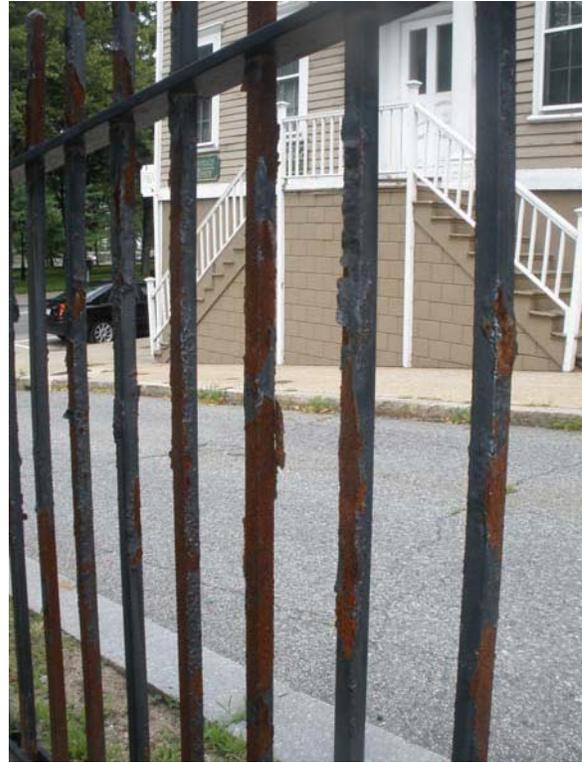
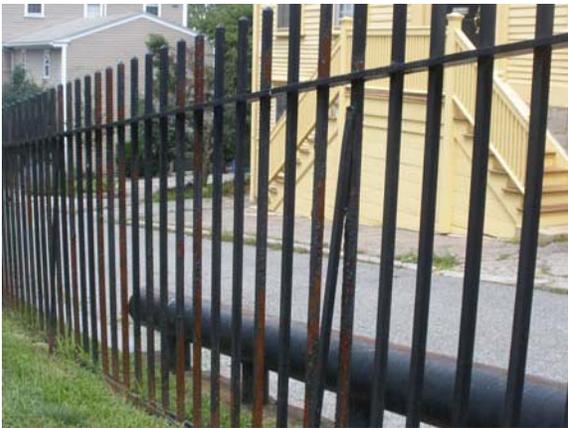
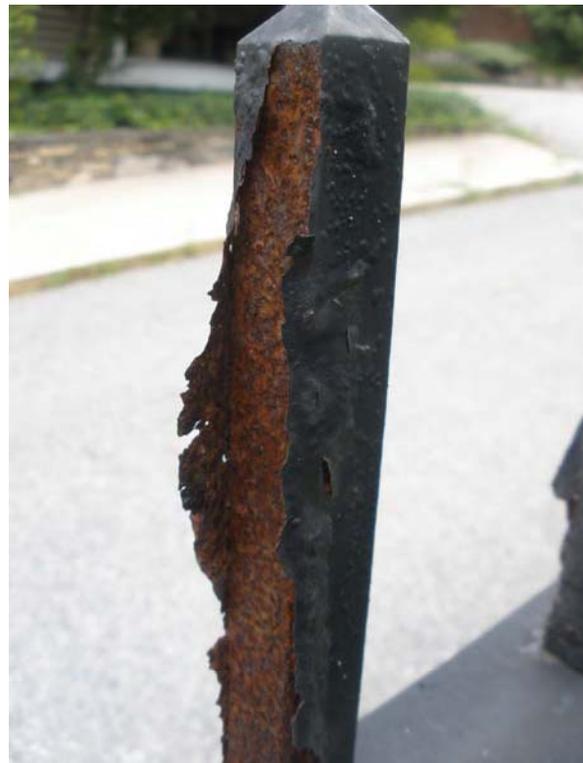
## Wrought Iron Fence Painting

The wrought iron fencing, which surrounds the parade ground and runs along North Court Street, South Court Street and North Main Street, is in need of painting. The fence, which is painted black, is rusty and peeling. All loose and flaky paint should be scraped and sanded. The rust should be removed using a wire brush. The fence should be primed with an oil rust inhibiting primer and finished painted with two coats of Benjamin Moore Metal Enamel. Final coat should be brushed on.
