CREATION DATE : 18-OCT-13
 BID NUMBER: 7527366
 TITLE: DEMOLITION OF STRUCTURES &
 ASBESTOS/DEBRIS REMOVAL - DOT
 BID CLOSING DATE AND TIME: 08-NOV-2013 02:00:00

**PRE-DEMOLITION SURVEY
OIL AND HAZARDOUS MATERIALS
UNIVERSAL WASTE
ASBESTOS CONTAINING MATERIALS
LEAD BASED PAINT COATED MATERIALS**

**FORMER HOLLYWOOD LANDSCAPING
3034 POST ROAD
WARWICK, RI**

**ASBESTOS CONTAINING MATERIAL AND
LEAD BASED PAINT COATED MATERIAL SURVEY**

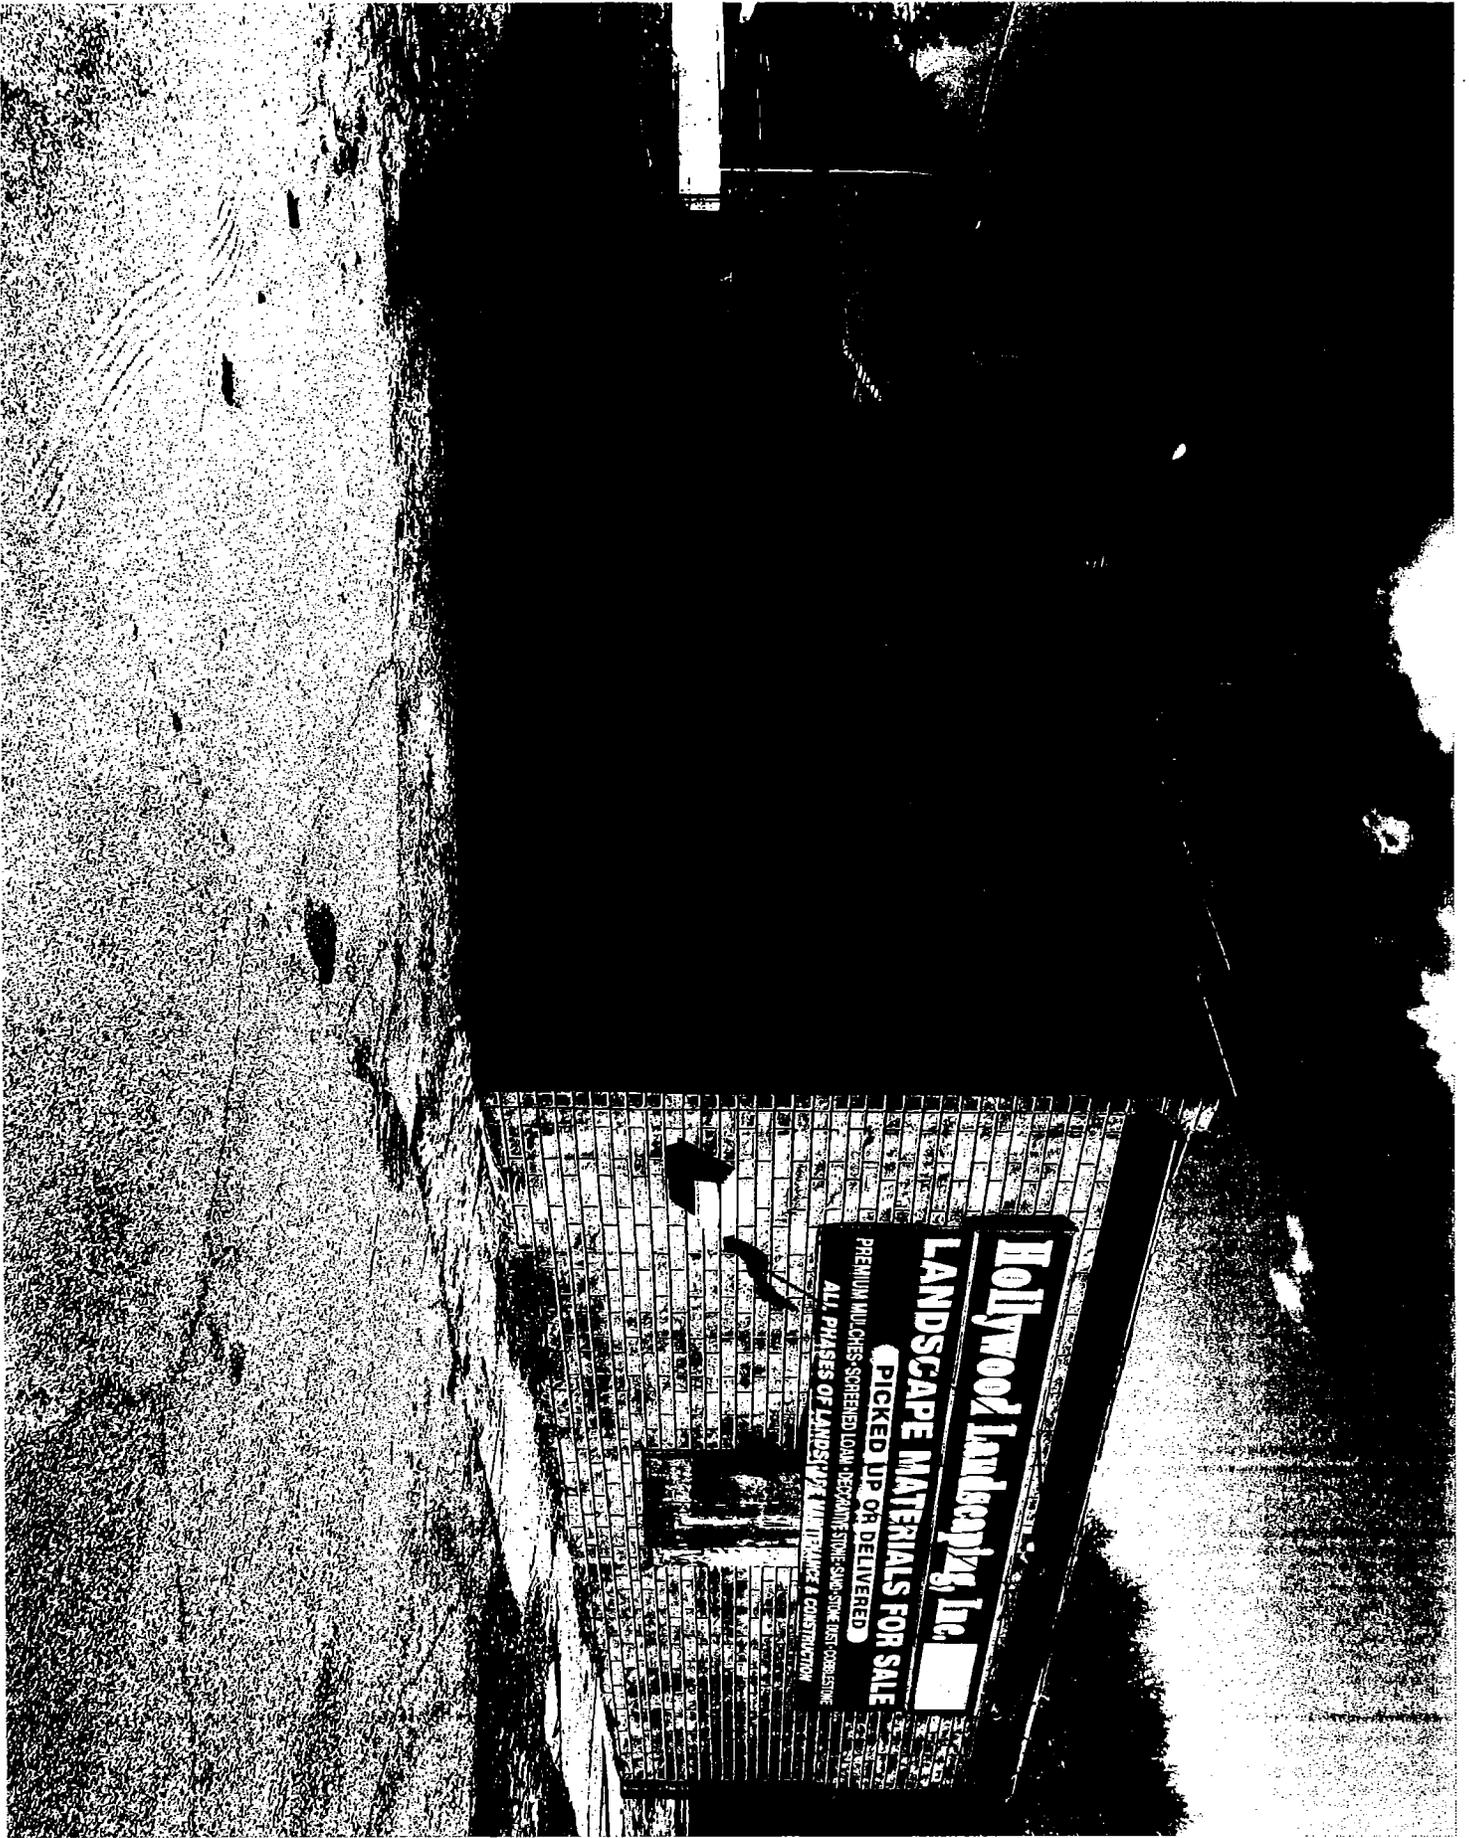
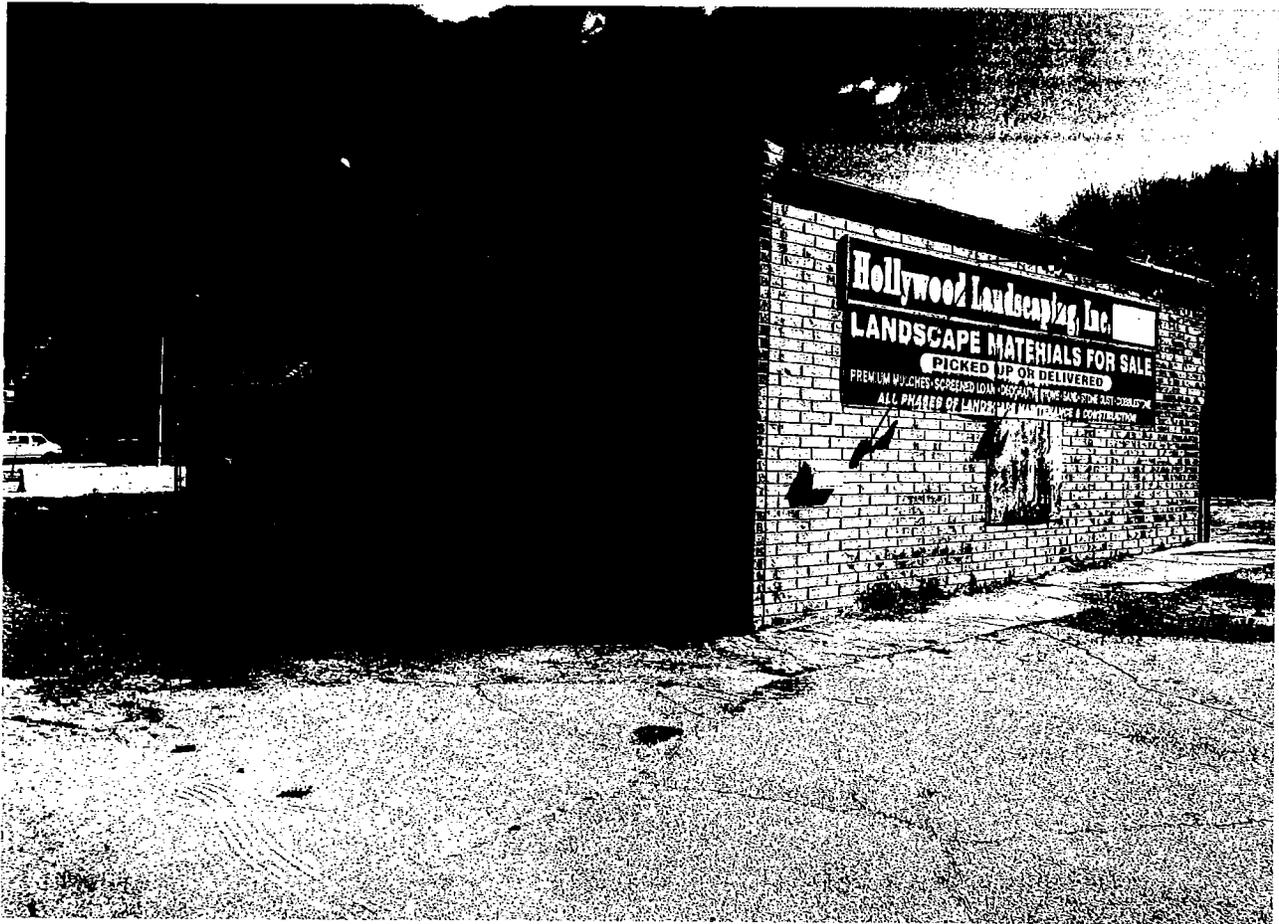
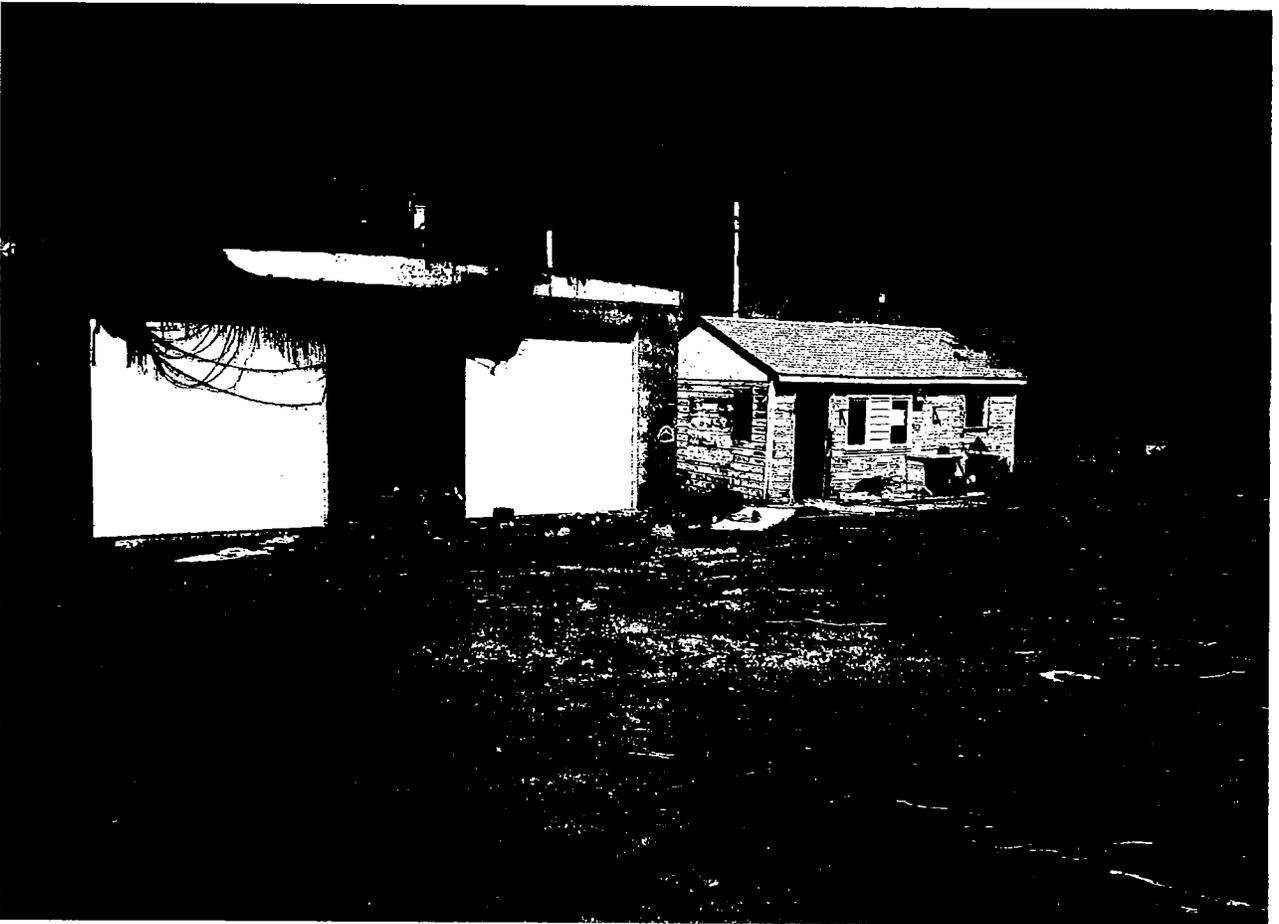
One of the buildings is a flat roofed brick garage brick garage. The west side of the garage has two vehicle-door ways closed with brick. Three windows and one doorway were installed in the closed doorways. Two vehicle access overhead garage doors are located on the structure's east side. A doorway is found at the building's north-west corner.

The other two buildings are wood shingled one story structures with concrete slab on grade floors. The structures are separated from each other by approximately five feet and are connected via an interior hallway. The northwest structure's exterior walls are surfaced with wood shingles and what appears to be asphalt shingles on the four-pitched roof. One door and windows are present on the structure's east side. The northeast structure's exterior walls are surfaced with wood shingles and what appears to be asphalt shingles on the two-pitch roof. One door and two bay windows are located on the structure's west side.
