LOI # 7243882

**TITLE: A & E Services – Rhode Island College Recreation Center**

**RHODE ISLAND COLLEGE**  
**SCOPE OF WORK**  
**ARCHITECTURAL/ENGINEERING**  
**RECREATION CENTER**

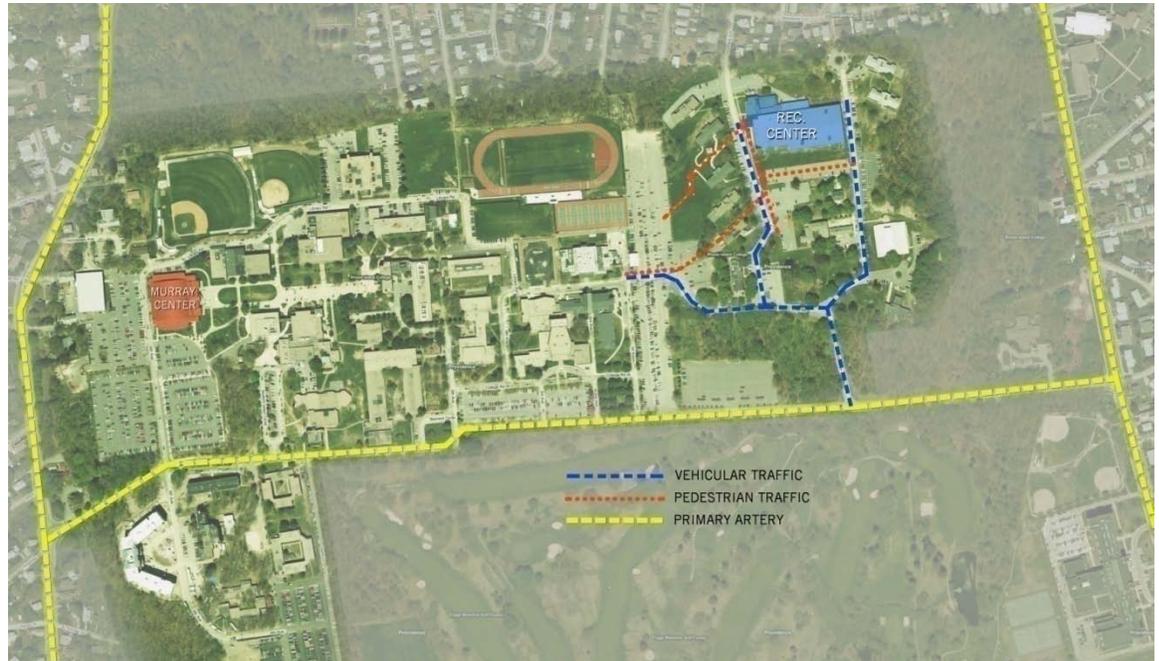
Figure 1. Campus Plan. The Recreation Center serves as the “activity” hub of the east campus.

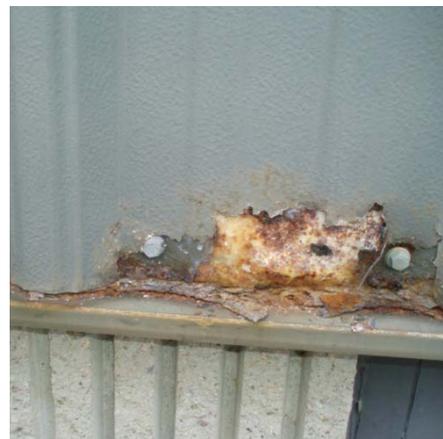
Significant rusting has occurred at the bottom edge of the metal paneling throughout the perimeter of the fieldhouse and natatorium. This condition is primarily the result of metal flashing construction above the concrete masonry, where water is allowed to stand, and thereby oxidize the adjacent vertical metal panels. Water is not properly weeping off the building at this location because paneling had been sealed tight to the base flashing, which also prevents the interior of the wall system to vent. Additionally, because of increased humidity at the natatorium (and to a lesser extent at the fieldhouse), water vapor is allowed to collect on the interior surface of the metal panel during cooler months, notably in areas where the vapor barrier and insulation are damaged or have been removed completely. Vapor moves down along the panels' inside face and seeps behind the flashing, thereby contributing to the rusting at this location.

In several instances, batt insulation was improperly installed between the flashing and metal panel, allowing the insulation to become saturated where the metal panel did not stand clear of the base flashing. Mold has been identified in these locations. At the north side of the building, outside of athletic offices, metal panels have been vandalized and damaged from vehicular contact. Water intrusion has also been identified within this wall system on the north side, in part due to improperly drained roofs and unsuitable weeping details.

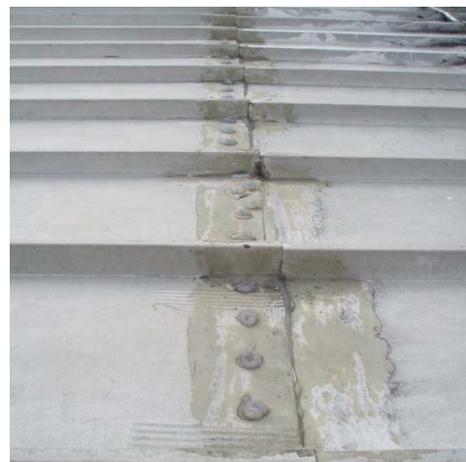
Roofing at the 1980's addition is predominately exposed seam metal with standard aluminum gutters and leaders. The fieldhouse roof is insulated in similar fashion to the exterior walls with a vinyl vapor barrier and batt insulation fastened between roof purlins. Roof drainage at these sloped metal roofs show evidence of being inadequate; many locations suffer from congested and damaged gutters. Panels are fastened to roof purlins with rivets. These rivets along with metal roofing seams are water sealed with a silicone-based exterior caulking. Sealant has shown significant decay and is largely ineffective, and often the source of various leaks. In areas where mechanical units sit, water has filtered into the building and saturated batt insulation at the roof. Damaged insulation has fallen into the fieldhouse on several occasions.

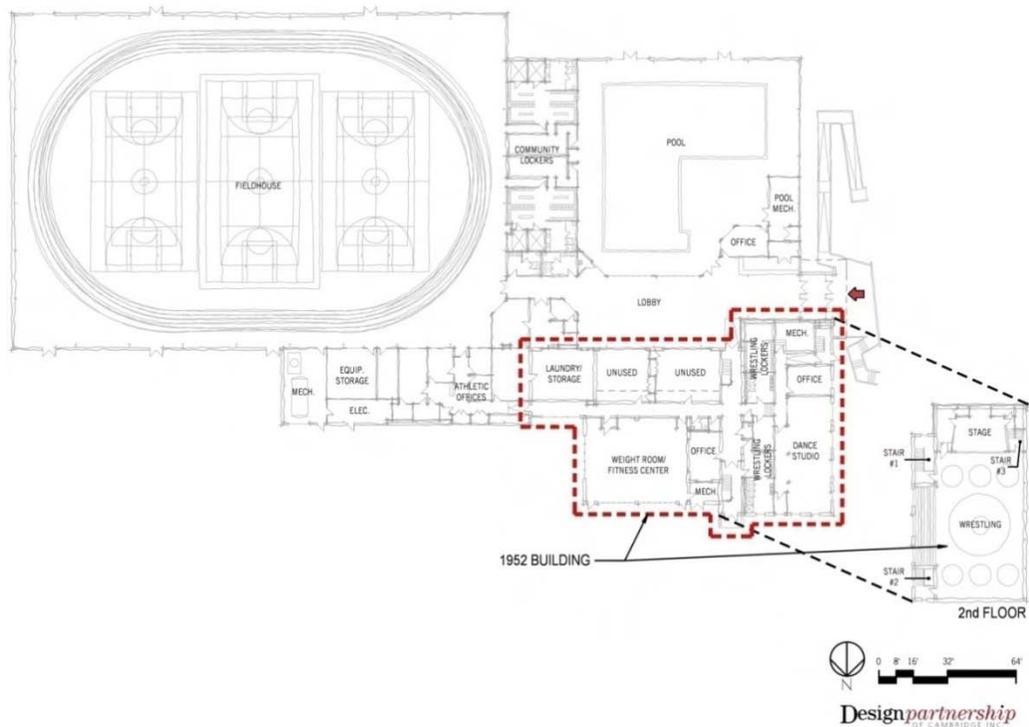
Figure 2. Existing Conditions Floor Plan.

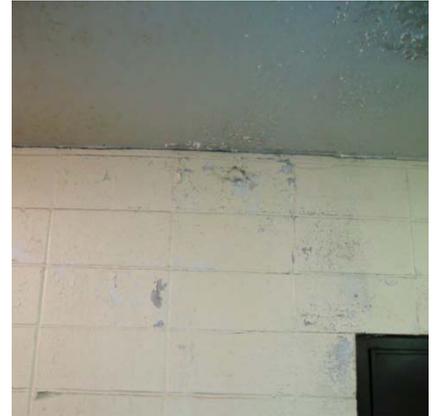
- At male locker room, gang showers are strongly disliked by students and faculty.
- Poor ventilation has led to significant disrepair of painted gypsum board ceilings.

- Trench drains at both male and female showers are undesirable and difficult to maintain.
- Thin sheet tile at locker rooms have worn significantly due to heavy use, and are not durable enough surfaces to be used within the locker areas.
