**TITLE: Engineering Services Building Envelope Repairs and Leak Investigation
RI Youth Training School**

- **This addendum releases Attachment A - A report and analysis conducted by the firm of Simpson, Gumpertz & Heger**

Project 100264 – Leakage Investigation, Roosevelt Benton Youth Assessment Center,
Pastore Government Center, Cranston, RI

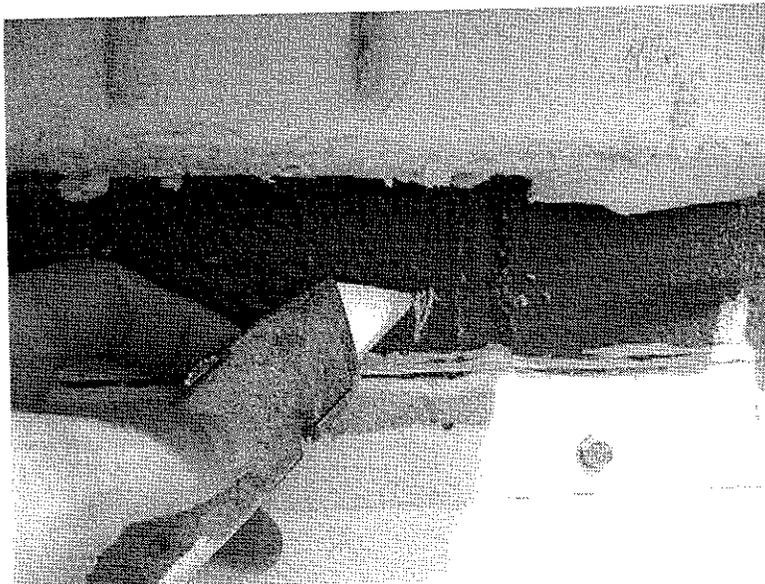
Photo 9

Small area of dampproofing scraped away to show thickness

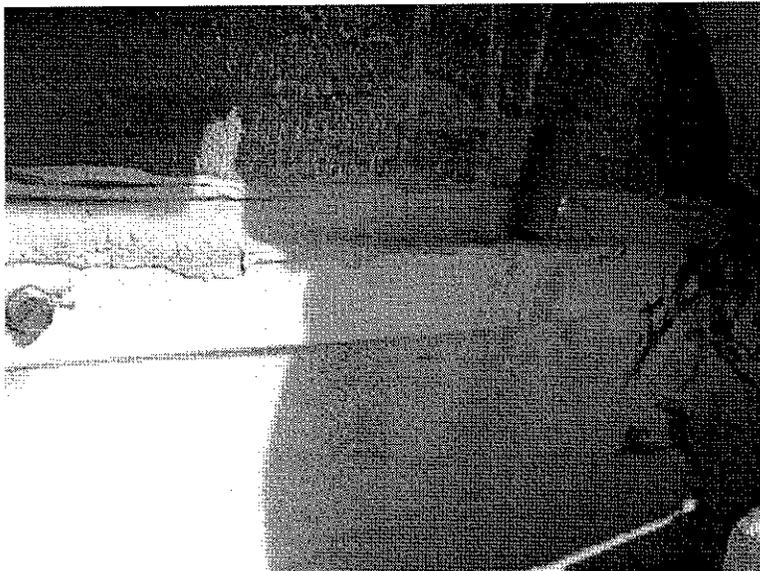
Photo 29

Pressure bar at top edge of fabric flashing not tight to backup wall

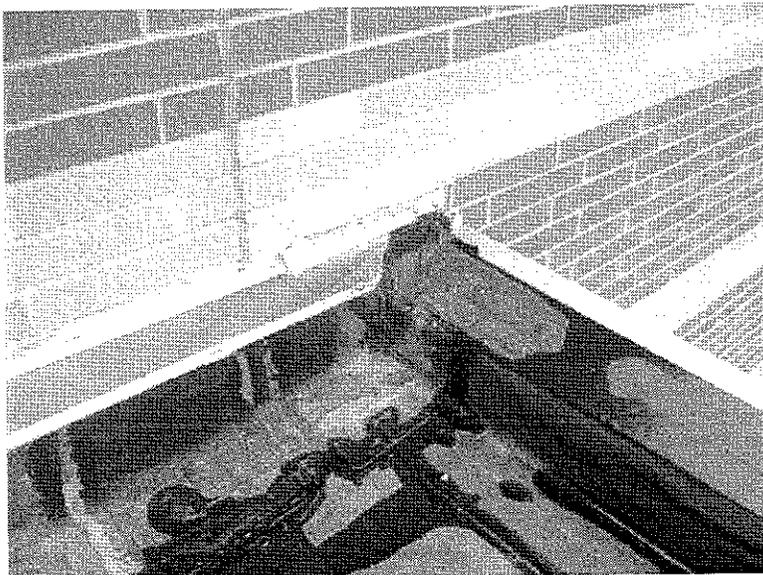
Photo 36

Roof edge termination/
transition

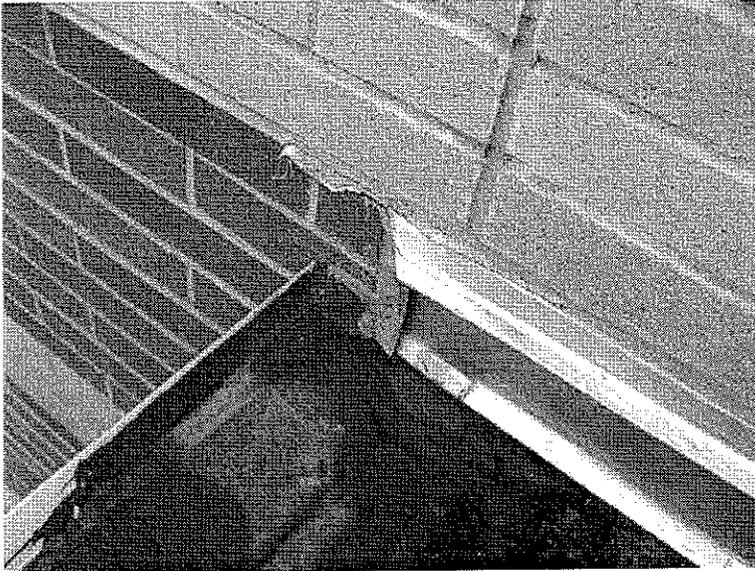
Photo 37

Roof edge termination/
transition.

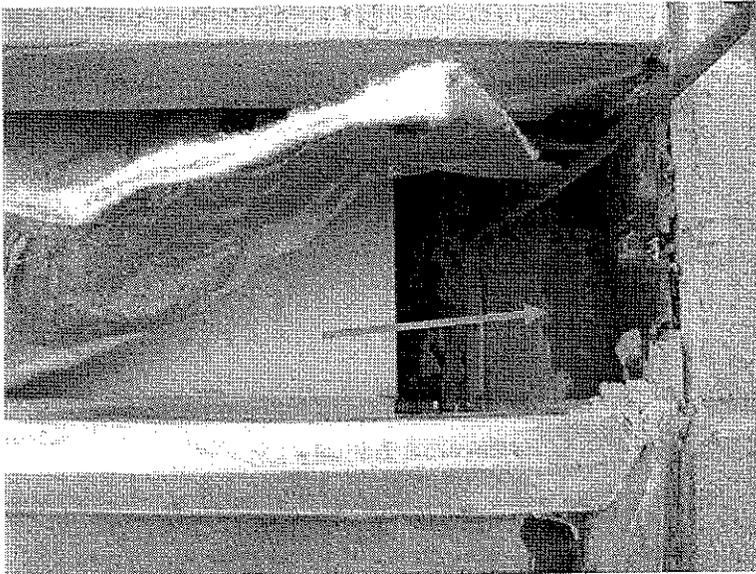
Photo 38

Metal pipe or column that
interrupts CMU backup at
Area 2 wall.

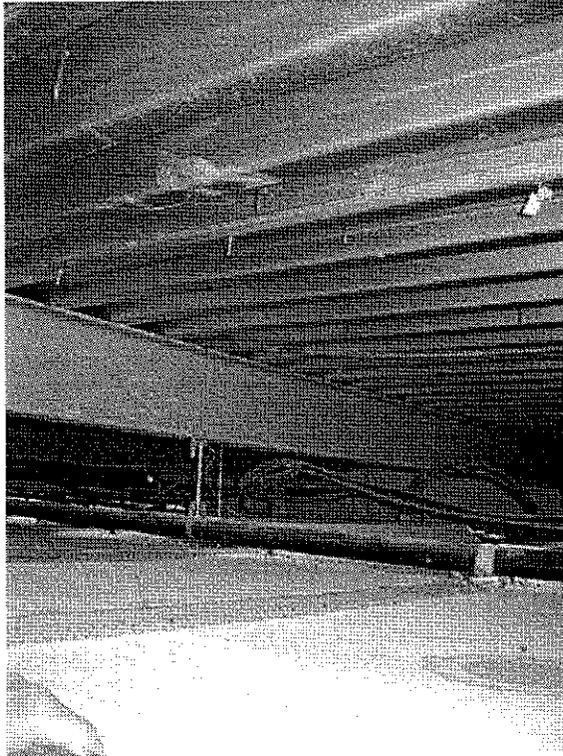
Photo 43

- The roofing system consists of (from top to bottom) a fully adhered 0.060 in. thick black Carlisle EPDM membrane, multiple layers of mechanically attached rigid polyisocyanurate (iso) insulation boards with fiberglass facers, and a structural deck (Photo 42).
- A precast concrete plank deck is present at Area 1, though Area 2 and various other areas of the building include corrugated metal decking. At Area 1 it is unclear if sloped insulation is provided or if a sloped concrete topping layer is in place. Corrugated decking below Area 2 runs almost parallel (slightly skewed) to the longitudinal exterior walls, and structural steel I-beams run perpendicular to the walls and extend to the CMU backup of the walls (Photo 43).
- No vapor barrier is present below the insulation.

Corrugated steel decking
and steel I-beams supporting
Area 2.

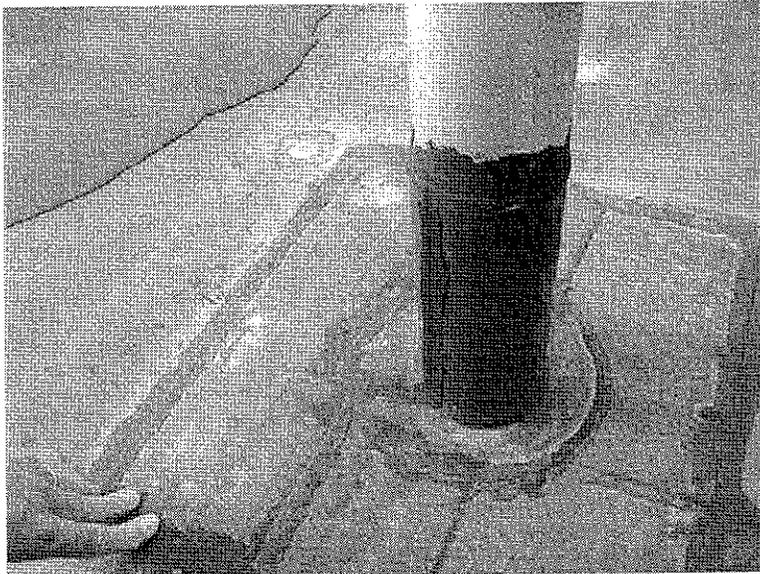
Photo 44

- Seams in the EPDM membrane are treated with butyl seam tape.
- Various penetrations and flashings are present, such as round pipe penetrations with pipe-wrap flashings and pitch pockets at irregular penetrations (Photos 44 and 46). We do not note any complex, unusual, or otherwise suspicious roof penetrations. A lightning protection system is in place along many roof edges. Most clips for the lightning wires are adhered in place (Photo 47), though at upstands/"spikes," the attachment brackets are screwed down through the roofing with a single lag screw or bolt (Photo 48).

Roof penetration flashing
detail at Area 1; no obvious
defects noted

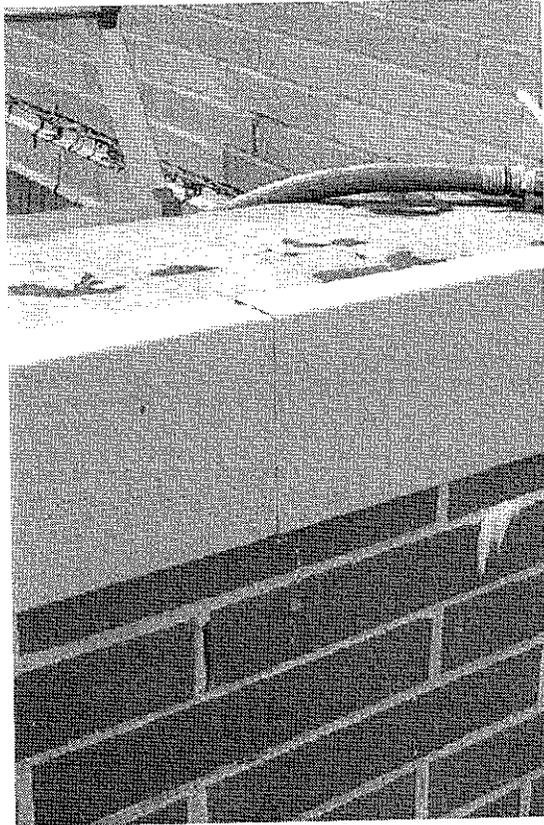
Photo 50

Typical roof edge flashing/
gravel stop with fascia
(F-shape).

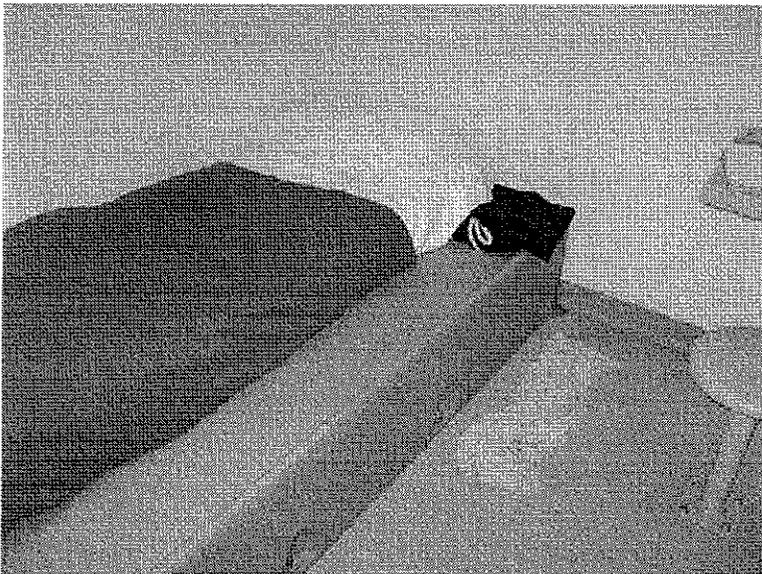
Photo 64

Test ID	Location	Test Type	Approx. Duration (min.)	Leakage Observed	Other Comments
Water Test 1 (WT1)	Area 1 – Roof (Photo 63)	Flood test/spray rack	120+	None*	*Water noted on floor of Unit A-105 below though not coming from roof/ceiling above (Photo 64); likely related to spigot leakage and TWF at grade.
WT2A	Area 1 – TWF via weep vent, just east of louver (Photo 65)	Hand nozzle, < 1 psi	30	None	
WT2B	Area 1 – TWF via weep vent, below east portion of louver	Hand nozzle, < 1 psi	20	None	
WT2C	Area 1 – TWF via weep vent, below east portion of louver	Hand nozzle, < 1 psi	20	Heavy leakage into Unit A-105 (drips from above; Photos 66 – 67) and adjacent common space/dayroom (noted at 10 min)	Feeler gage enters between fabric flashing and metal drip here; also location of seam in metal drip flashing Leakage occurs at location of stained ceiling tiles and other water stains below.
WT3	Area 1 – Masonry and TWF by west portion of louver (Photo 68)	Spray rack	< 5	Heavy leakage into Unit A-105 (drips from above; Photo 69) and adjacent common space/dayroom (noted almost immediately; <3 min.).	Louver masked off with plastic. Leakage occurs at location of stained ceiling tiles and other water stains below

Water noted on the floor
during WT1

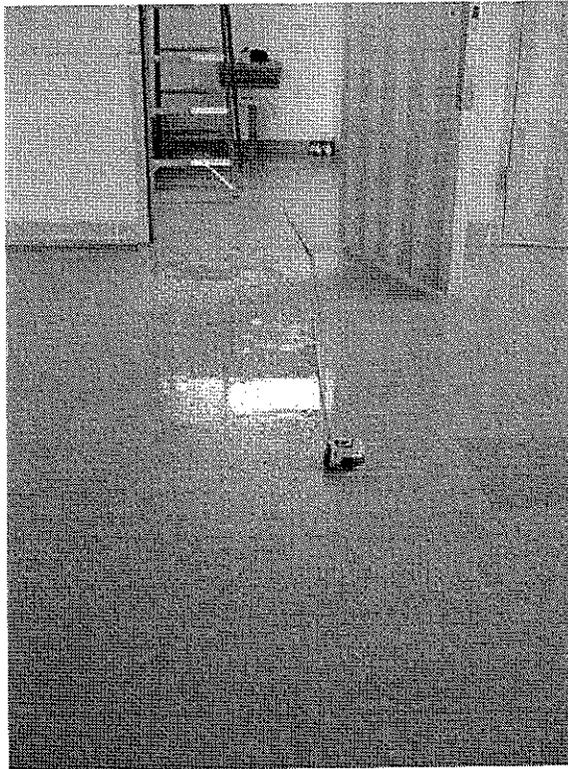
Photo 67

Water collecting on floor during water test.

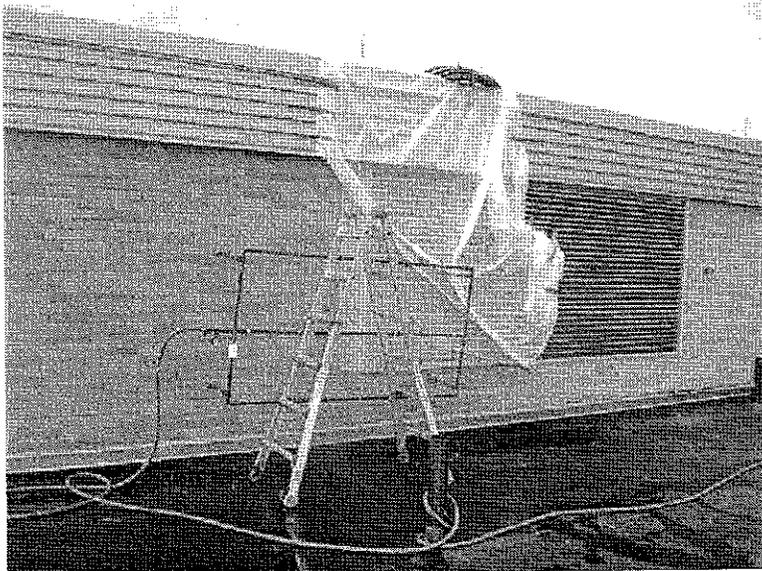
Photo 68

WT3 in progress.

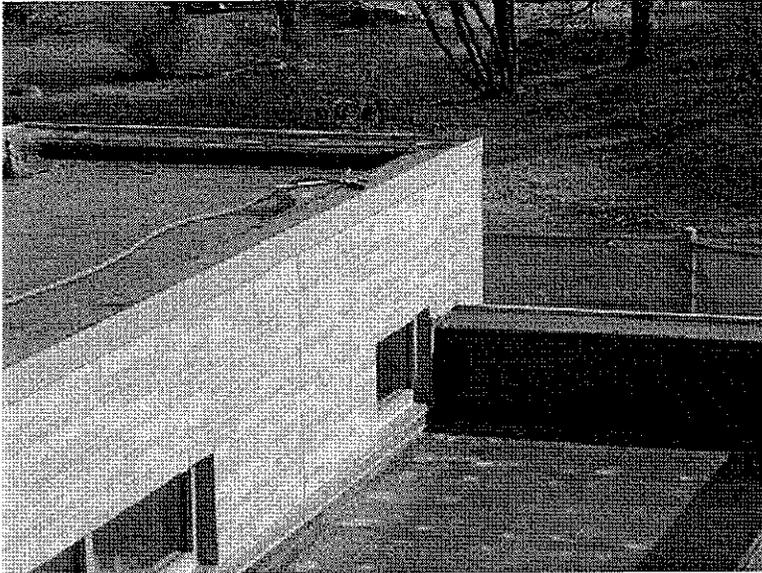
Photo 76

Test ID	Location	Test Type	Approx. Duration (min.)	Leakage Observed	Other Comments
WT12	Area 3 – Roof, southwest end	Spray rack	60	None.	
WT13	Area 3 – EPDM and roof edge flashing (gravel stop) at parapet at outside building corner (Photo 76)	Spray rack	30	<u>Leakage</u> running down inside face of CMU wall (noted at 20 min. though likely started earlier).	Leakage occurs at location of water stains/ streaks on inside surface of CMU wall
WT13A	Area 3 – EPDM and roof edge flashing (gravel stop) at parapet at outside building corner; water directed at gap between gravel stop and EPDM below (Photo 77)	Hand nozzle, < 1 psi	10	<u>Heavy leakage</u> running down inside face of CMU wall (noted at < 5 min) (Photo 78).	Leakage occurs at location of water stains/ streaks on inside surface of CMU wall.

WT13 in progress
